DeKalb County Historic Preservation Commission

Staff Report

H. 1397 & 1399 Oxford Road, Vickers Design Group. Demolish a nonhistoric and a historic structure, construct a nonhistoric mix use building. **1247410.**

Two-Story Building Built in 1920s; One-Story Building Built in 1960s. (18-053-02-003)

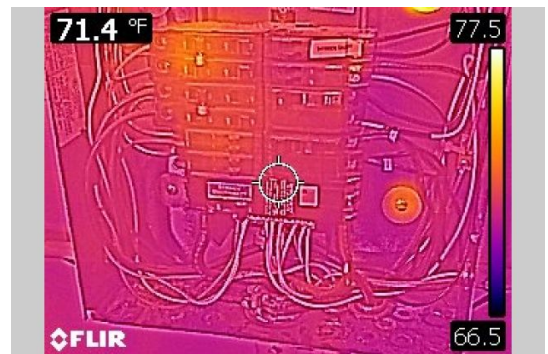
CONDITION #23

Location: House
Condition: Oxide Inhibitor Paste Missing in Panel Connections
Explanation: An oxide inhibitor applied to the aluminum wire connections reduces or prevents oxidation from occurring and should be applied by a licensed electrician. Corrosion was also noted on some breakers.
Suggested Action: Have a licensed electrician replace all compromised components and apply oxide inhibitor.
Significance: Safety Concern

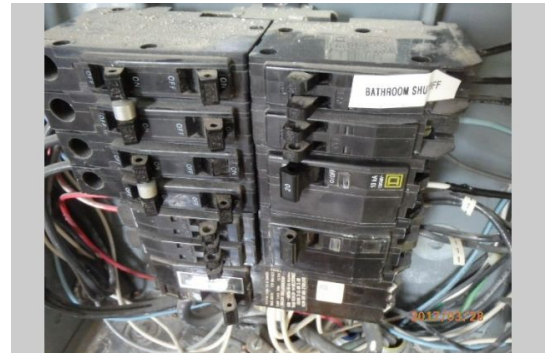
CONDITION #26

Location: Both Panels
Condition: Damaged Breakers
Explanation: Knobs are broken off of some breakers.
Suggested Action: Have all damaged breakers replaced,
Significance: Safety Concern

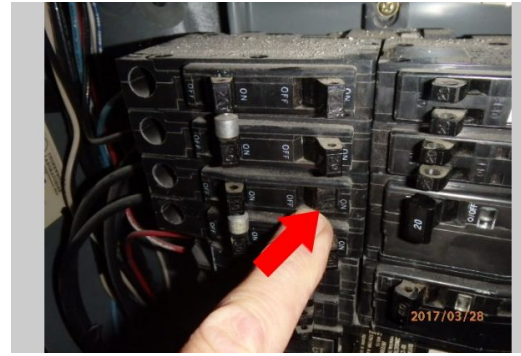
CONDITION #27

Location: House Panel
Condition: Wire Connector(s) Missing
Explanation: As wire circuits enter the electrical panel, they should be secured to the metal with a connector or clamp to prevent chafing on the metal edges.
Suggested Action: Have an electrician add connectors (and conduit) to all unsecured wiring at the panel and distribution system.
Significance: Safety Concern

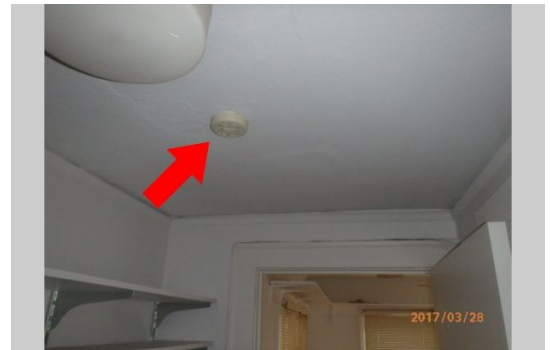
CONDITION #30

Location: House Upper
Condition: Globe Missing at Light Fixtures
Explanation: The light fixture globe helps to protect the bulb, subdue the heat emanating from the bulb and to more evenly displace the light.
Suggested Action: Replace light fixture globes where needed.
Significance: Needs Handy Repair

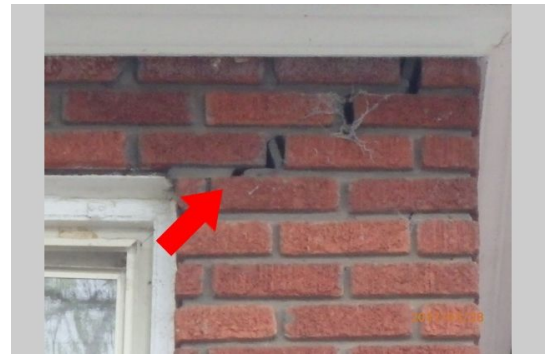
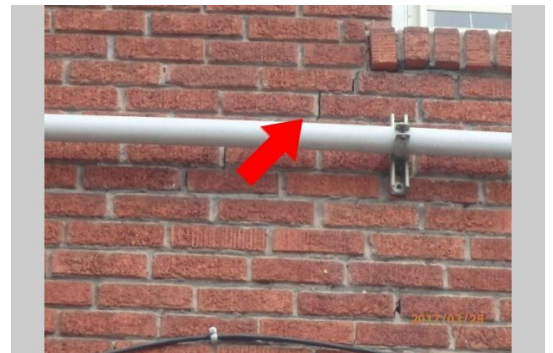
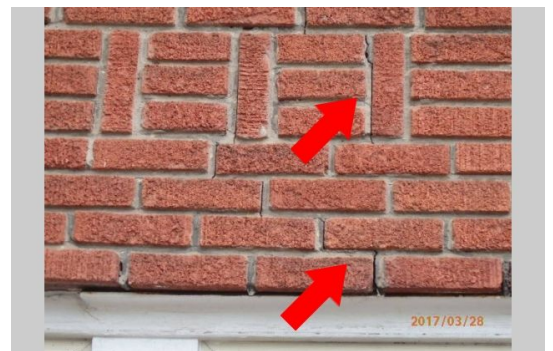
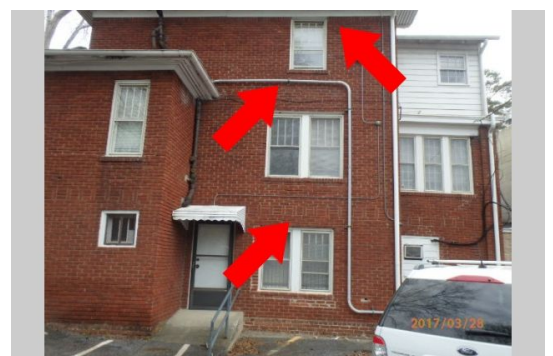
Description: Wood Siding and Brick Cladding
Location: House Rear
Condition: Abnormal Cracking
Explanation: Abnormal cracking at the brick was noted.
Suggested Action: Consult a structural engineer for further evaluation and repair specifications.
Significance: Needs Pro Repair

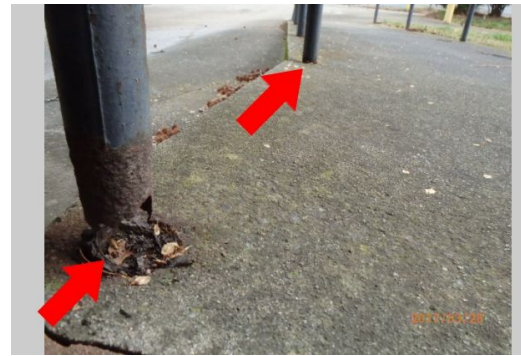
CONDITION #39

Condition: Guardrail Height Too Low
Explanation: Guardrails should be 36 inches high for safety, with gaps no more than 4 inches.
Suggested Action: Consult iron worker to correct this condition.
Significance: Safety Concern

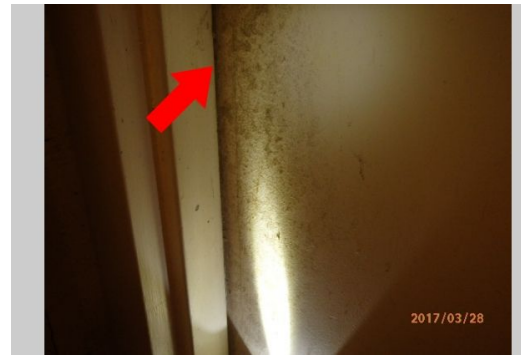
CONDITION #45

Location: House- Main Floor -right Doors
Condition: Egress Limited
Explanation: The 2 right doors are inoperable and do not allow emergency egress.
Suggested Action: Restore operation for safety.
Significance: Safety Concern

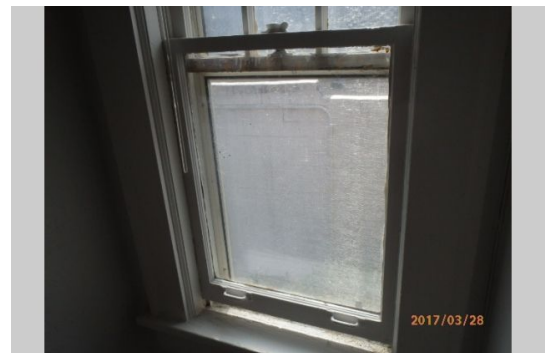
CONDITION #56

Location: Upper Rear
Condition: Cracked Window Pane
Suggested Action: Properly replace all cracked panes.
Significance: Safety Concern

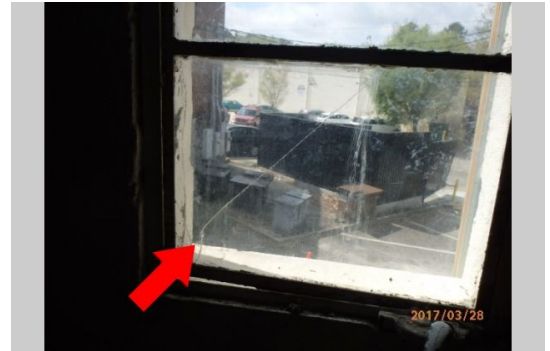
CONDITION #57

Location: House Windows
Condition: Lead Paint Hazard
Explanation: Peeling paint was noted, which likely contains lead. Operating windows releases lead dust and paint chips.
Suggested Action: Consider window replacement. Have the windows repaired and repainted by a contractor certified by the GA Environmental Protection Division, for Lead-safe Renovation, Repair, and Painting.
Significance: Safety Concern

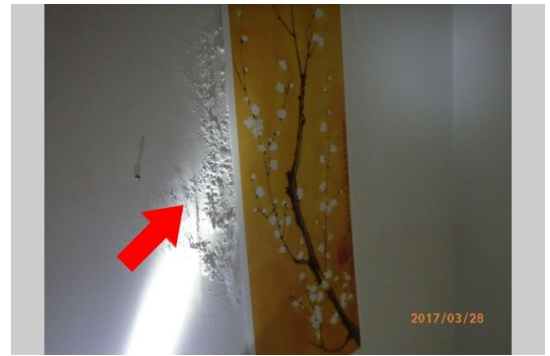
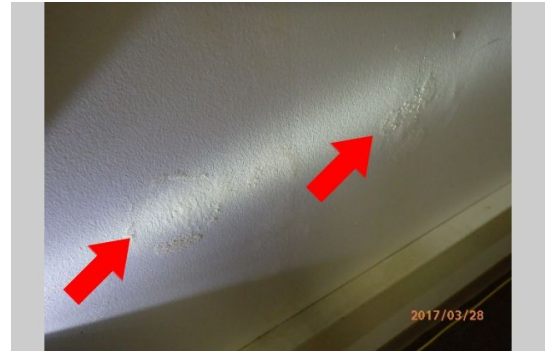
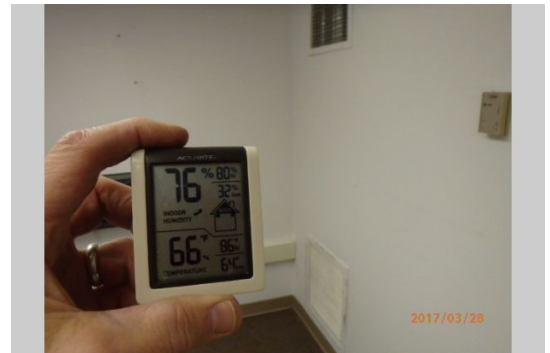
Location: Office Basement
Condition: Mold Noted
Explanation: Surface mold was noted, as well as significant moisture damage.
Suggested Action: Cut out affected sections. Have a waterproofing contractor provide recommendations. Consult a mold specialist for further testing and remediation options.
Significance: Safety Concern

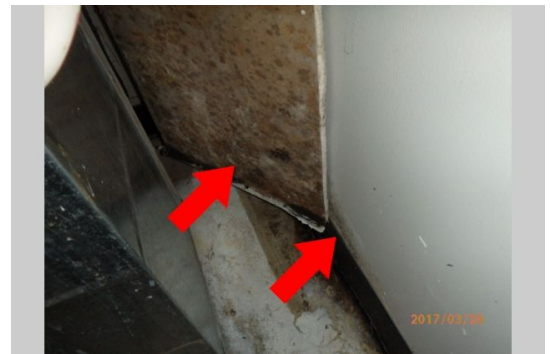
CONDITION #62

Location: Office Attic Front Wall
Condition: Mold Noted
Explanation: Mold was noted on the inside of the front exterior wall.
Suggested Action: Consult a mold specialist for further testing and remediation options.
Significance: Safety Concern

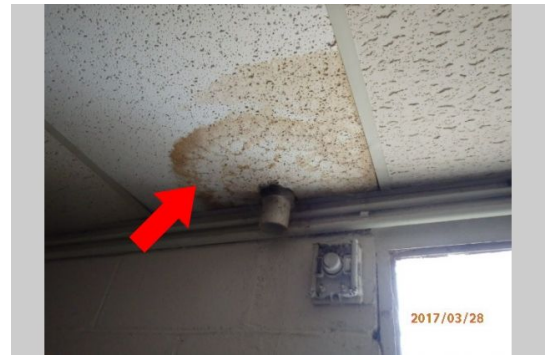
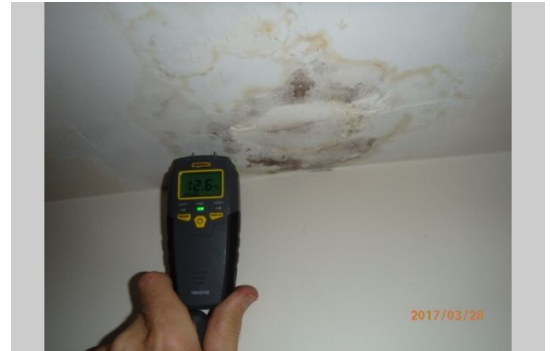
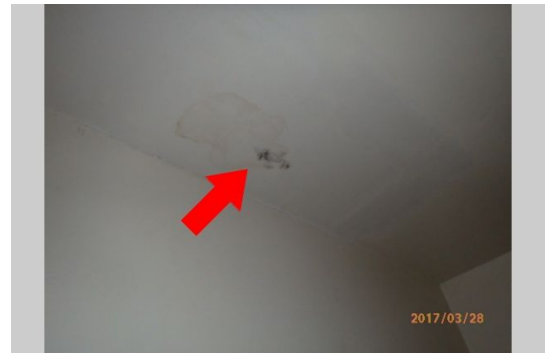
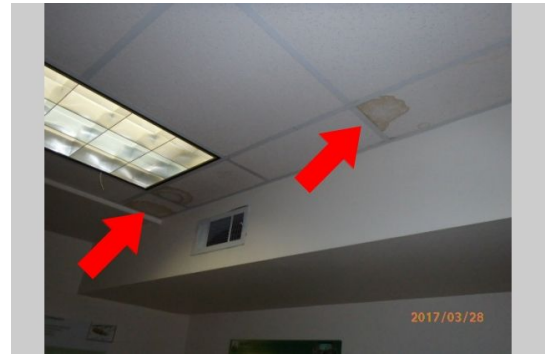
Location: Office Main Floor Ceiling
Condition: Water Stains Noted
Explanation: Water stains usually indicate previous roof leaks. Stains were tested with a moisture meter and some were found slightly elevated.
Suggested Action: Consult a roofer for evaluation and recommendations for the low-slope roof.
Significance: Needs Pro Repair

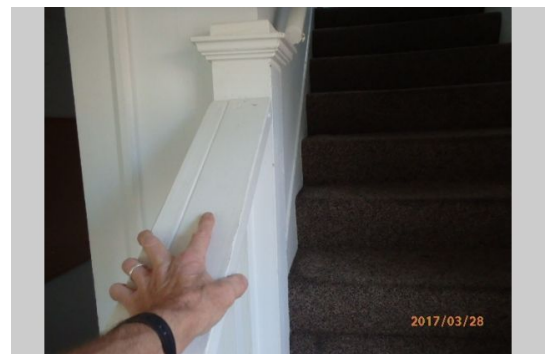
CONDITION #69

Location: Lower Stair
Condition: Guardrail Missing
Explanation: The missing guardrail represents a safety hazard.
Suggested Action: Ensure proper guardrails at all locations.
Significance: Safety Concern

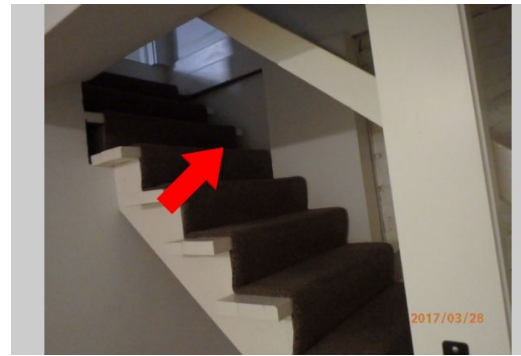
CONDITION #70

Location: Office Rear
Condition: Winder Stair
Suggested Action: Take caution when trying to navigate these stairs. The stairs would have to be rebuilt to conform to today's standards.
Significance: Safety Concern

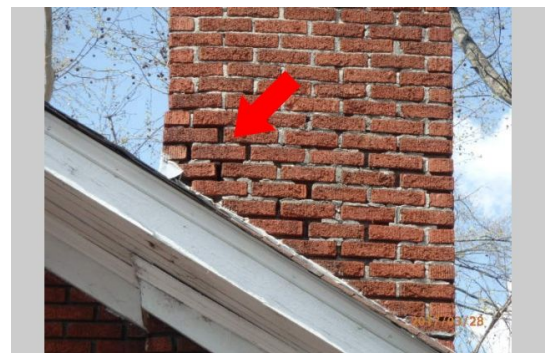
CONDITION #102

Condition: Brick Deterioration Noted
Explanation: A portion of the brick has broken off.
Suggested Action: Have a mason chip out all spalling/deteriorated brick and replace.
Significance: Safety Concern

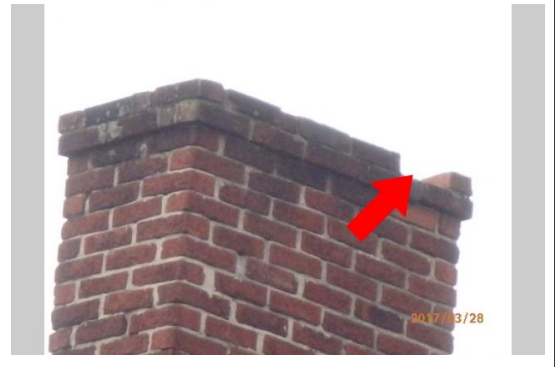
CONDITION #103

Condition: Rain Cap Missing
Explanation: Metal rain caps protect the chimney from the effects of weather, along with mechanical systems that vent through chimneys
Suggested Action: Consult a fireplace specialist for fabrication and installation as desired.
Significance: Upgrade Advised

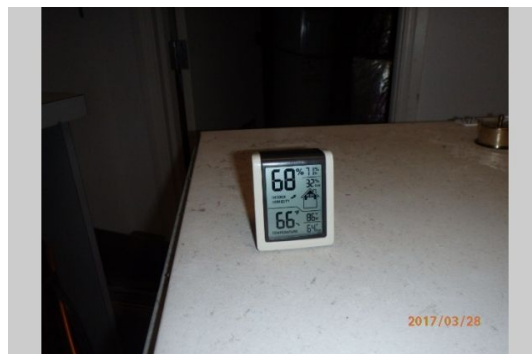
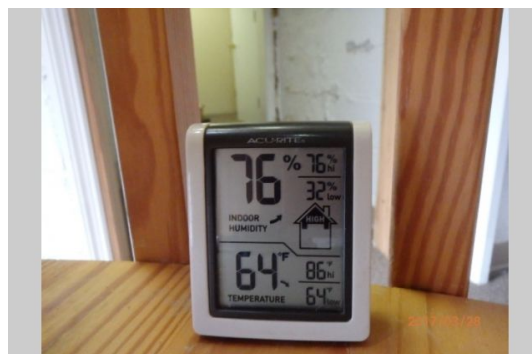
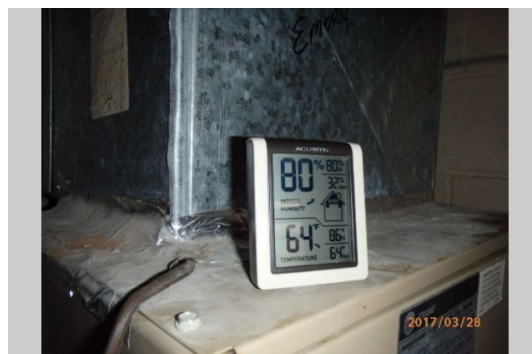
Location: All Lower Level
Condition: Elevated Humidity
Explanation: Maintaining interior relative humidity below 50% minimizes mold growth.
Suggested Action: Use the HVAC system, and a dehumidifier as needed to control moisture.
Significance: Maintenance Item

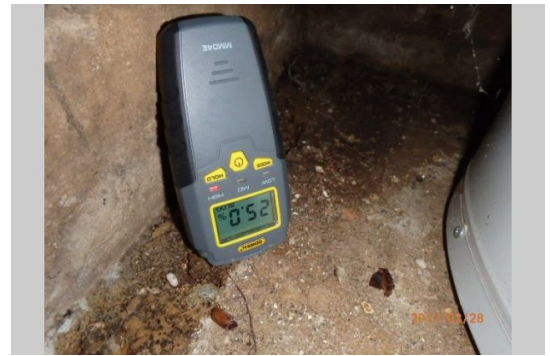
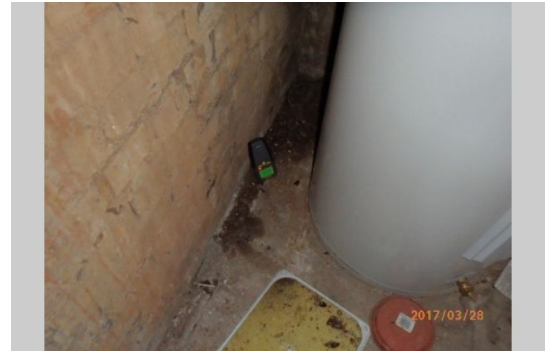
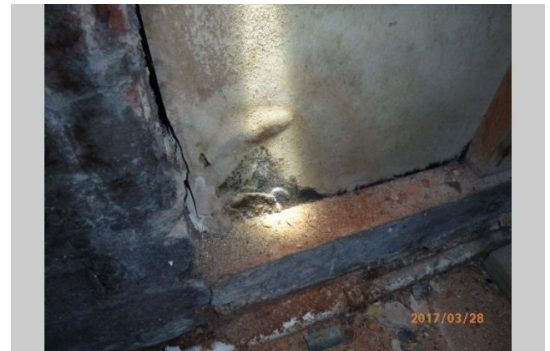
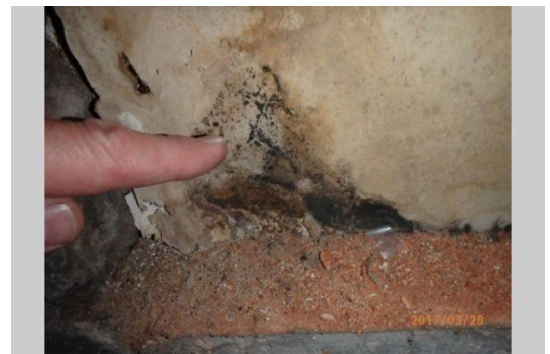
Location: At Water Heater and Furnace
Condition: Mold Like Spores Noted
Explanation: Stains and dampness were noted behind the water heater. Mold like spores were noted on the wallboard. 4- A tape-lift sample was collected and taken to the lab.
Suggested Action: Consult a mold remediation specialist for further evaluation and treatment as necessary.
Significance: Safety Concern

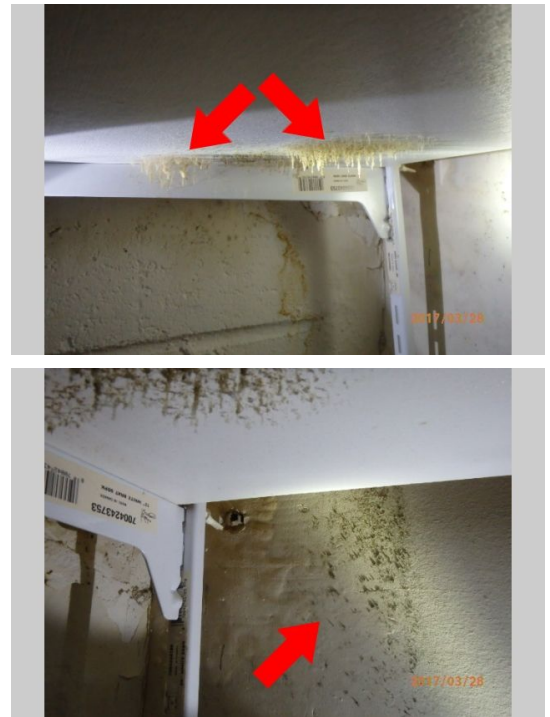
CONDITION #115

Location: Hall Closet at Panel
Condition: Reversed Vapor Barrier
Explanation: The insulation is backward, according to the manufacturer label printed on each batt. The exposed facing is also flammable and a fire safety hazard.
Suggested Action: Reverse the batts so that the vapor barrier is installed against the heated surface.
Significance: Safety Concern
