DeKalb County Historic Preservation Commission

K. 1080 Clifton Road, Brian E. Daughdrill. Demolish a historic house, remove a nonhistoric garage, and construct a nonhistoric house. **1248160.**

Subject: **Structural Assessment**
1080 Clifton Rd
Atlanta, GA
CERM Project No. 2025-0862F-017F

STRUCTURAL ASSESSMENT

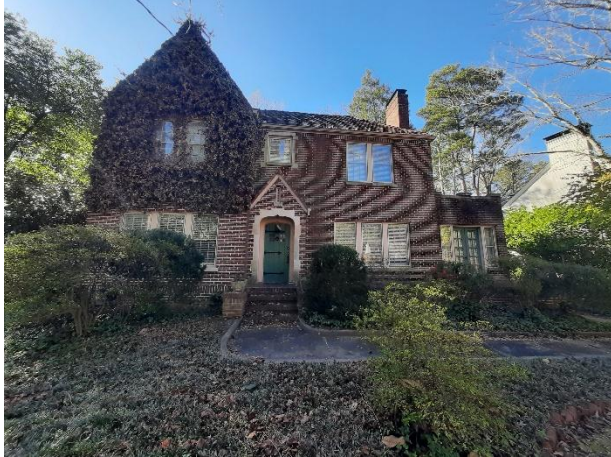
Photo 1
Front of House (East Façade)

- a. Brick pilasters in crawlspace at the east side
 - b. Ivy covering a portion of the east façade (Ivy had been trimmed back from the first floor at the time of our visit). See **Photo 1**.

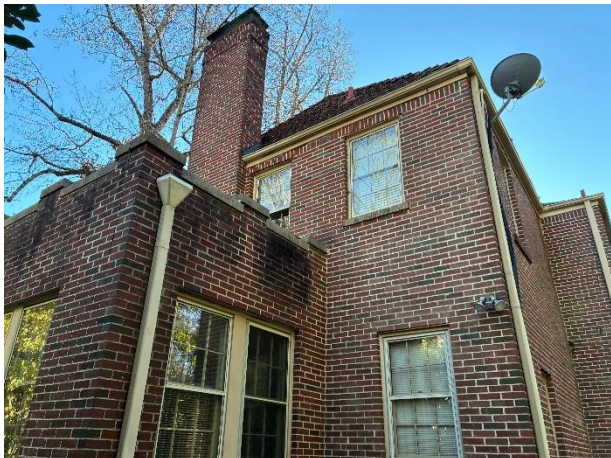
Photo 3
North Side of House

3. One chimney / fireplace. See **Photo 3**.
4. Wood stick framed roof
 - a. Clay tile roof over main house
 - i. Low slope portion of main roof over the private bathroom on the second floor does not appear to have clay tile

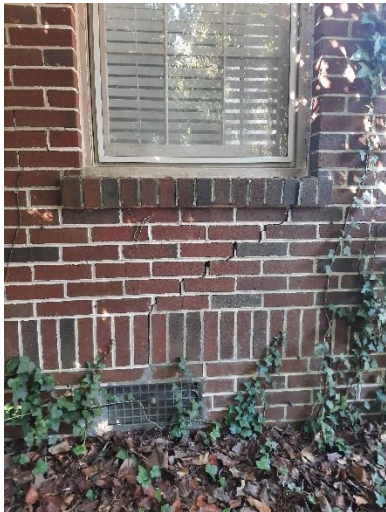
Photo 5
Stair-Step Crack (South Wall)

- a. **Photo 21** is in the same corner as the stairstep crack in **Photos 5 through 7.** A small ball placed on the floor of the dining room to test for floor slope did not roll toward this corner indicating a relatively level floor.

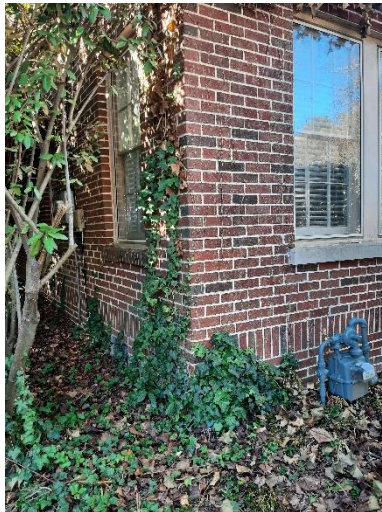
Photo 6
Stair-Step Cracks (SE Corner)

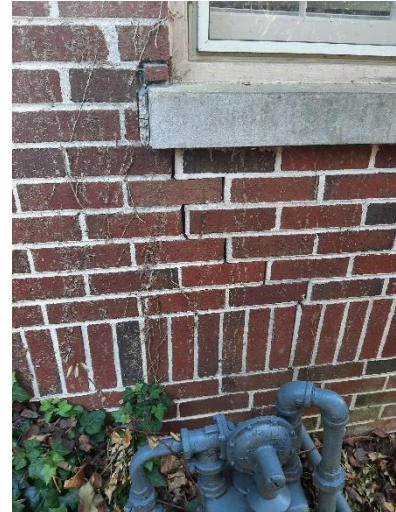
Photo 7
Stair-Step Crack (East Wall)

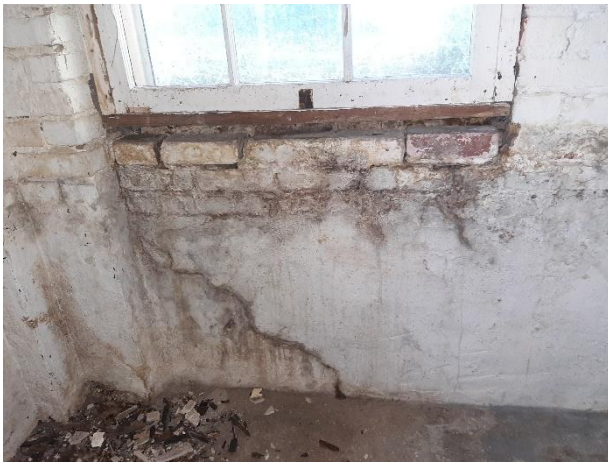
Photo 8
Stair-Step Crack at Basement

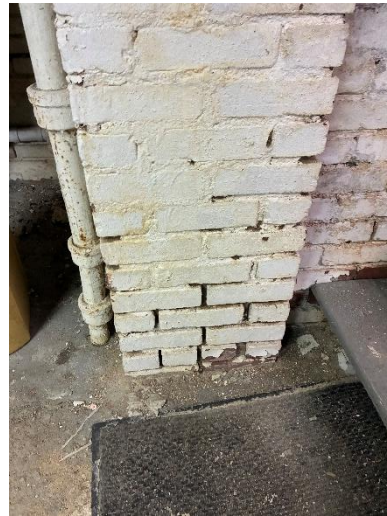
- ii. Loss of mortar / cracked mortar in some locations
 - 1. Ivy / vines growing on the wall can cause damage
- iii. Steel lintels supporting brick above windows show signs of rust, but no significant deflection or damage to adjacent brick
- b. The brick walls below grade appear to be in adequate condition with the following exceptions
 - i. Stair-step crack under window adjacent to driveway. See **Photo 8**.
 - ii. Loss of mortar in some locations. See **Photo 9**.
 - iii. Evidence of water leaks, primarily at windows and piping but some water intrusion / stains at other locations could be due to inadequate exterior waterproofing. See **Photos 10 through 12**.

Photo 9
Loss of Mortar at Brick

- i. Need to verify framing is adequate or if beam reinforcing / replacement is necessary. See **Rehabilitation Feasibility Section 2.a.**
 - d. Clean brick and repoint where necessary

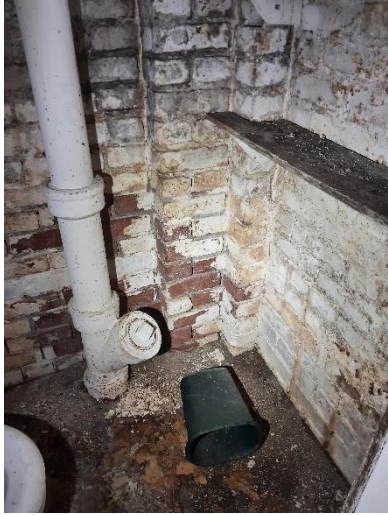
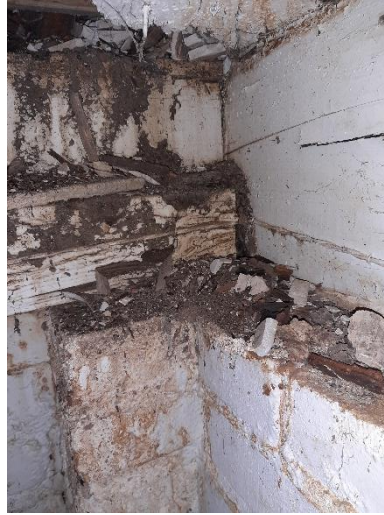
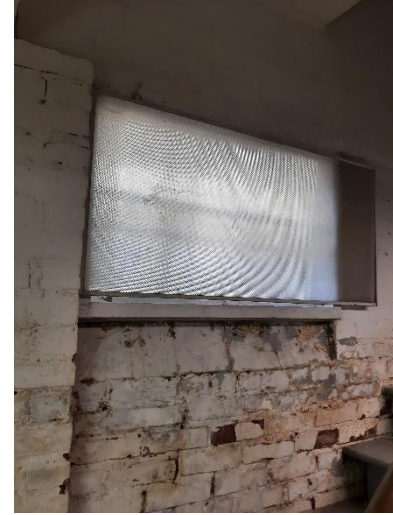
Photo 10
Water Leak Staining / Damage

Photo 11
Water Leak Staining / Damage

Photo 12
Water Leak Staining / Damage

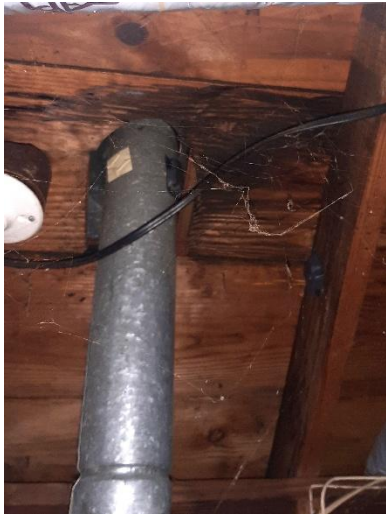
Photo 13
Water Damage at Vent

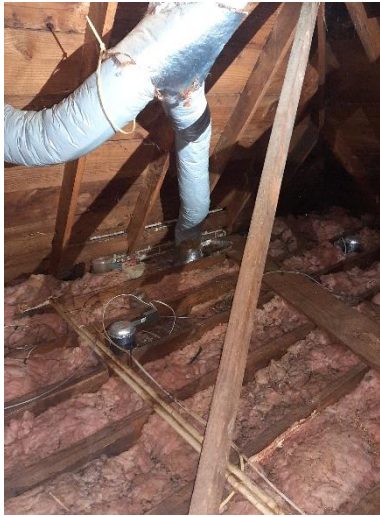
Photo 14
Containers to Collect Water

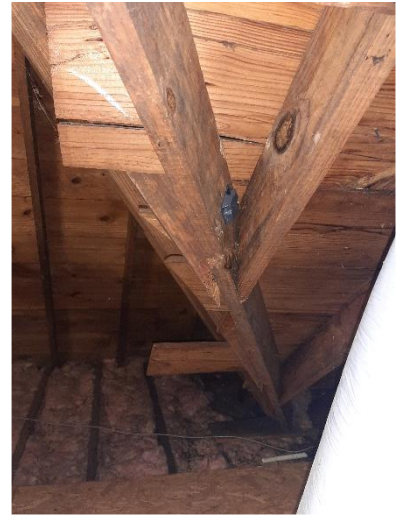
- i. Sykes was only able to observe the top side of the roof from the ground and recommends a specialist be engaged to inspect the existing clay tile roof for missing / damaged tiles and any other deficiencies.
- ii. The roof framing was visible in the attic and water intrusion was observed at the roof specifically around openings, the chimney, the low slope portions, and the perimeter. **See Photo 13.** Containers were placed in some locations presumably to collect water. See **Photo 14.**
- iii. At least one rafter at a valley was dislodged. **See Photo 15.**

Photo 15
Dislodged Roof Rafter

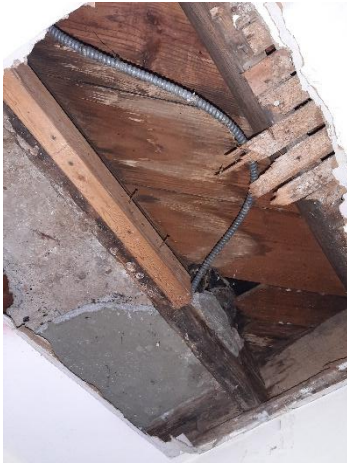
Photo 16
Damage at 2nd Floor Framing

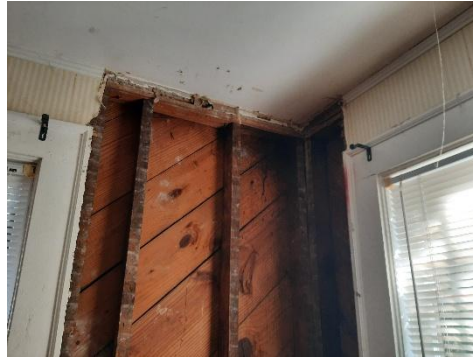
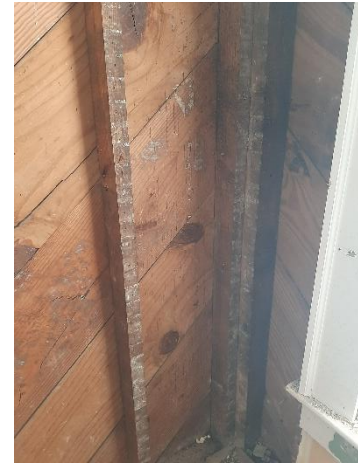
Photo 17
Second Floor Wall

Photo 18
Second Floor Wall

- iv. Second floor wall framing was visible in the southeast bedroom. See **Photos 17 and 18**. The framing appeared to be in good condition; however, Sykes recommends a mold assessment. See **Public Safety Considerations** section.

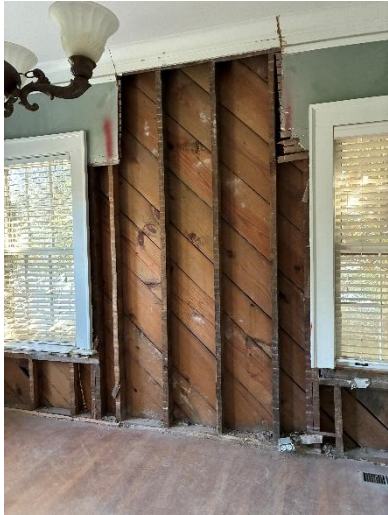
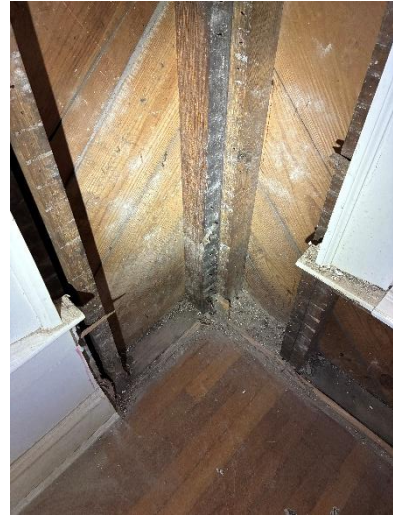
1. See **Structural Assessment Section g** for the Sunroom / Enclosed Porch comments.
 2. The wall framing visible in the dining room appeared to be in good condition; however, Sykes recommend a mold assessment. See **Public Safety Considerations** section.

Dining Room Wall Framing

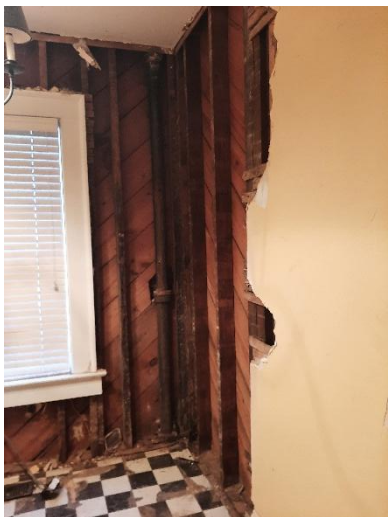
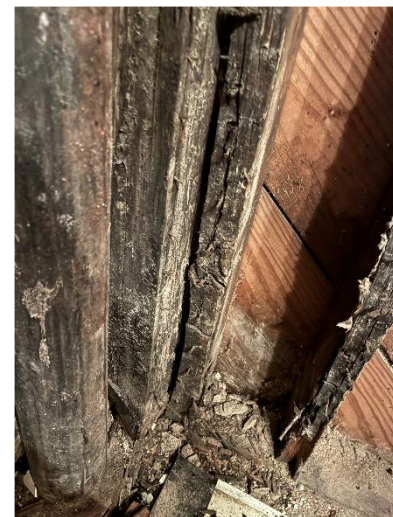
3. The wall framing at the northwest corner of the Breakfast Nook has severe damage from water intrusion. This could be due to a roof leak and / or leaks from the pipe in the vicinity. There is also damage to the roof and the second floor in this location. The framing away from this corner appeared to be sound.

Breakfast Nook Wall Framing

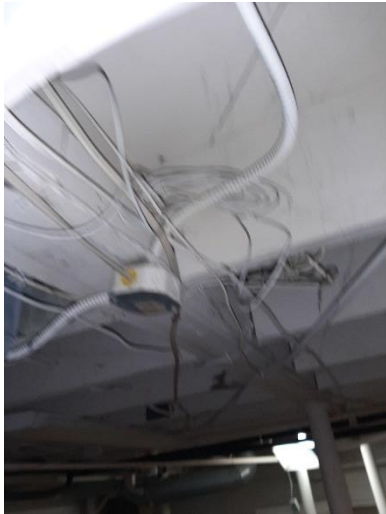
- ii. First floor framing was visible from the basement. See **Photo 25**.
 - 1. Floor joists are supported by wood ledgers. A few joists show cracking at the notch.
 - 2. The ledgers are nailed to beams / rim joists. Some ledgers have slight separation from the support member.
 - 3. There is floor damage directly below the northwest corner of the Breakfast Nook. See **Photo 26**. This damage extends from the roof to the basement in this location.
 - 4. Beams are supported by multiwythe brick or CMU walls, by other beams, or on columns.
 - a. No metal connectors were observed
 - b. The header beam at the stairs has been cut to allow for piping. See **Photo 27**.
 - c. Some beams at the columns show signs of crushing at the column caps. See **Photos 28 and 29**.

Photo 25
First Floor Framing

- i. The basement wall adjacent to the driveway, the rear of house at basement windows, and the exterior basement entry require particular attention
 - c. Updating first floor framing at posts (replace damaged column and add larger column caps), additional attachments at ledgers, repair at overcut joists

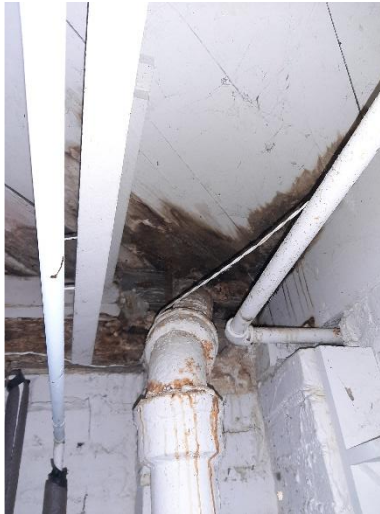
Photo 26
Floor Damage below Breakfast Nook

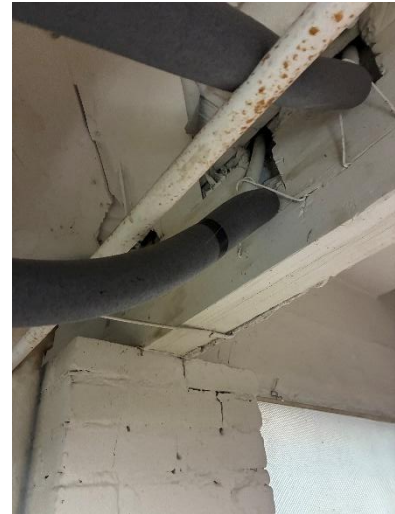
Photo 27
Header Beam at Stair Opening

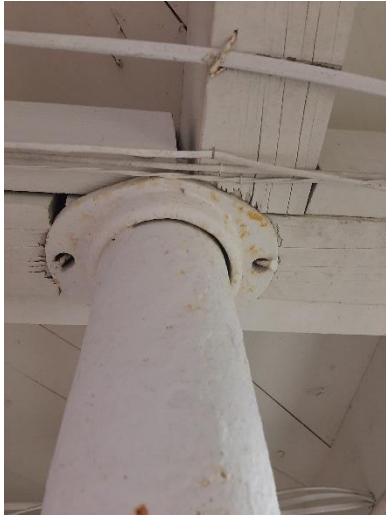
- 1. The top of the pipe columns have separate cast caps with two holes for nails to be fastened to the beams above. See **Photos 28 through 30**.

Photo 28
Top of Pipe Column

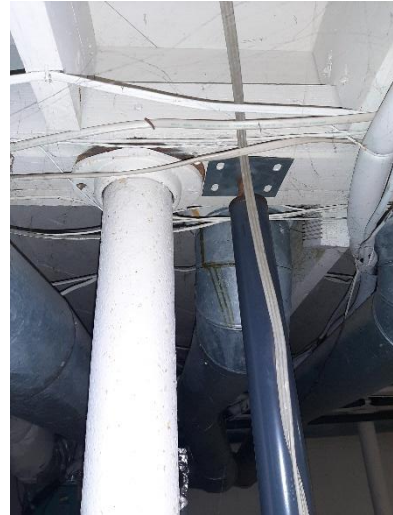
2. One column has an adjacent shoring post. The bottom of the beam is at least 1/2 inch above the column cap, so the column is no longer load bearing. A slight indentation is visible where bearing occurred indicating compression of the wood possibly due to inadequate bearing area. See **Photos 29 and 30**.

Photo 30
Top of Pipe Column
With Adjacent Shoring Post

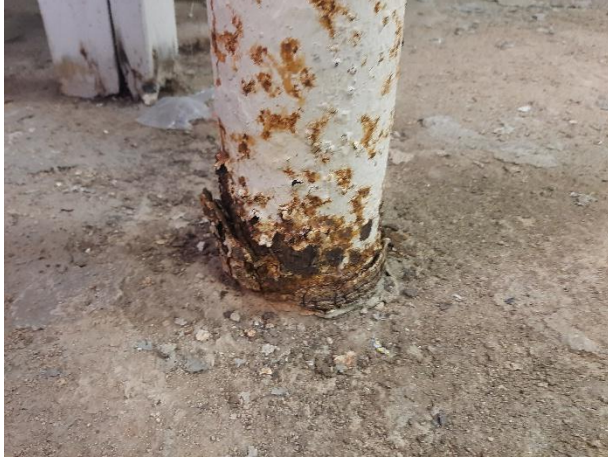
Photo 31
Rusted Bottom of Column

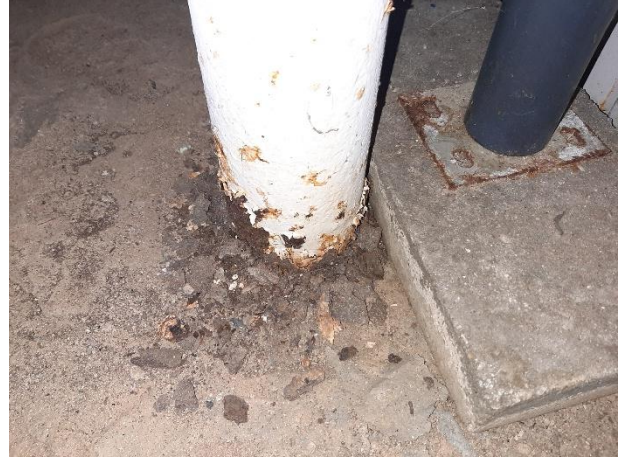
- f. Foundations / Basement / Crawlspace
 - i. Foundations could not be assessed since they are below grade and would require excavation to expose them.
 - ii. See **Structural Assessment Section 2.b** for exterior multiwythe brick walls below grade.
 - iii. Columns
 1. The bottoms of the columns are rusted. Some are in extremely poor condition with significant loss of section. See **Photos 31 and 32**.
 2. The column foundations are unknown.
 3. One column has an adjacent shoring post. See **Photos 30 and 32**.

Photo 32
Rusted Bottom of Column at Adjacent Shoring Post

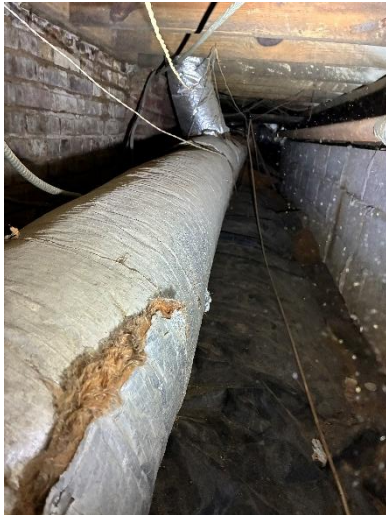
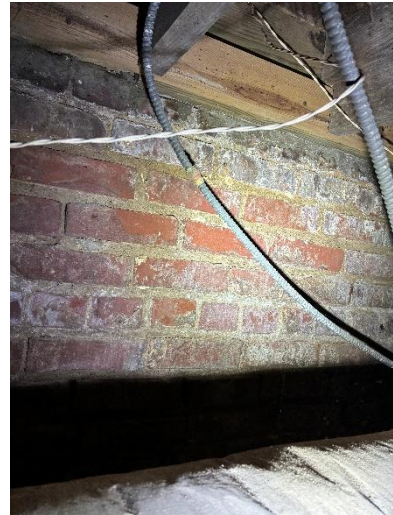
1. The accessible portion of the crawlspace (under the front patio) was dry at the time of Sykes' visit. Some localized water stains were observed on the exterior brick wall and the interior CMU wall. See **Photos 33 through 35**.

Photo 33
Crawlspace

Photo 35
Exterior Wall at Crawlspace

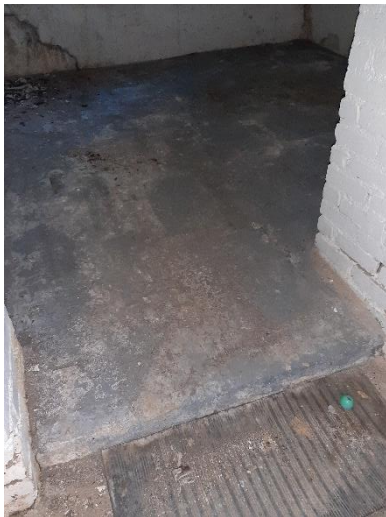
- v. Slab on Grade
 - 1. The thickness of the slab on grade is unknown.
 - 2. No standing water at the time of Sykes' site visit; however, there is damage to the slab on grade due to continuous water intrusion and prior patching. See **Photos 36 and 37**.
- vi. Exterior Entrance
 - 1. There is an exterior entrance to the basement that allows water to enter. See **Photo 38**.
- vii. A mold assessment is recommended. See **Public Safety Considerations** Section

Photo 36
Slab on Grade

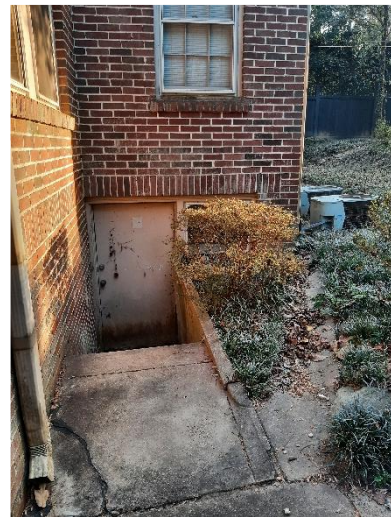
Photo 38
Exterior Basement Entrance

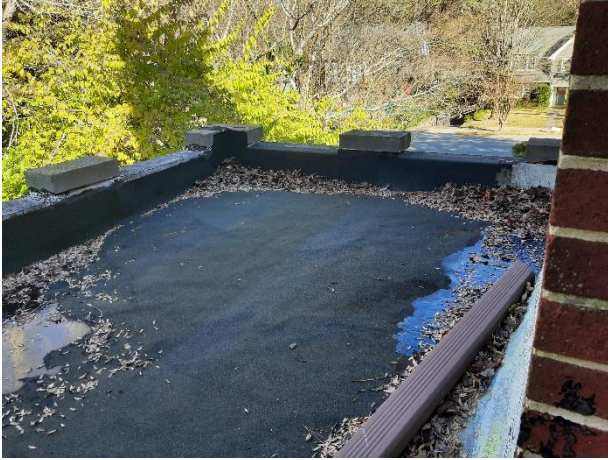
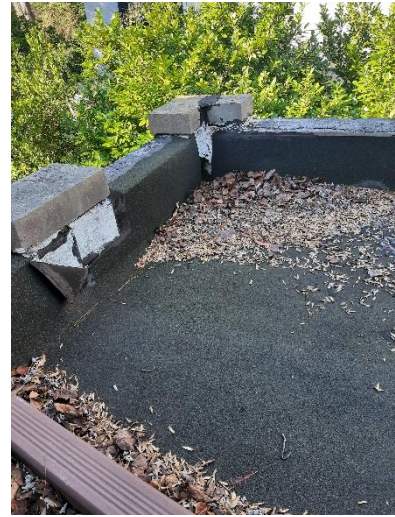
- g. Sunroom / Enclosed Porch
 - i. This area shows the most damage to the structure.
 - ii. The roof over the Sunroom / Enclosed Porch shows extensive signs of water intrusion with damaged and rotten roof joists. The framing over the window on the north side is damaged and rotten with mold growing. See Photos **39 through 42**.

Roof of Sunroom / Enclosed Porch

- i. Roof over sunroom would need to be completely redone. There is significant damage to the wood where the roof has leaked
 - b. Sykes recommends a roof assessment for main building. The corner of the roof over the private bathroom on the second floor and the breakfast nook on the first floor shows signs of significant water leaks. This low slope portion of the high roof does not appear to have the typical clay tile that was observed on the rest of the high roof. Damage to the framing from water leaks was also observed at framing near the chimney.

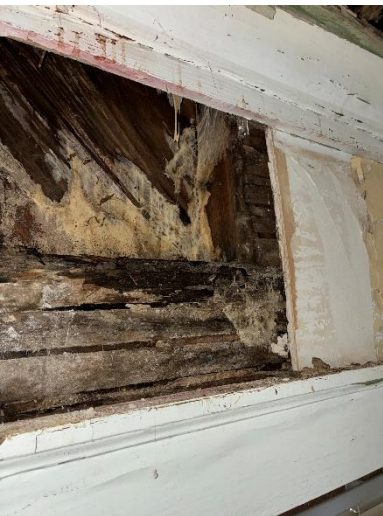
Mold / Rot over North Window at Sunroom / Enclosed Porch

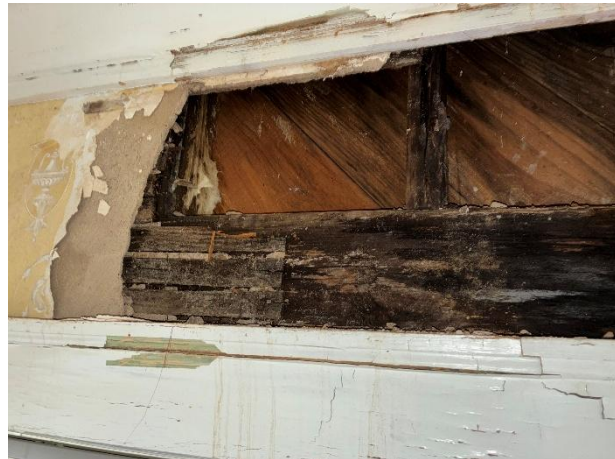
Rotten Framing over North Window at Sunroom / Enclosed Porch

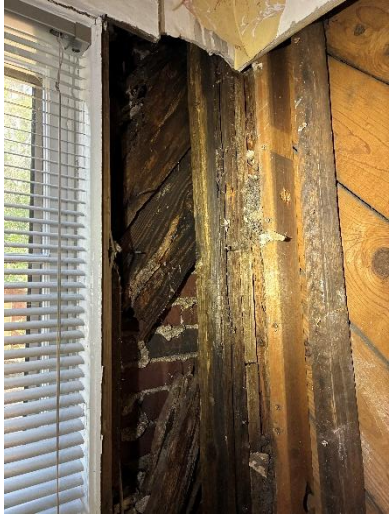
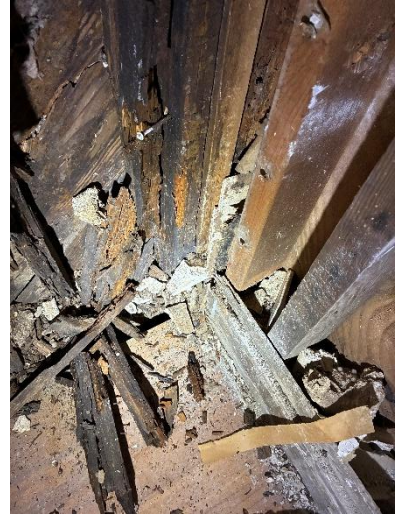
- iii. The wall in the northwest corner has extensive damage and rot. Some of the wall studs and exterior diagonal sheathing have partially rotted away and the exterior brick veneer is visible. See **Photos 43 through 45.**
- iv. The floor shows signs of water damage but most of the framing below appears sound. See **Photos 46 and 47.**

Photo 43
Northwest Corner Framing
At Sunroom / Enclosed Porch

Photo 45
Northwest Corner Framing
At Sunroom / Enclosed Porch

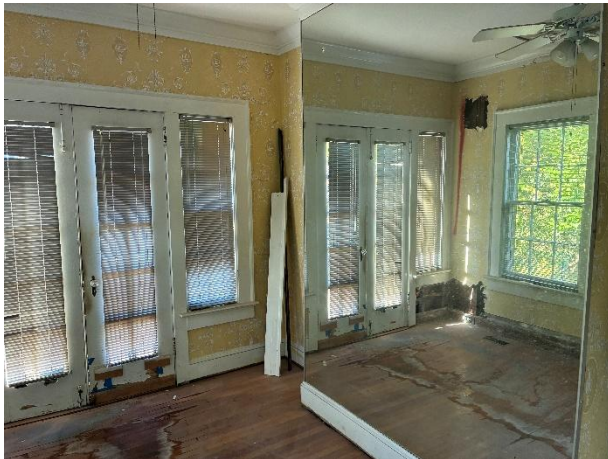
Photo 46
Water Damage at Floor of
Sunroom / Enclosed Porch

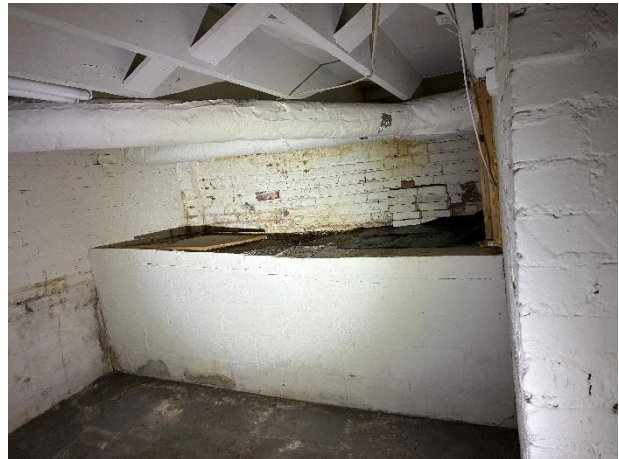
Photo 47
Basement Below Sunroom / Enclosed Porch
Showing Floor Framing
