Chief Executive Officer
Michael Thurmond

DEPARTMENT OF PLANNING & SUSTAINABILITY

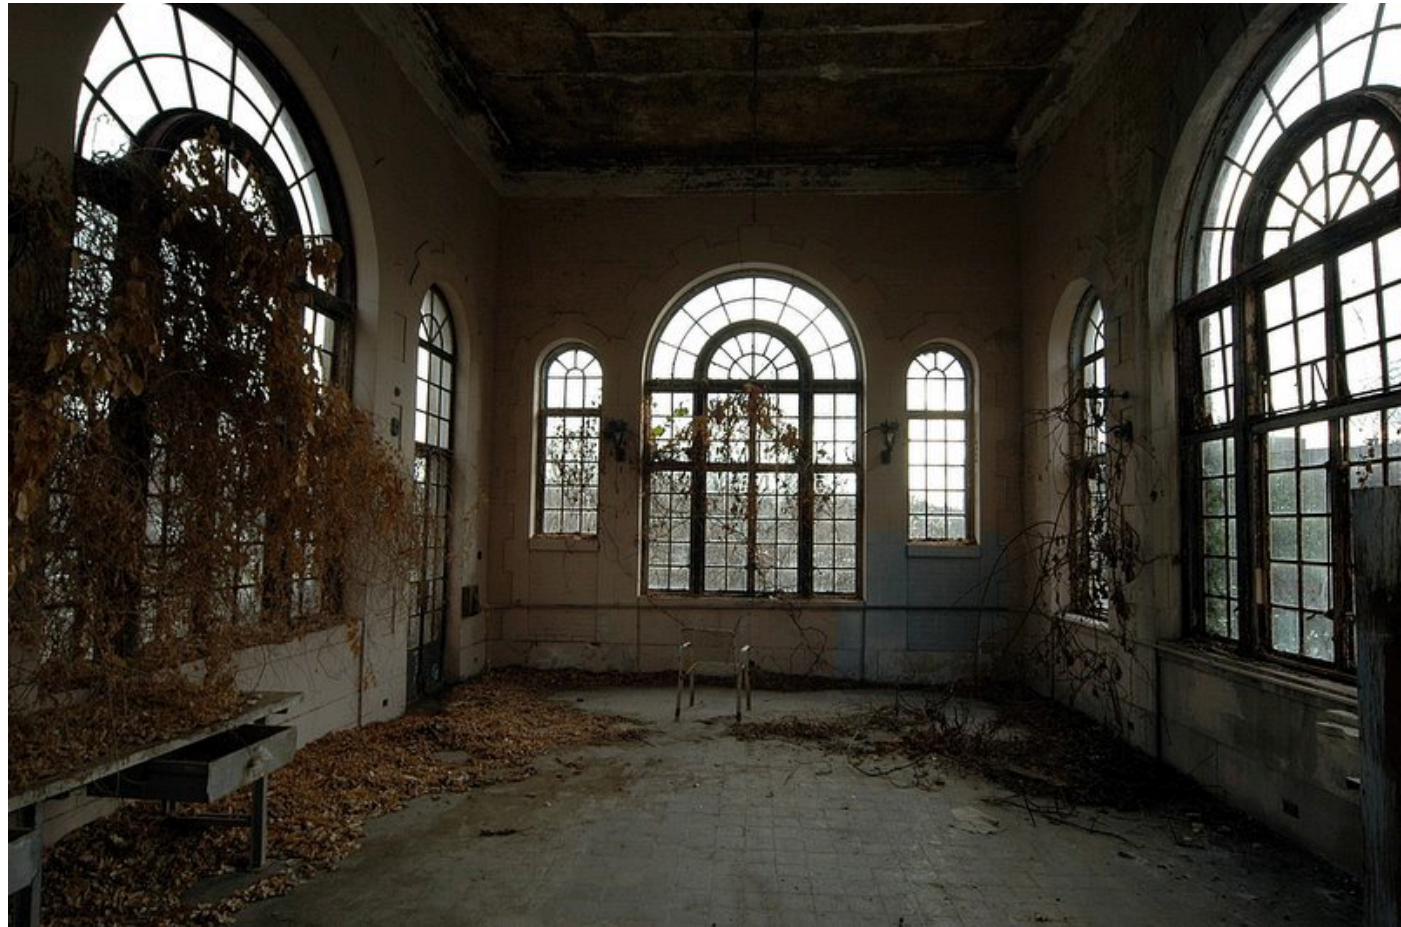
1925-48: Candler Additions

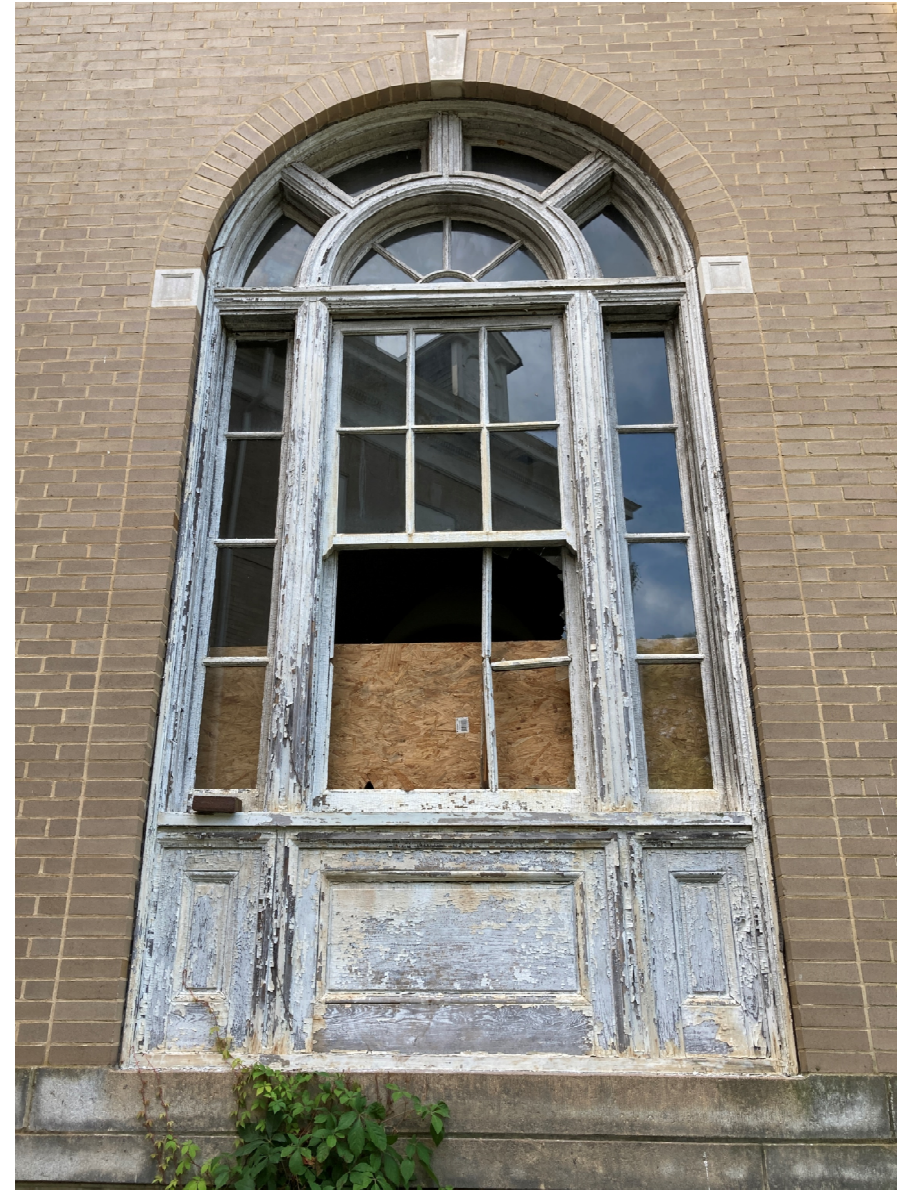
Replacement Windows: Non-conforming replacement windows should be removed and replaced with historically accurate windows as part of the rehabilitation.

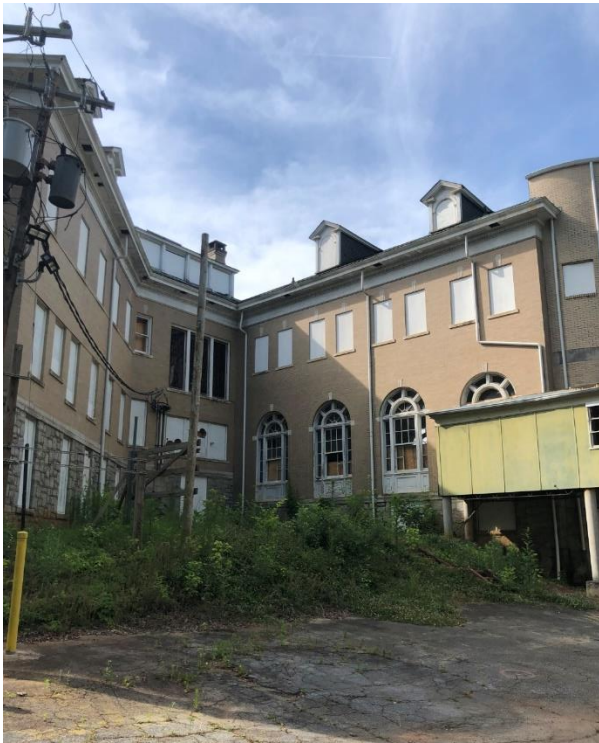
IMG EX2-1: Northwest courtyard on the back of house. Broken windows are to be fixed, and the bridge the carriage house is to be removed. This is the location of the new addition to the house which includes a new elevator.

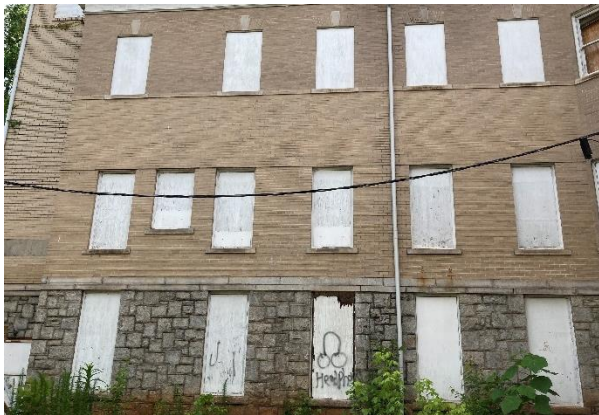
IMG EX2-3: Boarded up windows cover the East Wing of the Candler Mansion, largely protecting the broken windows that lie behind.

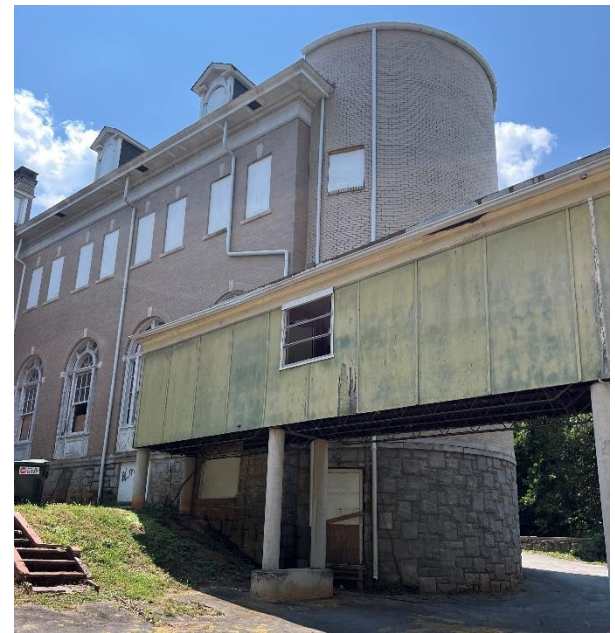
IMG EX2-4: Closer look at the Solarium half circle stair addition as well as the addition of the bridge that connects to the Carriage House.

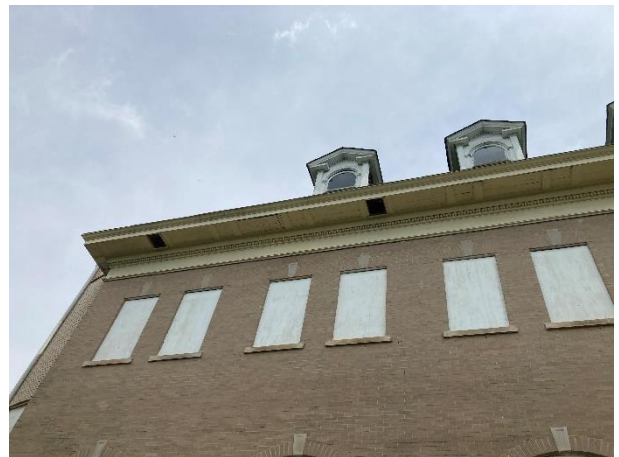
IMG EX3-4: Jack arch windows in the children's rooms above the Solarium. Brick on Southeast side is largely in good condition.

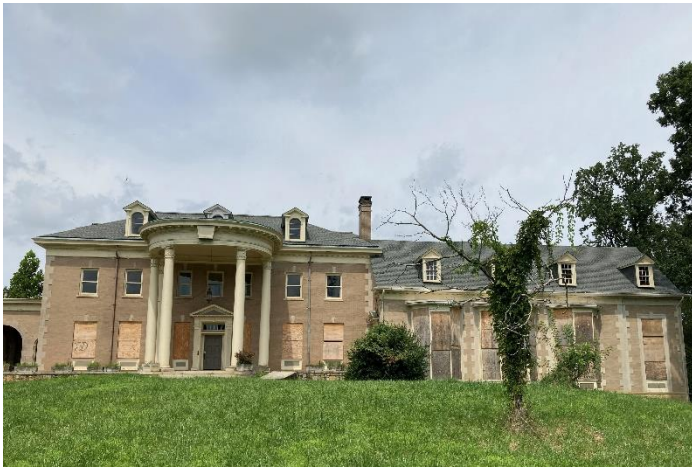
IMG EX4-1: South angle approaching the Candler Mansion.

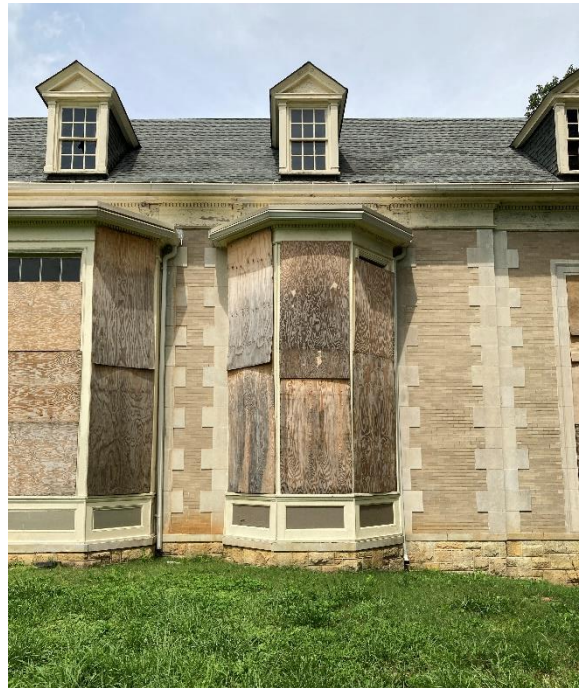
IMG EX4-2: Boarded up, damaged windows of the Music Room.

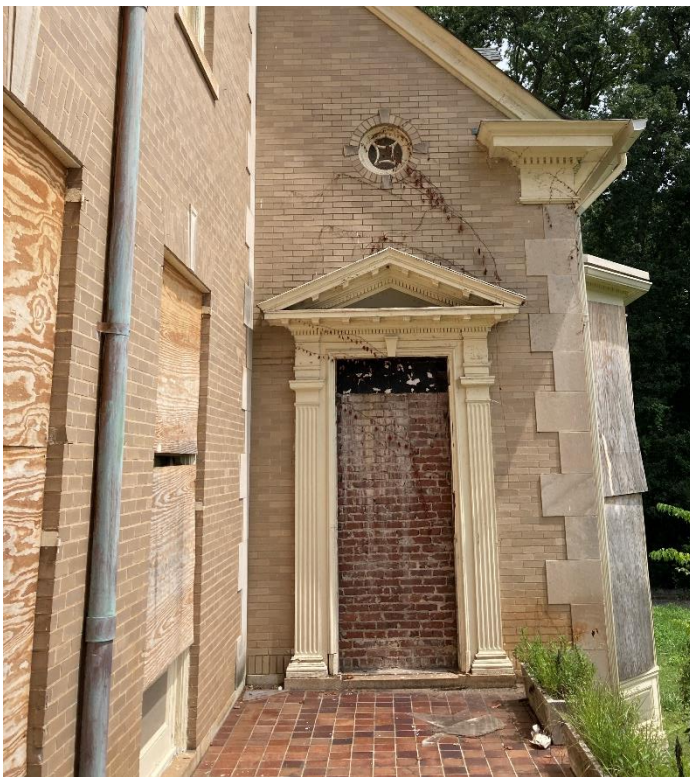
IMG EX4-3: Detailed trim of brick-filled door that leads to nothing on the interior side. Trim needs repair.

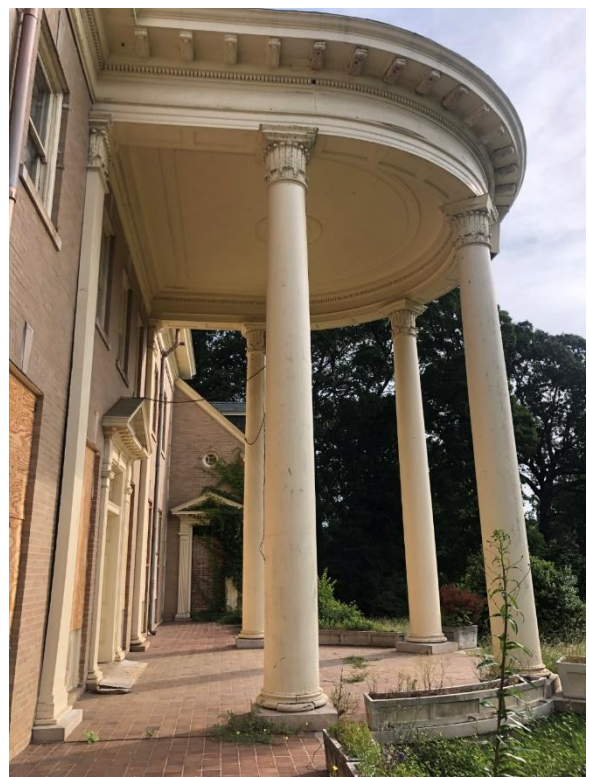
IMG EX4-4: Entry patio for main door. Column bases need to be addressed.

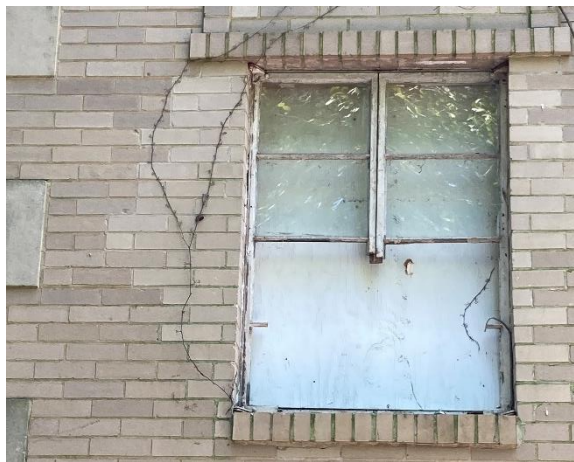
IMG EX6-5: Broken steel window on the Organ Room; typical for many steel and wood windows around the property.

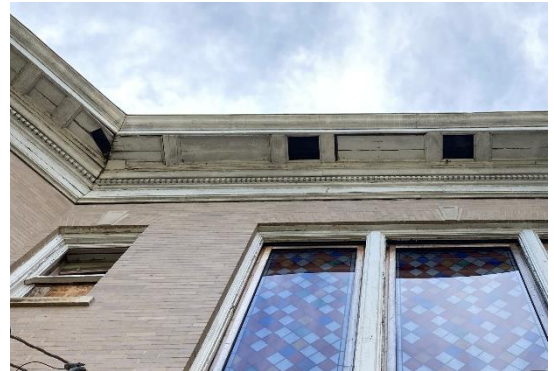
IMG EX6-4: Deteriorating roof trim on west side of mansion.

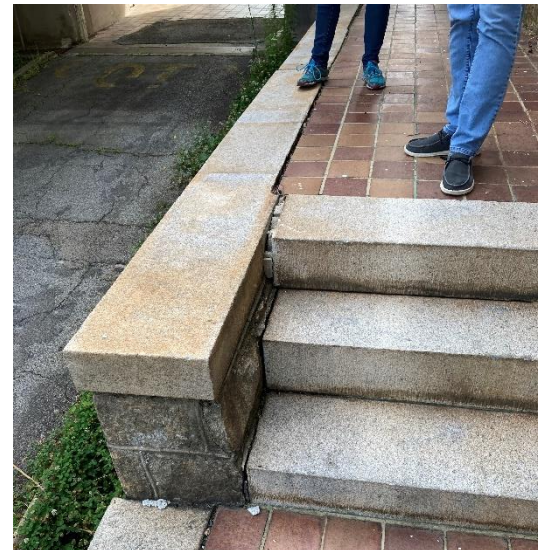
IMG EX6-6: Stone retaining wall breaking away from tile walkway; needs to be redone.

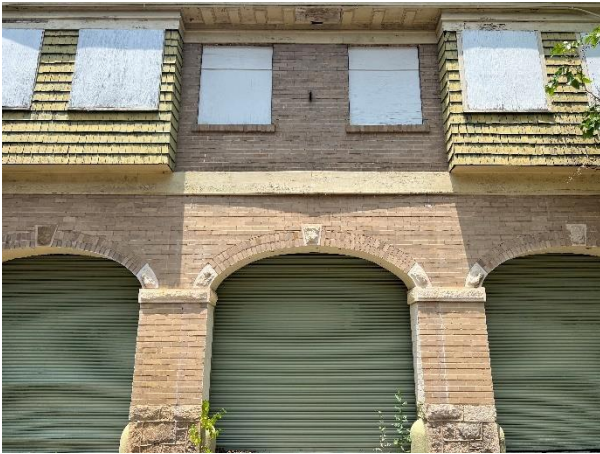
IMG CH1-1: East facing, front portion of Carriage House. Deteriorating roof trim and paneling need to be fixed.

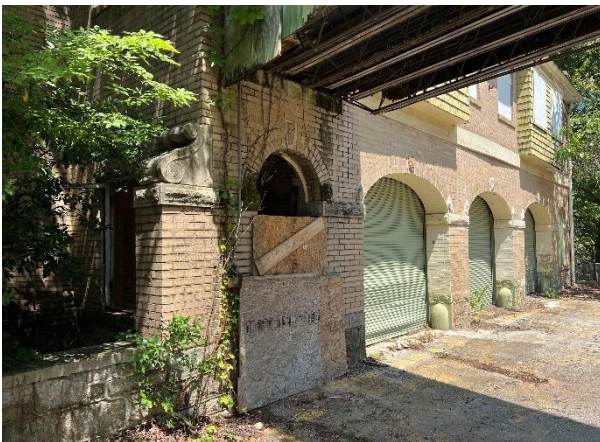
IMG CH1-3: Connection point between bridge from Solarium to second floor. Previous entry below now boarded up.

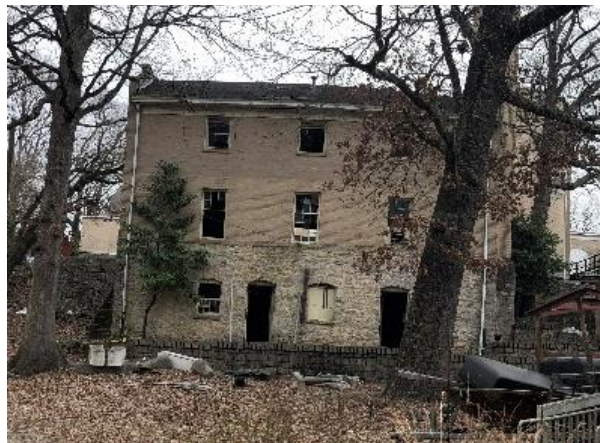
IMG CH1-4: West side entry to basement which contains many examples of deterioration. There is a large topographical change in this area.

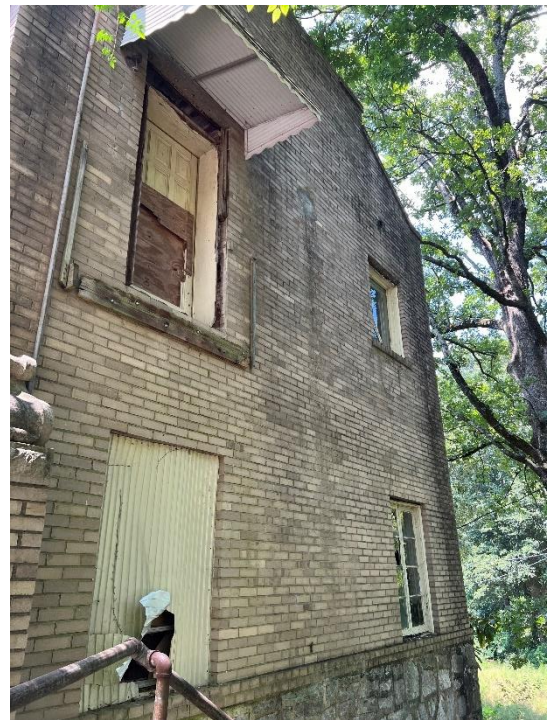
IMG CH1-2: North side with stairway down to back of Carriage House. Replace door with window matching adjacent.

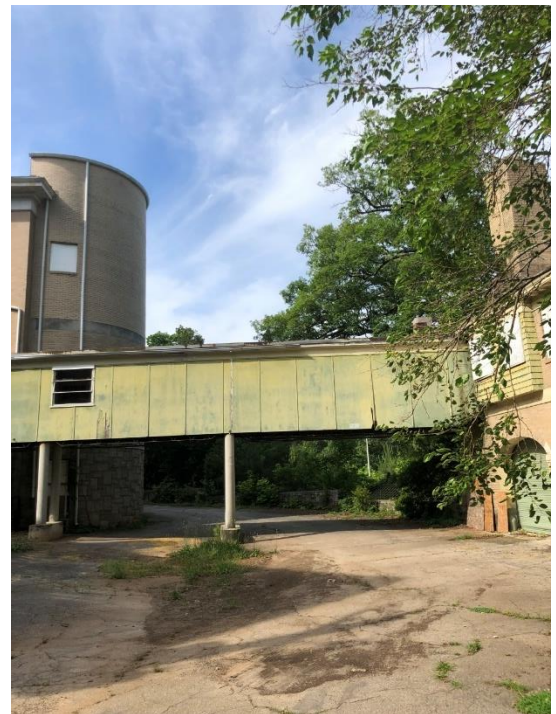
IMG CH1-5: Bridge connection from Main House to Carriage House which is to be demolished.

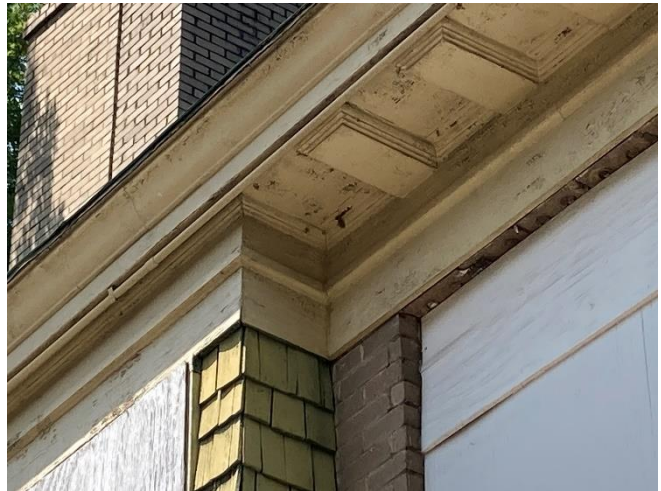
IMG CH2-4: Corner where deteriorating paneling connects with trim as well as brick wall.

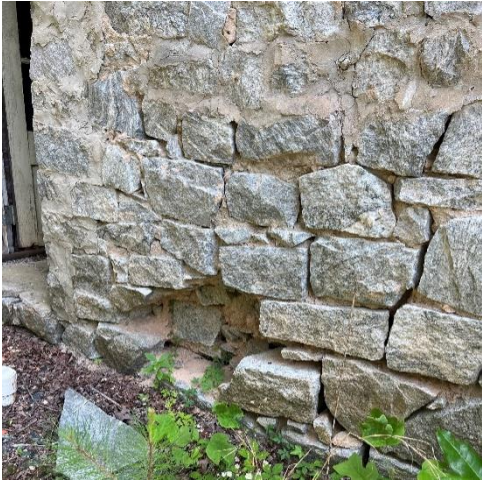
IMG CH3-1: Missing and cracked stone on basement level.

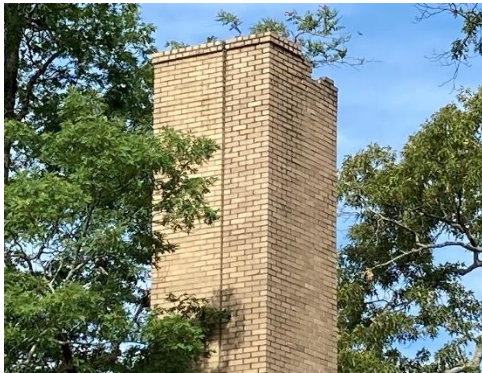
IMG CH3-3: Replacement needed on chimney with bricks missing on the top.

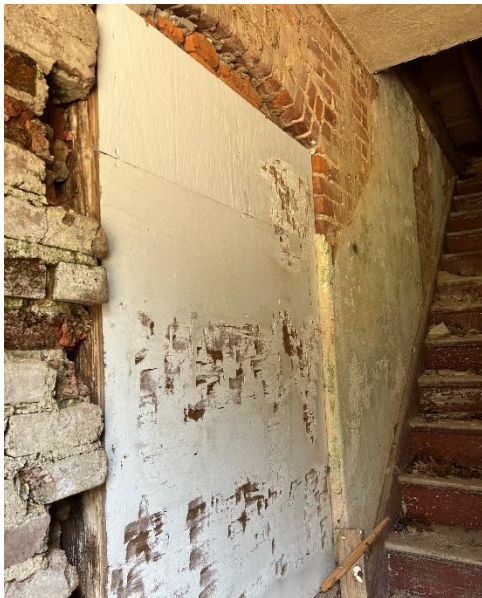
IMG CH3-4: Patched up entry and staircase on first floor.

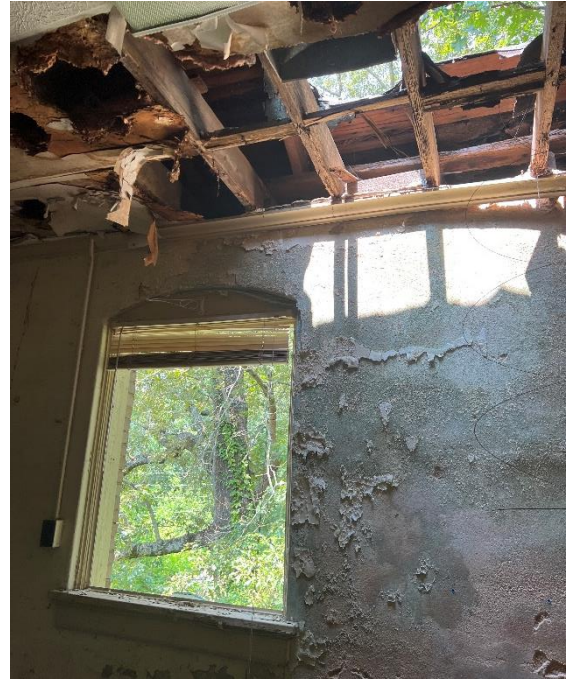
IMG CH3-2: Hole, one of two, in roof allowing structural deterioration. Framing repairs needed before roof replacement.

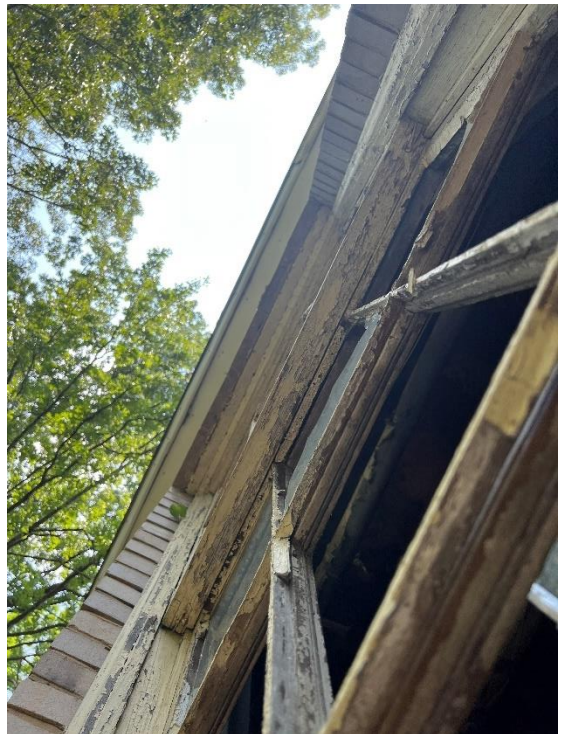
IMG CH3-5: Chipped paint and wood on windows. Window is missing windowpanes.

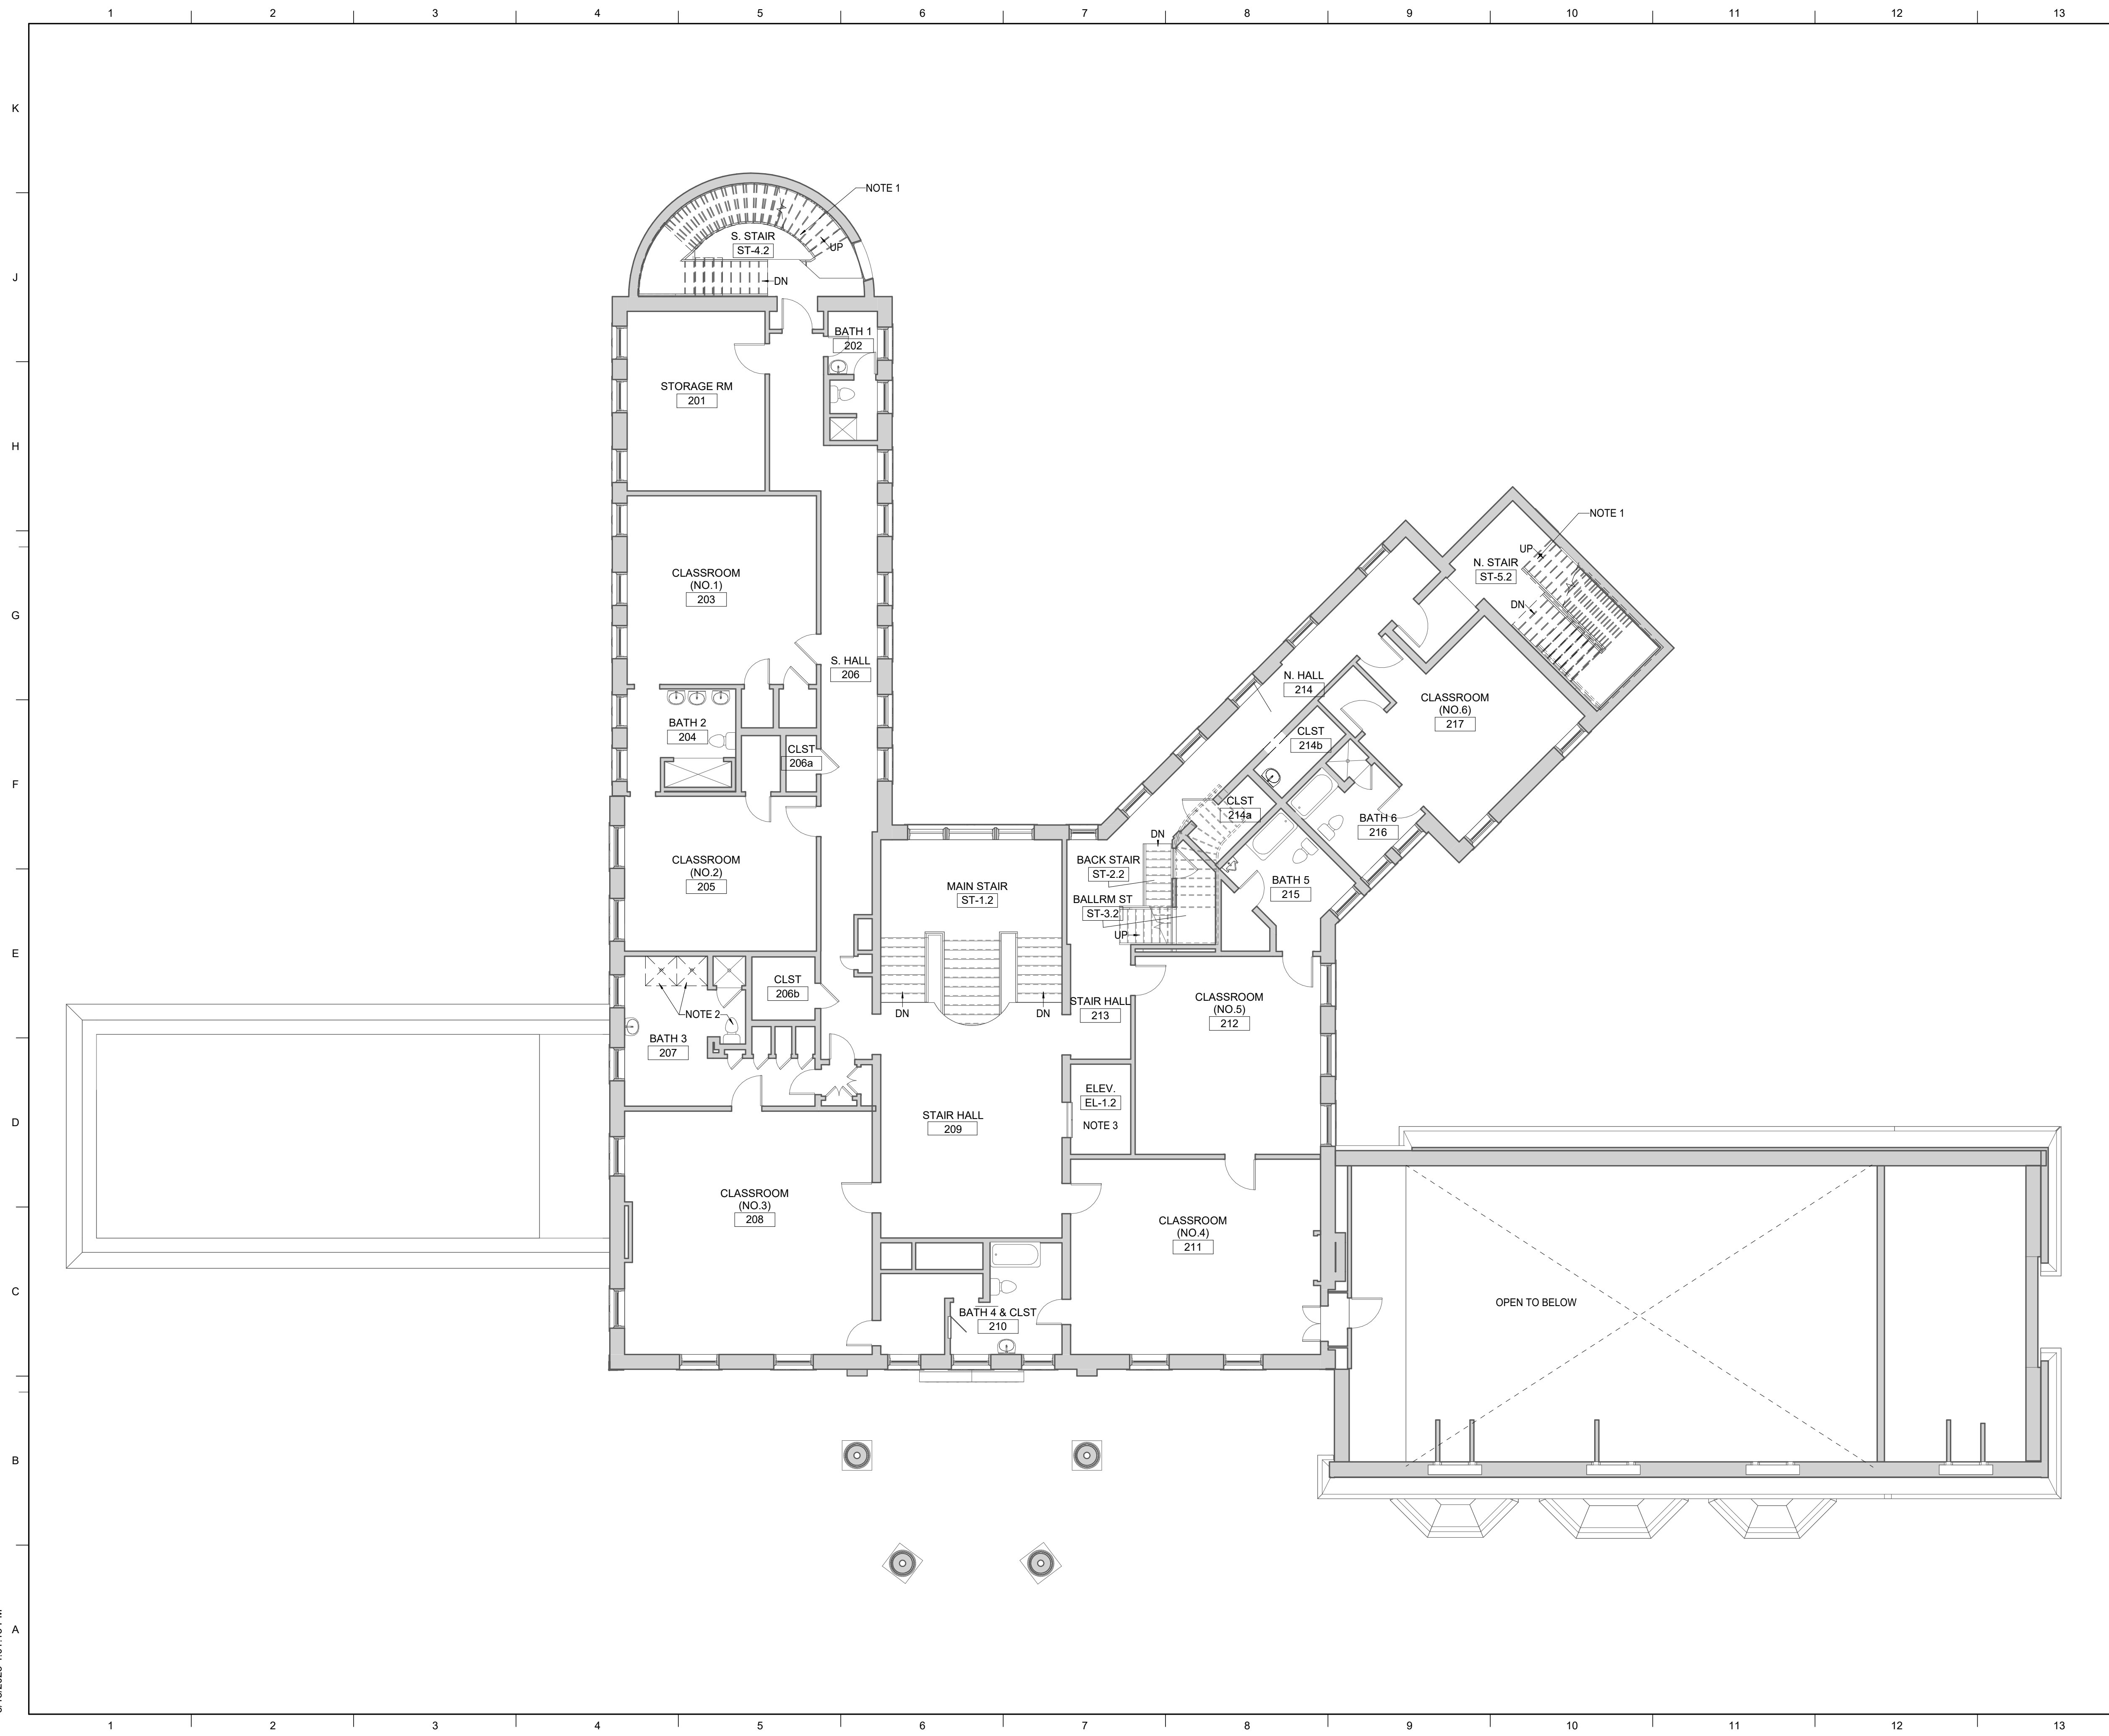
Autodesk Docs//P0035-23 Briarcliff Candler Mansion/P0035-23_Central_V23.rvt
 8/18/2023 4:01:06 PM

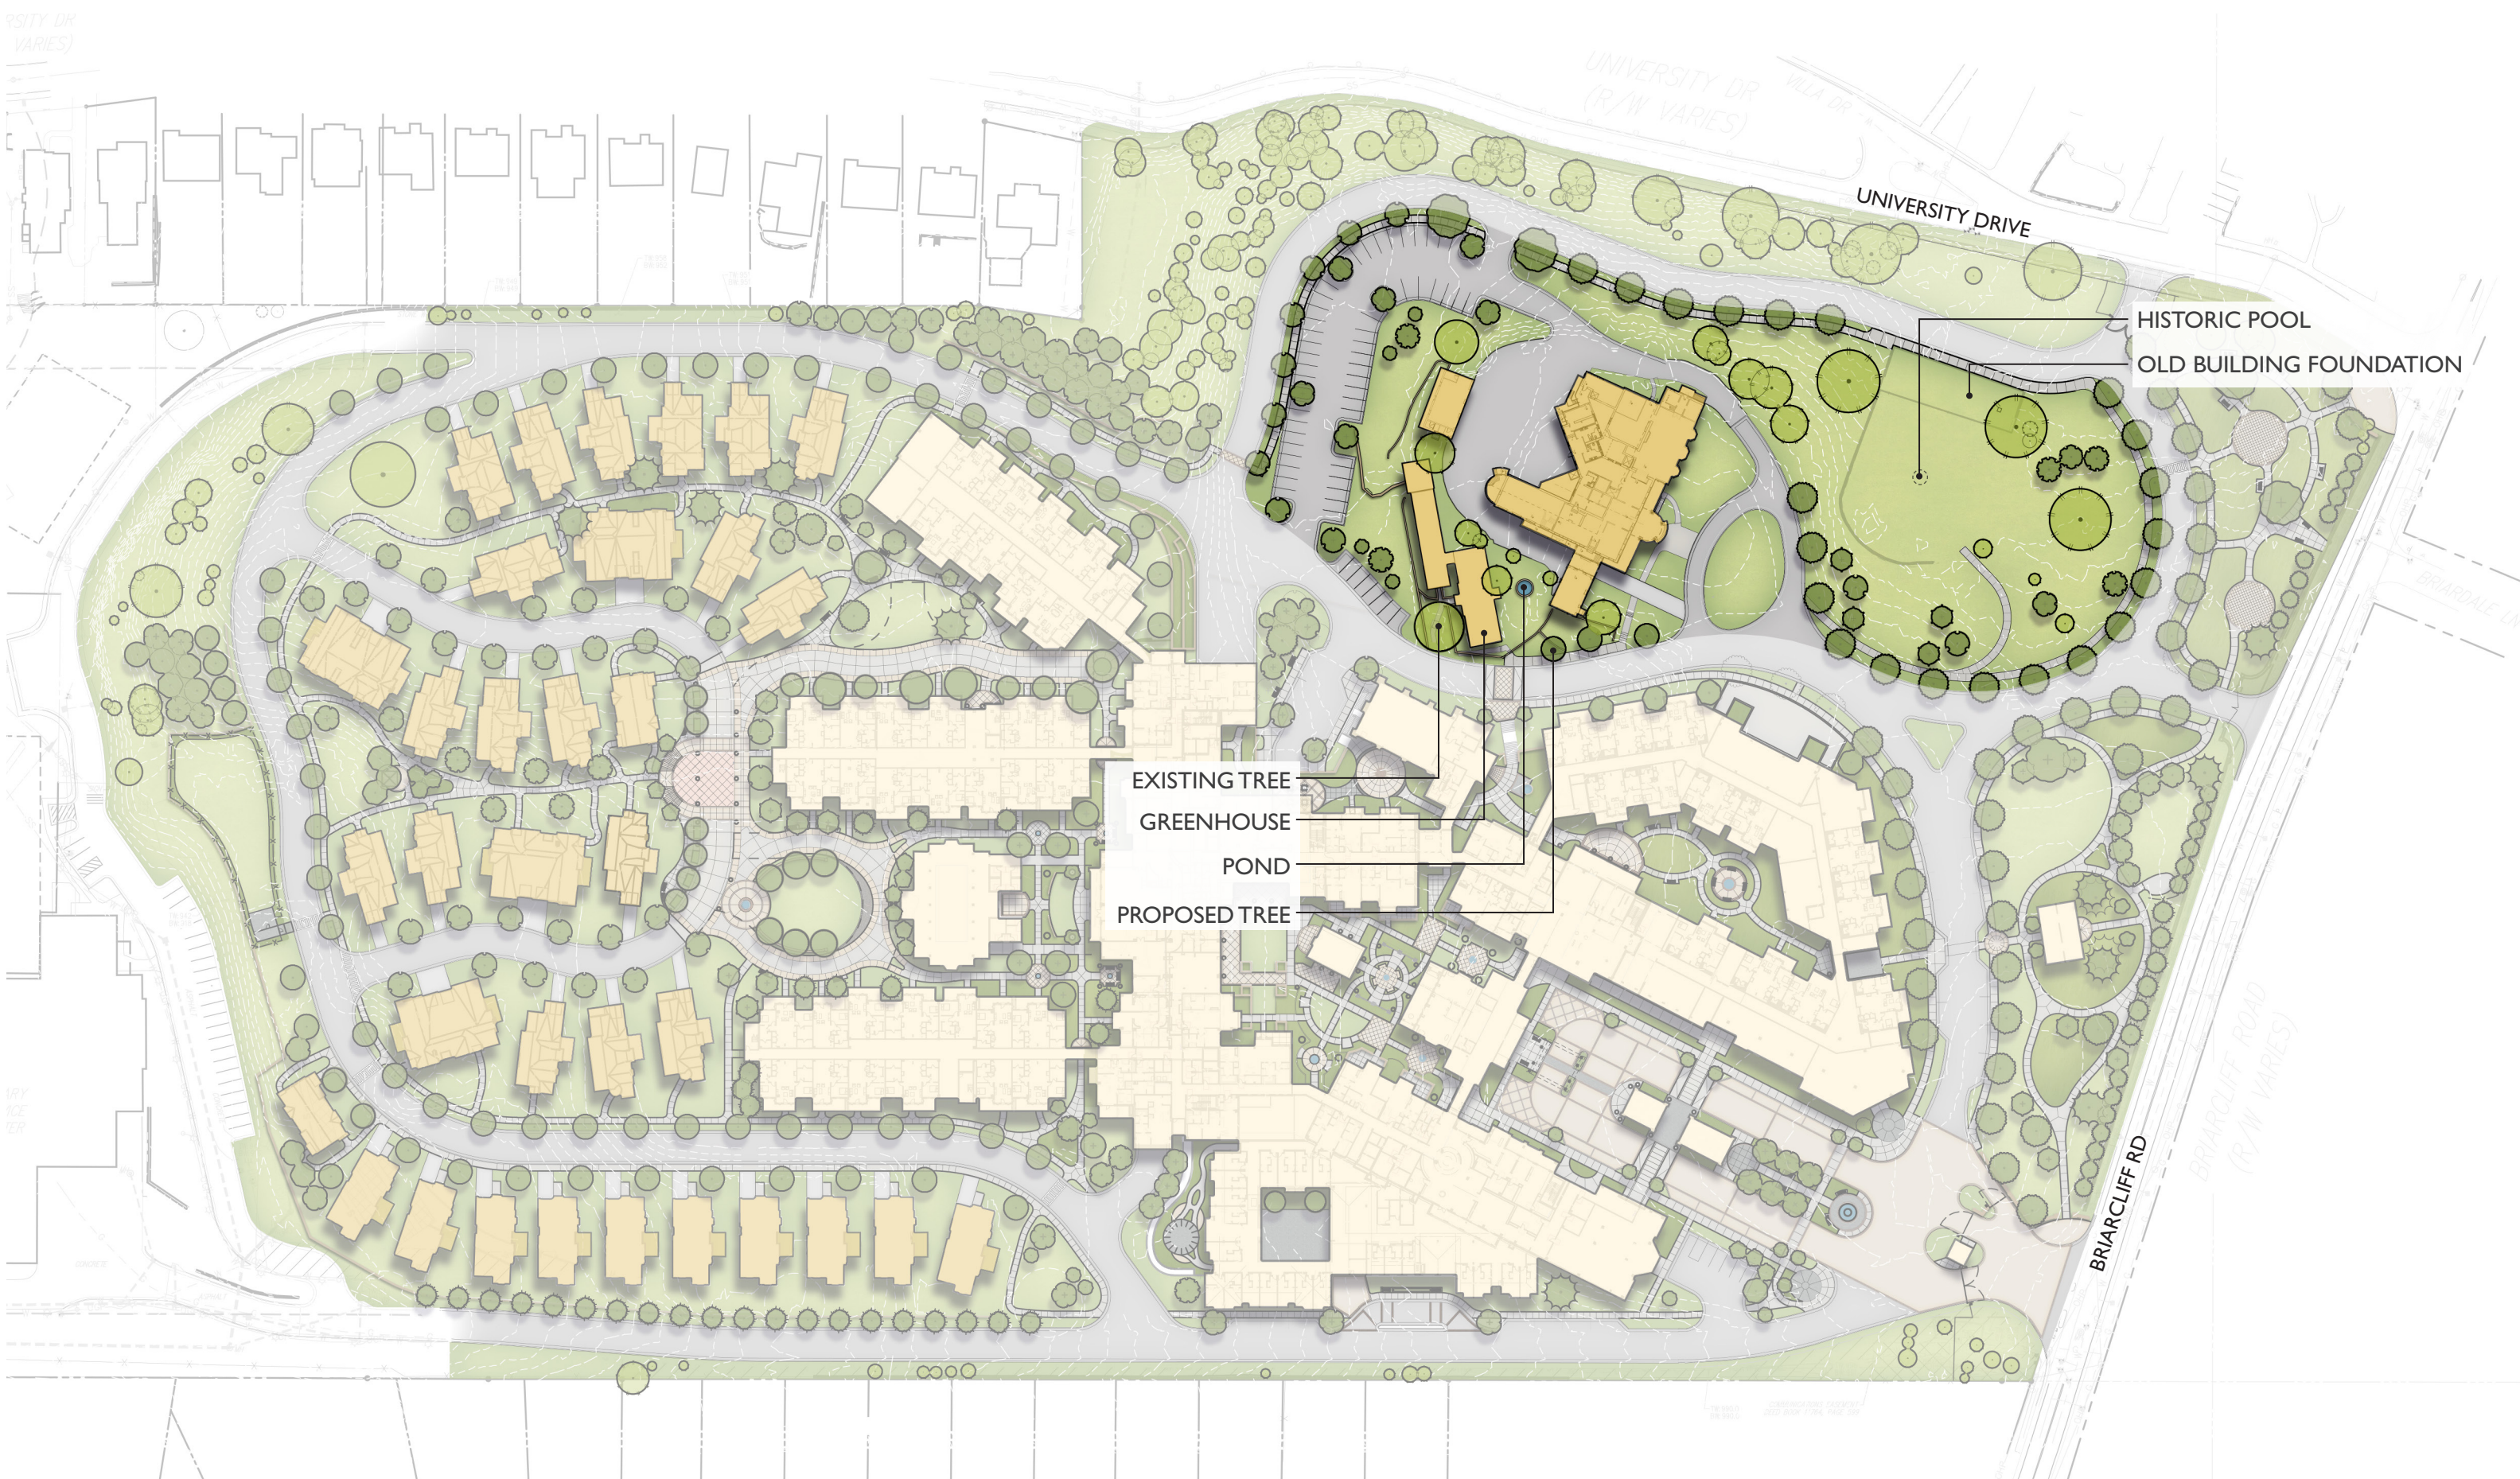
HISTORIC POOL
 OLD BUILDING FOUNDATION

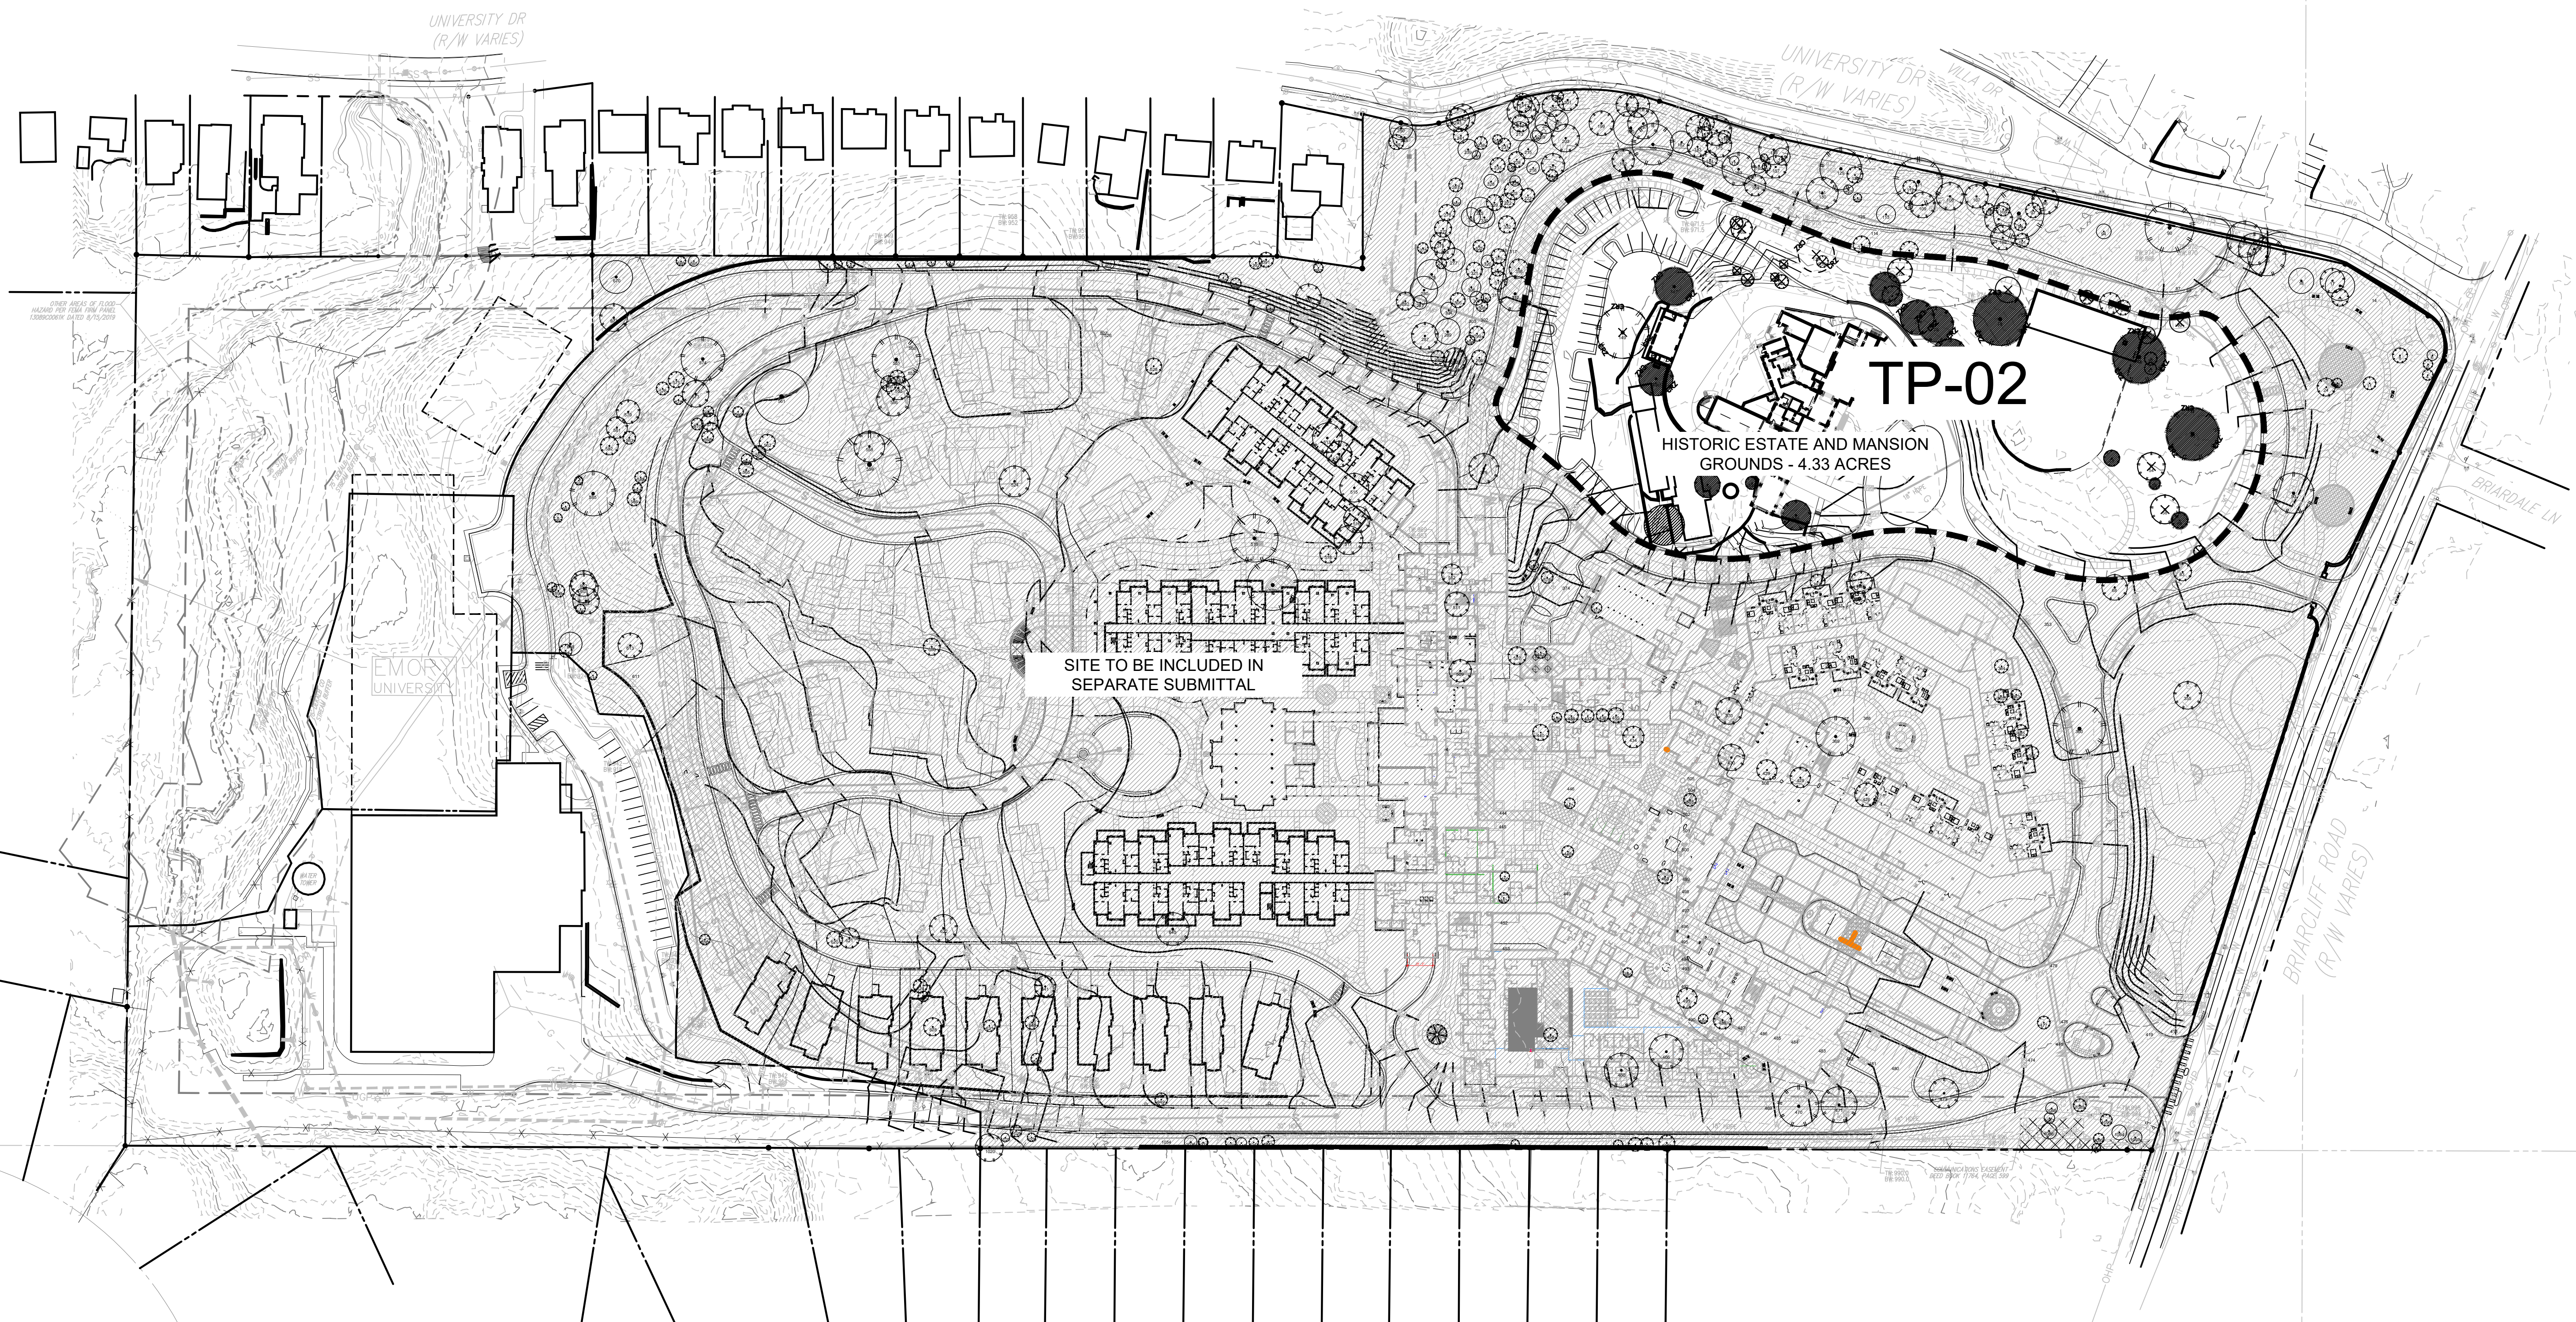
CORSO DRUID HILLS
 MANSION AND HISTORIC GROUNDS SITE PLAN

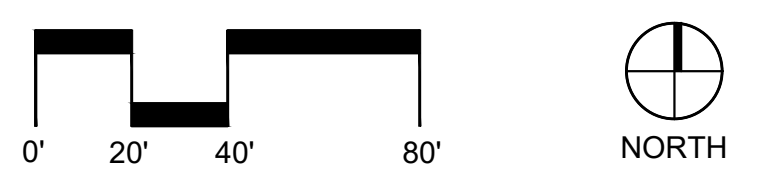
A TREE REPLACEMENT KEY PLAN
 TP-03 SCALE: 1" = 80'-0"
