Chief Executive Officer
Michael Thurmond

DEPARTMENT OF PLANNING & SUSTAINABILITY

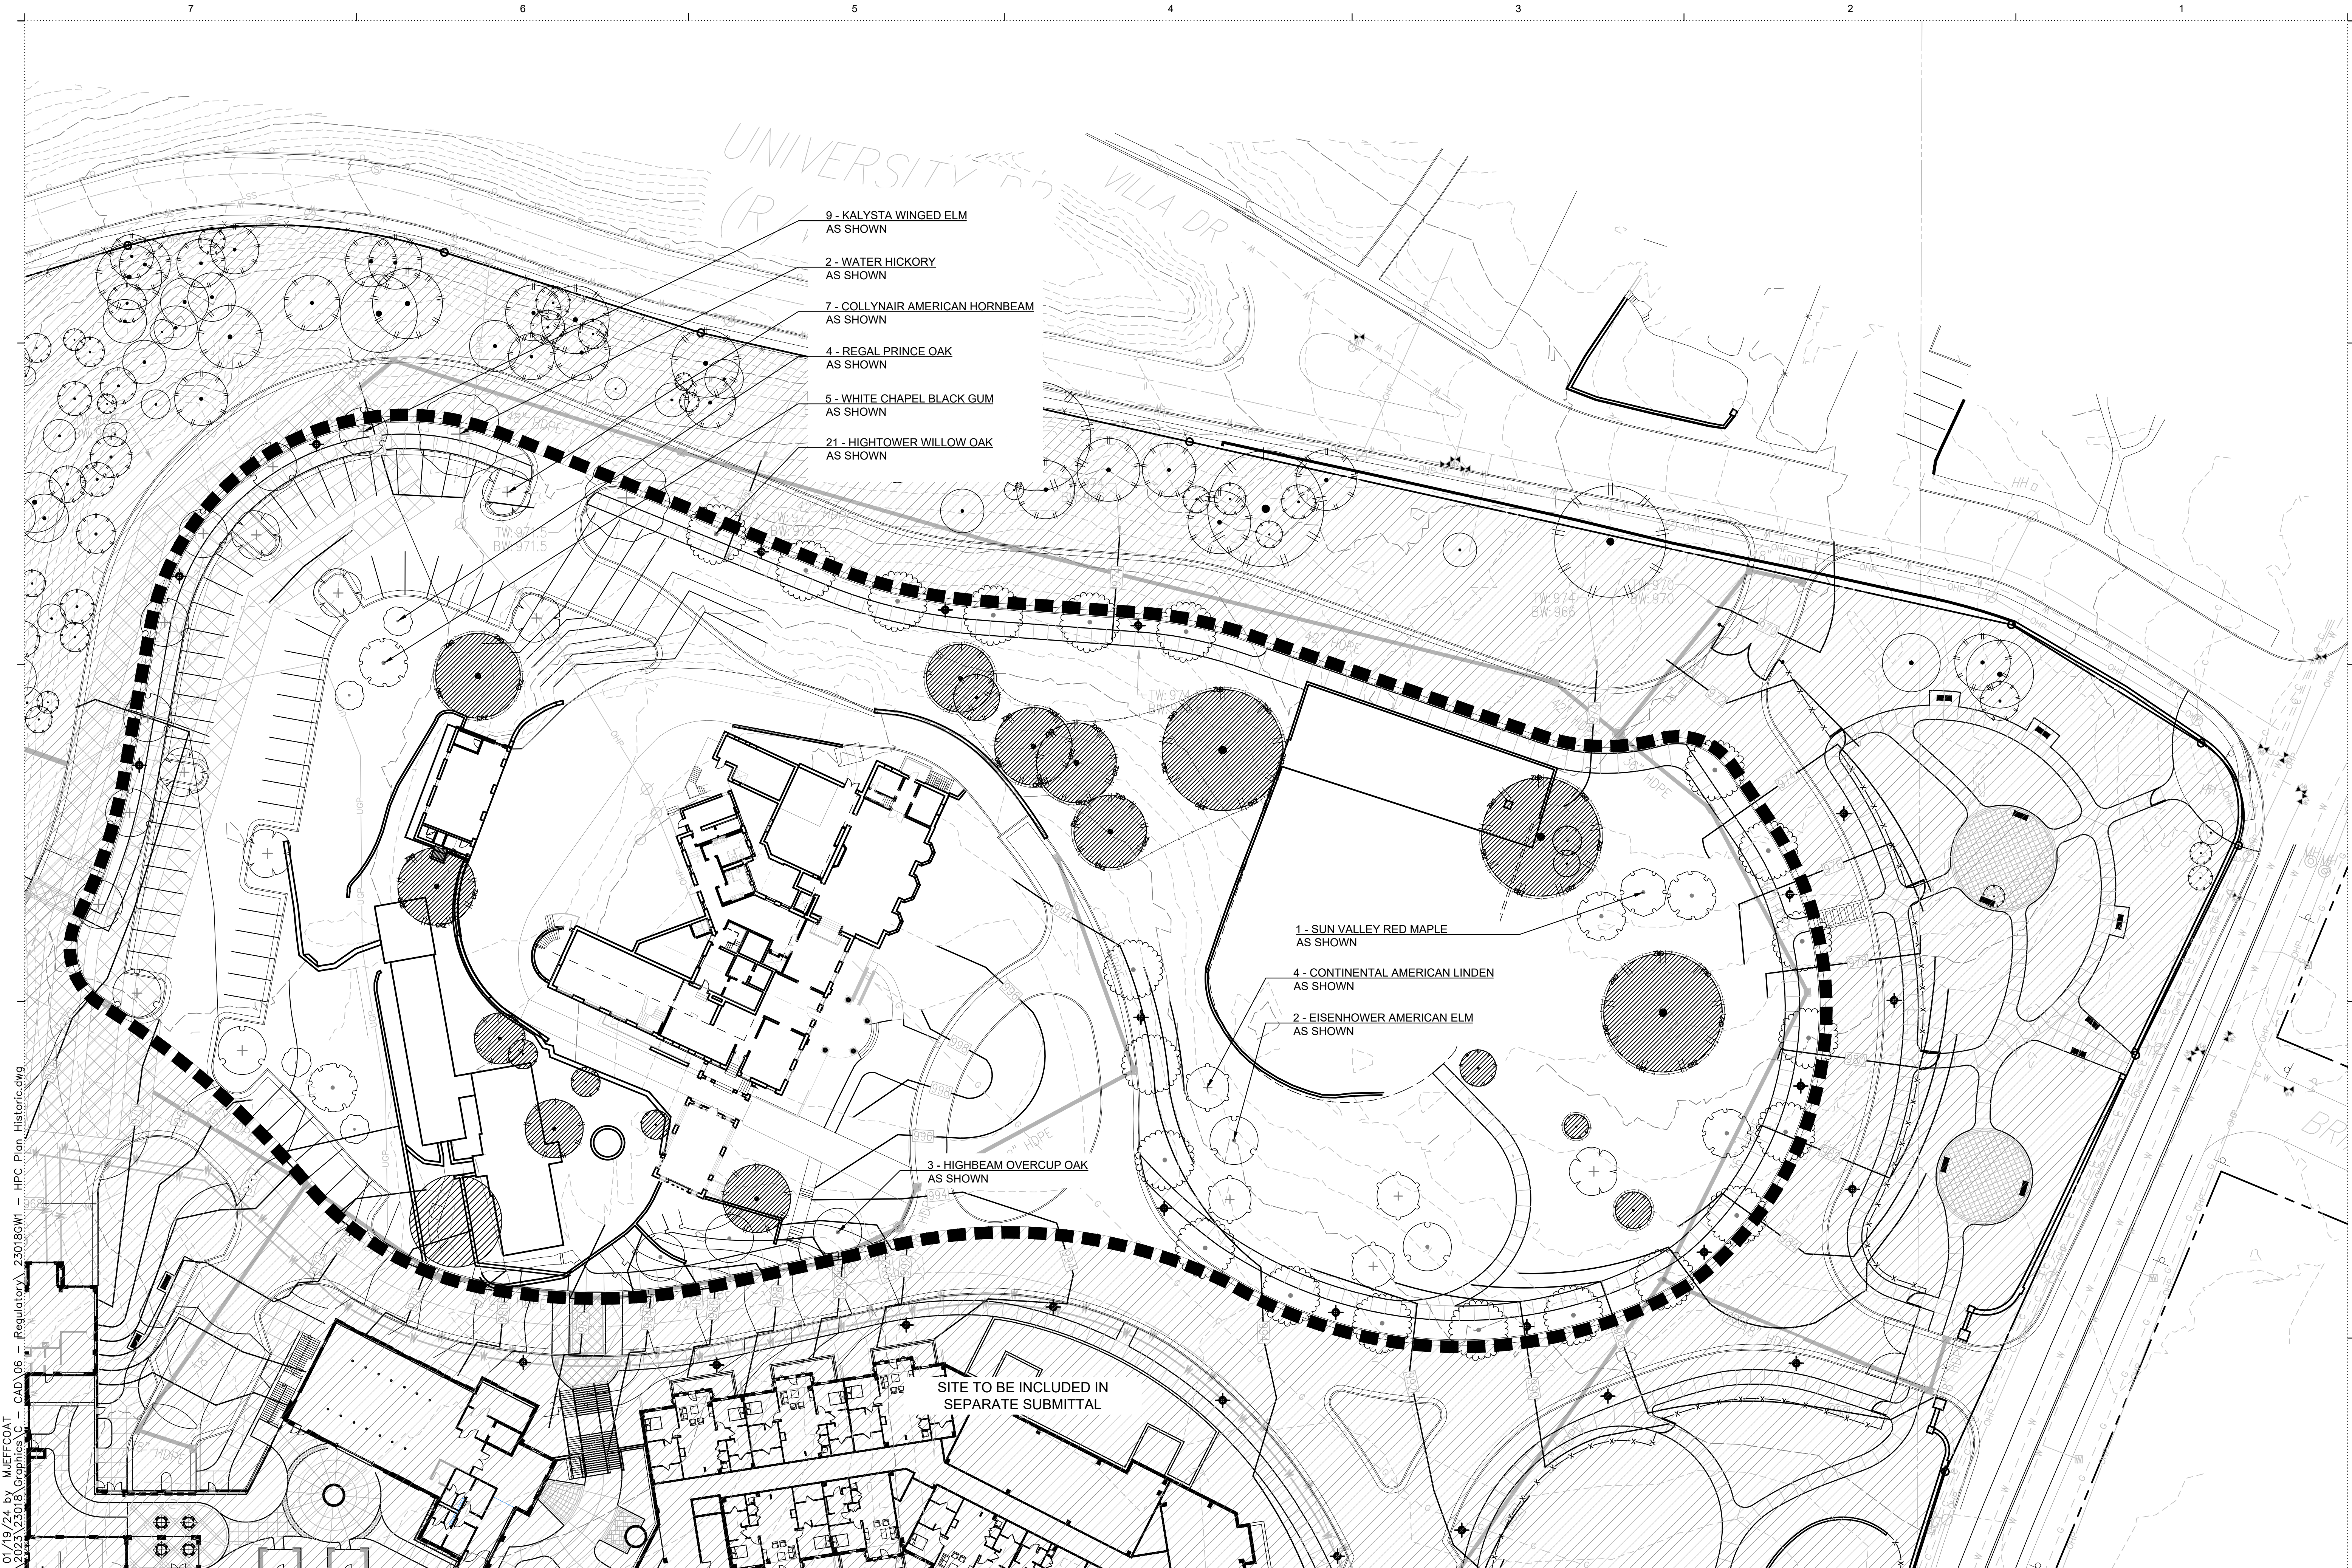
- 9 - KALYSTA WINGED ELM
AS SHOWN
- 2 - WATER HICKORY
AS SHOWN
- 7 - COLLYNAIR AMERICAN HORNBEAM
AS SHOWN
- 4 - REGAL PRINCE OAK
AS SHOWN
- 5 - WHITE CHAPEL BLACK GUM
AS SHOWN
- 21 - HIGHTOWER WILLOW OAK
AS SHOWN

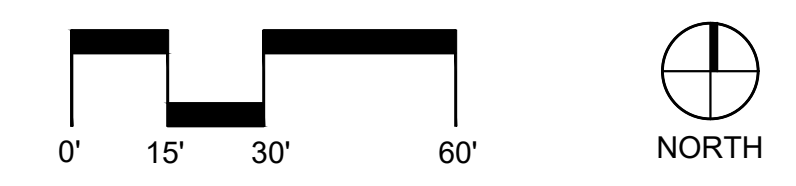
Last modified on 01/19/24 by M.EFFCOAT
 File located in S:\2023\23018\Graphics\CAD\06 - Regulatory\2301806WI - HPC Plan - Historic.dwg
