### Application for Certificate of Appropriateness

Address of Subject Property: 1035 Oxford Rd

## **STRUCTURAL ENGINEER INSPECTION REPORT**

Site Address: 1035 Oxford Rd NE, Atlanta, GA 30306  
Inspection Date: Friday, August 29, 2024,  
Prepared by: Harry Wahba, P.E. (Lic. PE039356)  
Phone: (470) 295-3779  
Email: fivestarengineeringllc@gmail.com

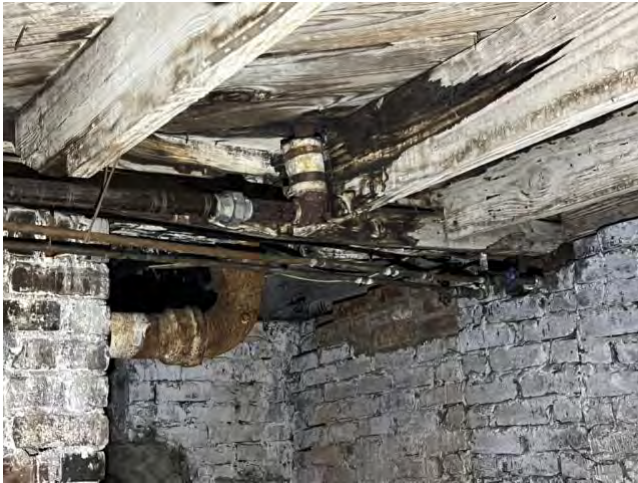
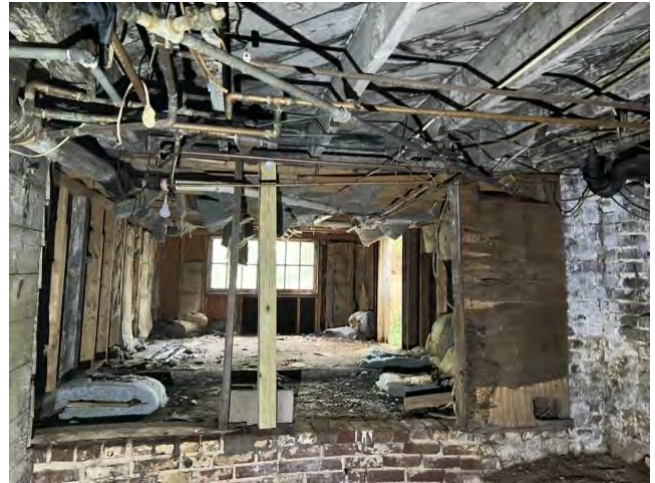
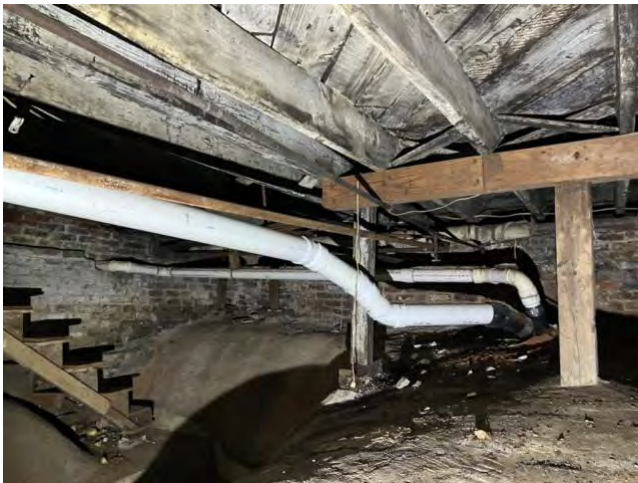
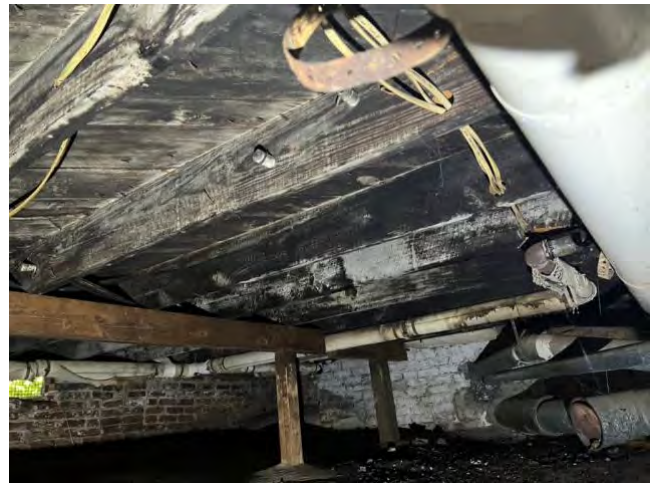
Exhibit 1:

**Observation #1:** Damaged floor joists and beams and uneven floor in different floor locations; see Exhibit 1.

**Conclusion:** The floor joists/beams and subfloor have been severely damaged for an extended period due to a leak or moisture condition. Any moisture problems contributed to decay and weakened the floor joists and subfloor. Also, there are noticeable deflections on the surface. This condition is called "creep" and is observed in buildings 40 years or older. This type of age deflection occurs when, after many years of continuous loading, the cells in the

wood change shape, and some of the fibers start to bend. Breakage and collapse seldom occur because the breaking strength of wood usually doubles its fiber bending strength. Accordingly, creeping floors tend to deflect and then set. Also, many Improper supplemental supports and beam/joists have been noticed.

**Recommendation:** We recommend replacing all the rotted beams/joists and adding more support in the form of new structural beams and columns, such as new wood/steel posts.

Assuming the joists are in good condition, reinforcing the floor can solve uneven floor problems. Beefing up the floor joists can diminish uneven floor issues. It is essential to demolish all the wooden structural elements of the house and build a new floor system and foundation.

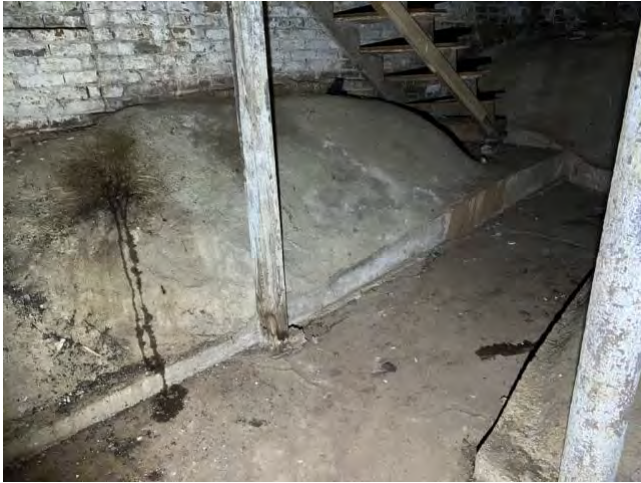
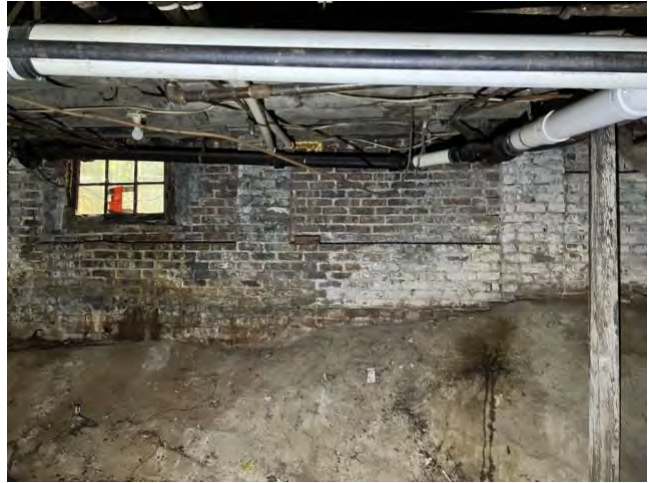
**Exhibit 2:**

**Observation #2:** There has been inappropriate excavation within the interior walls and middle support footings; see Exhibit 2.

**Conclusion:** When excavating to convert the low crawl space to a deeper level, the soil within the perimeter is excavated to the desired depth, usually done by hand. Once the footings have been exposed without adequate support or soil stabilization, the structural integrity of the home foundation will be compromised.

**Recommendation:** It is recommended to support the crawl space wall and middle piers foundation. This can be achieved by adding new supports such as steel posts and footings and stabilizing the soil with concrete flowable fill. Alternatively, creating a "bench ledge" by constructing a small retaining wall inside the perimeter of the foundation can help strengthen the structure and serve as a retaining wall for the soil outside the new foundation.

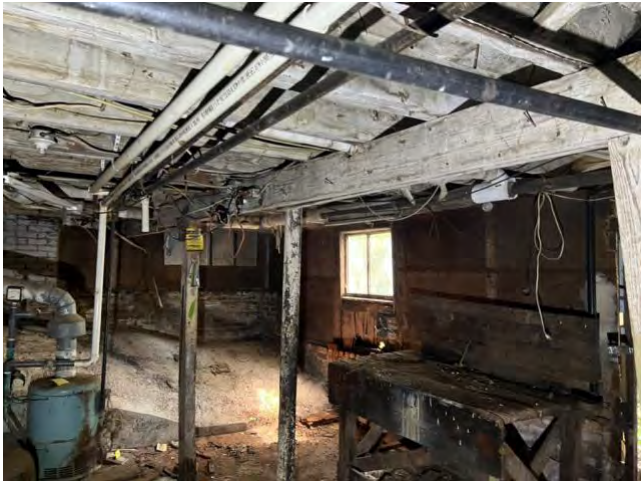
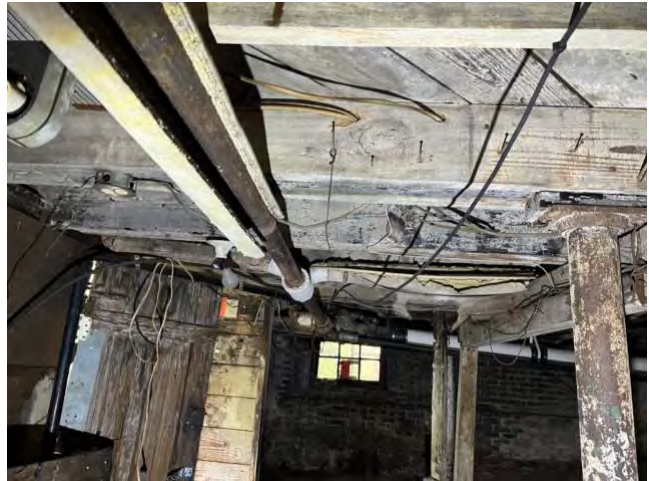
**Exhibit 3:**

**Observation #3:** The steel posts supporting the main beams display rust damage at the base; Exhibit 3.

**Conclusion:** Steel posts exposed to high humidity and moisture will eventually rust at various points. When these parts are subjected to flooding or repetitive wet conditions, they become corroded and lose their strength.

**Recommendation:** If the corrosion on the steel posts or base is not severe, they should be sanded down and coated with a zinc-rich primer. Subsequently, the steel should be covered with at least two coats of acrylic paint. If the rust damage is severe, it is best to replace the affected parts entirely. This can be accomplished by cutting out the severely rusted section, attaching an elevated base, or welding a new steel post to the bottom.
