Chief Executive Officer D Michael Thurmond	EPARTMENT OF F	PLAN	NING & SUST	AINABI	LITY Interim Director Cedric Hudson
	Application for	Certifi	cate of Appro	priatenes	S
Date submitted:		Date Re	ceived:		
Address of Subject Propert	y: 1035 Oxford Rd				
Applicant: Ben Darn	ner / Parkwood Liv	ing, L	LC E-Mai	bdarmer@bellso	uth.net / info@parkwoodliving.com
Applicant Mailing Address	1877 Ardmore R	d Atla	anta, GA 3030)9 /	
951 Edgewood /	Ave Atlanta, GA 30	307			
Applicant Phone: 404-6	95-0690 / 404-438	8-612	0		
Applicant's relationship to	the owner: Owner	Arch	itect Cont	ractor/Builde	r Other

STRUCTURAL ENGINEER INSPECTION REPORT

Site Address: Inspection Date: Prepared by: Phone: Email: 1035 Oxford Rd NE, Atlanta, GA 30306 Friday, August 29, 2024, Harry Wahba, P.E. (Lic. PE039356) (470) 295-3779 fivestarengineeringllc@gmail.com

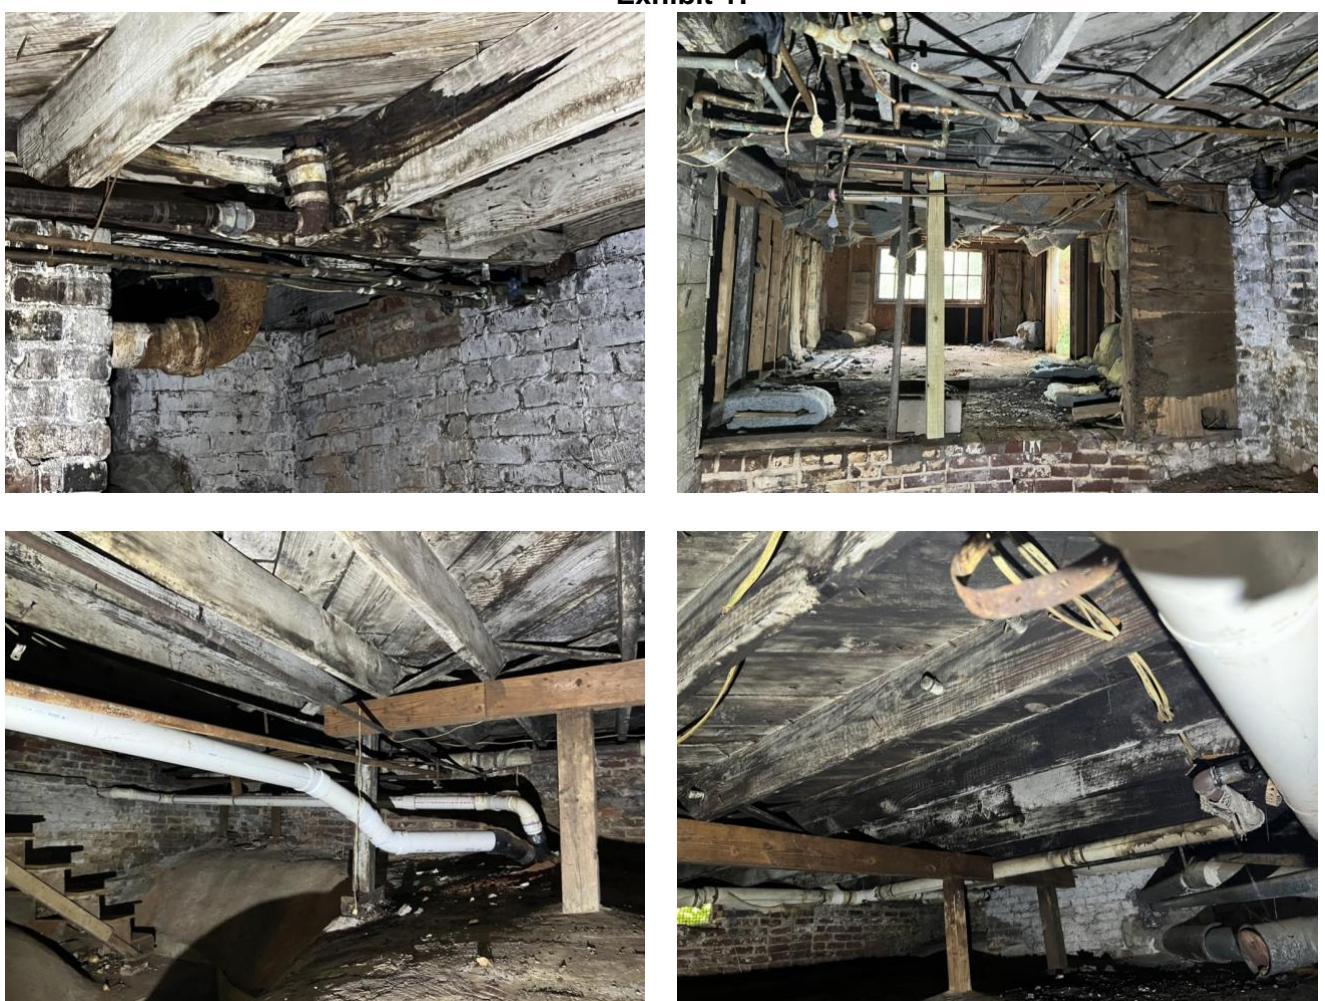
Exhibit 1:

Observation #1: Damaged floor joists and beams and uneven floor in different floor locations; see Exhibit 1. **Conclusion:** The floor joists/beams and subfloor have been severely damaged for an extended period due to a leak or moisture condition. Any moisture problems contributed to decay and weakened the floor joists and subfloor. Also, there are noticeable deflections on the surface. This condition is called "creep" and is observed in buildings 40 years or older. This type of age deflection occurs when, after many years of continuous loading, the cells in the

wood change shape, and some of the fibers start to bend. Breakage and collapse seldom occur because the breaking strength of wood usually doubles its fiber bending strength. Accordingly, creeping floors tend to deflect and then set. Also, many Improper supplemental supports and beam/joists have been noticed.

Recommendation: We recommend replacing all the rotted beams/joists and adding more support in the form of new structural beams and columns, such as new wood/steel posts.

Assuming the joists are in good condition, reinforcing the floor can solve uneven floor problems. Beefing up the floor joists can diminish uneven floor issues. It is essential to demolish all the wooden structural elements of the house and build a new floor system and foundation.

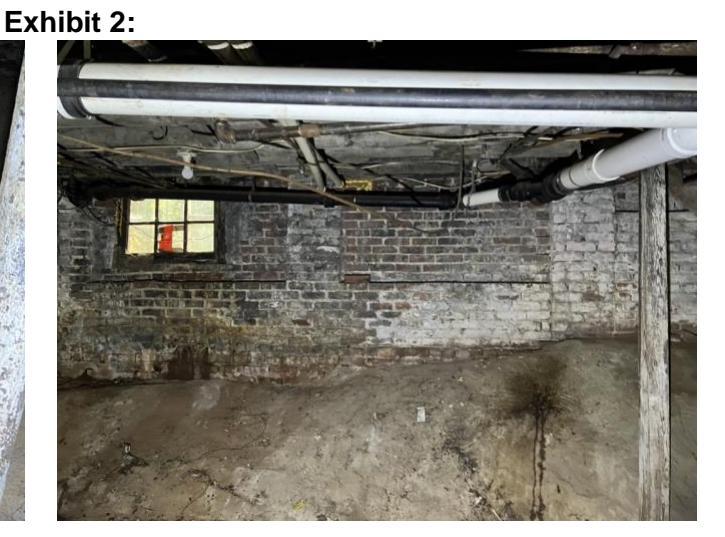
Observation #2: There has been inappropriate excavation within the interior walls and middle support footings; see Exhibit 2.

Conclusion: When excavating to convert the low crawl space to a deeper level, the soil within the perimeter is excavated to the desired depth, usually done by hand. Once the footings have been exposed without adequate support or soil stabilization, the structural integrity of the home foundation will be compromised.

Recommendation: It is recommended to support the crawl space wall and middle piers foundation. This can be achieved by adding new supports such as steel posts and footings and stabilizing the soil with concrete flowable fill. Alternatively, creating a "bench ledge" by constructing a small retaining wall inside the perimeter of the foundation can help strengthen the structure and serve as a retaining wall for the soil outside the new foundation.

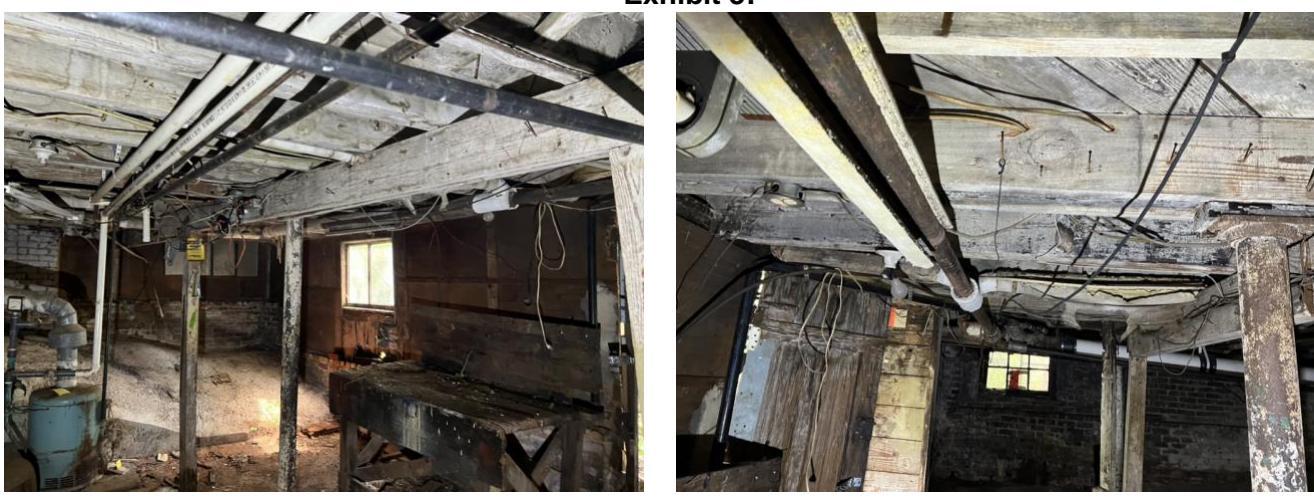
Exhibit 3:

Observation #3: The steel posts supporting the main beams display rust damage at the base; Exhibit 3. **Conclusion:** Steel posts exposed to high humidity and moisture will eventually rust at various points. When these parts are subjected to flooding or repetitive wet conditions, they become corroded and lose their strength. **Recommendation:** If the corrosion on the steel posts or base is not severe, they should be sanded down and coated with a zinc-rich primer. Subsequently, the steel should be covered with at least two coats of acrylic paint. If the rust damage is severe, it is best to replace the affected parts entirely. This can be accomplished by cutting out the severely rusted section, attaching an elevated base, or welding a new steel post to the bottom.
