# DeKalb County Historic Preservation Commission

## Staff Report

G. 1946 Edinburgh Terrace, Amina Bhatia. Replace windows on a historic house. **1247463**

Window replacement - sunporch  
1946 Edinburgh Ter NE, Atlanta, GA 30307

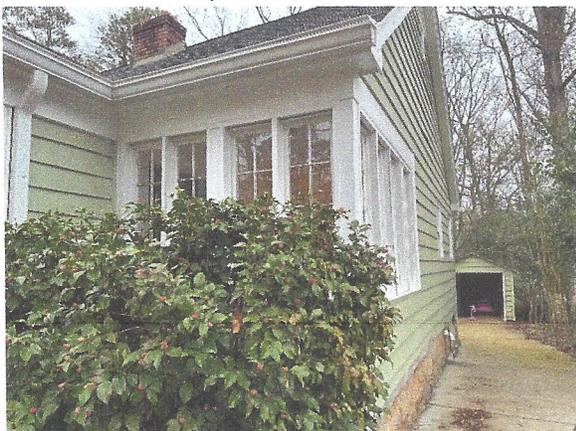
1. Four (4) original single pane windows located on the front of the house. (photo attached)
2. Four (4) original additional single windows located on the right side of the house. (photo attached)

Photo 1.\_ Exterior view of the house, showing current window placement in the front

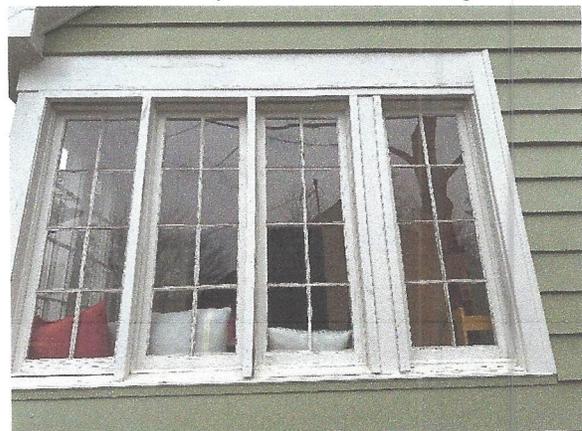
Photo 2. Exterior view of the house, showing current window placement on the right side

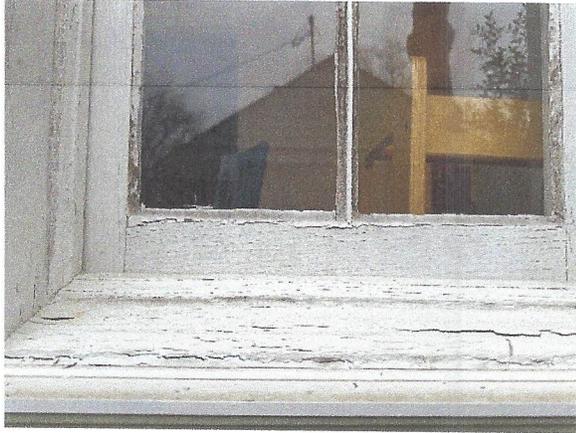
- Rotten wood present on several frames and sashes (see attached photo for close-up views of damage).
- Moisture spot visible inside the sun porch ceiling (attached photo), likely due to prolonged water infiltration. This has been a recurrent problem
- Deterioration compromises both the structural integrity and energy efficiency of the windows.

Photo 3. Close up of window showing damage

Window replacement: Remove existing 8x2W4H wooden single pane windows on sunporch and replace with 8x2W4H wooden energy effluent windows.
