Chief of Executive Officer Director Lorraine Cochran-Johnson Juliana A. Njoku Application for Certificate of Appropriateness

Subject Property Address: 1080 Clifton Rd NE, Atlanta, Ga 30307

SUMMARY OF STRUCTURAL ANALYSIS

1080 CLIFTON ROAD - SUPPORTING PICTURES

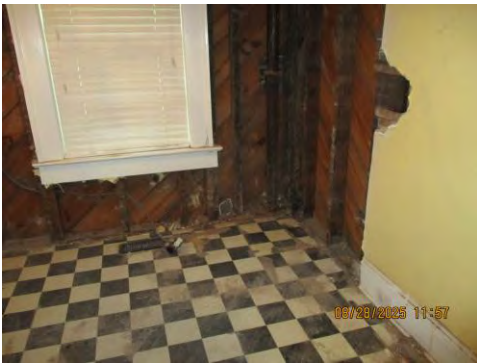
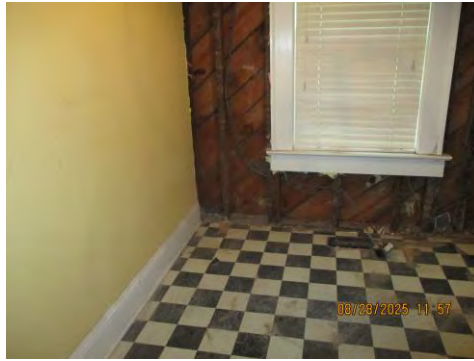
2. Breakfast Room

The exterior face of the stud walls at the main and upper floors is diagonal 1x board sheathing and has brick veneer. Water intrusion was observed in the ceiling and exterior walls in the main floor kitchen, breakfast room, living room, dining room, stair landing, side porch, and the upstairs bedrooms. The plaster and lath were removed in the areas with water stains. The joists, wall studs, subfloor, wall plates, and sheathing that were exposed had extensive rot and deterioration and mold. Where the sheathing was rotted, no brick ties were observed for the brick. Indications of past termite damage was observed. On the front of the house, the ivy was removed on the brick veneer exposing mortar separations and cracks in the mortar and the brick veneer, permitting water intrusion. The stair-step crack pattern in the brick mortar joints is an indication of a degree of foundation settlement. We were informed that in order to treat the mold, complete removal of the plaster and wood lath on the walls and ceilings would be required.

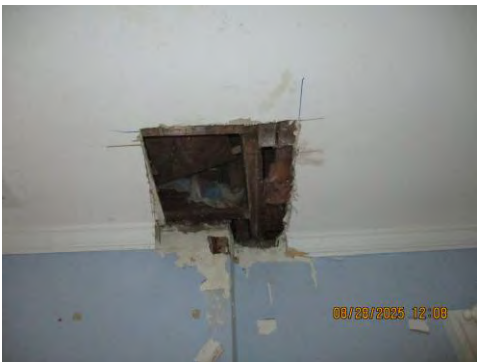
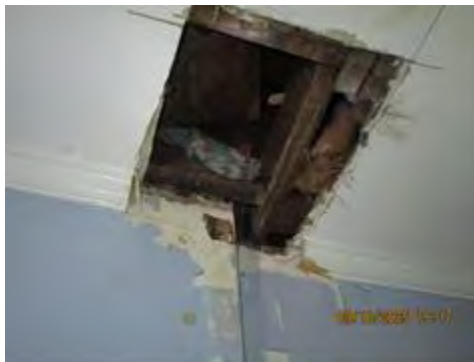
3. Upper Floor Ceiling at Chimney

The plaster and lath were removed from the walls and ceiling to observe the conditions of the floor and wall framing where water intrusion was observed. The wall studs, wall plates, and joists, had areas with significant rot and mold.

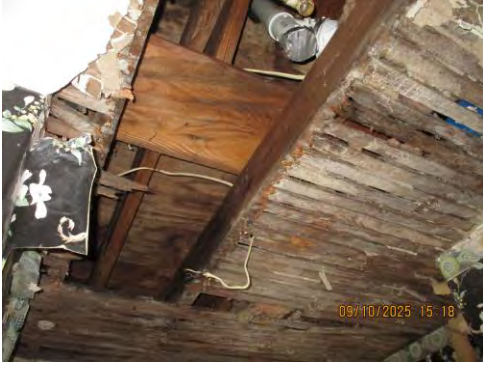
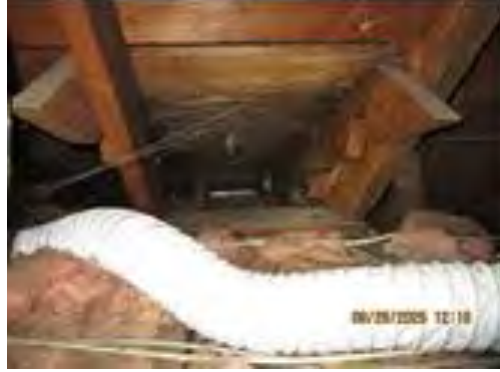
4. Attic

The attic flooring and joists had areas of water stains, rot, and mold due to leaks in the roof. Indications of rodent infestation was observed. Soffit ventilation was observed with no screens.

The roof decking had areas of sagging between rafters, water stains were observed indicating roof leaks. In the eaves, rot was observed in the roof framing where water from the gutters had backed up in the roof soffits. The water intrusion from the roof penetrated the stud walls of the second and first floors. Rot and mold in the upper floor ceiling framing adjacent to the chimney are indications improper flashing around the chimney. Gutters and downspouts are not functioning due to neglect, and require cleaning with repairs or replacement.

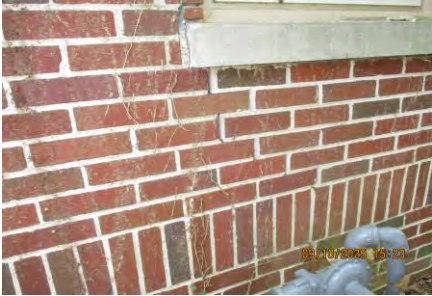
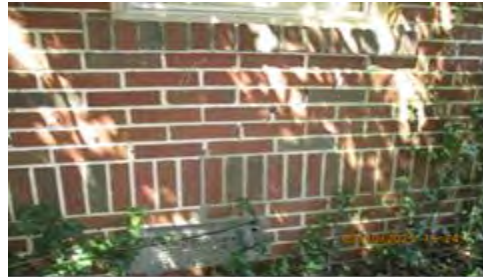
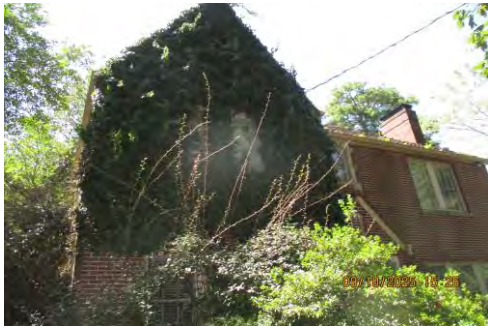
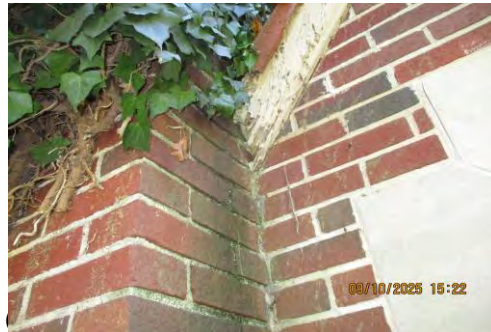
5. Brick Veneer

Stair step cracks in the brick veneer indicate settlement has occurred in the foundation. The basement/drawl space area has high levels of moisture, mold, and asbestos.

The brick veneer has areas of missing mortar and cracks in the mortar. Stair-step cracks in the mortar joints was observed at the front left and right corners, an indication of foundation settlement. The tile flooring has cracks due to exposure to the elements.

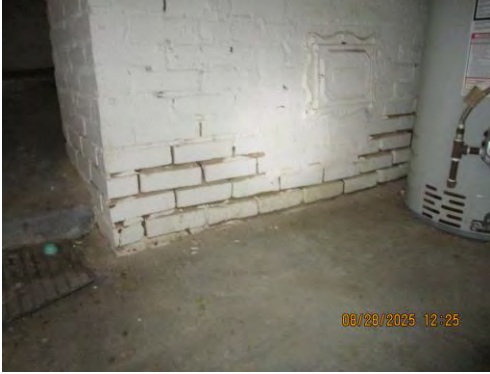
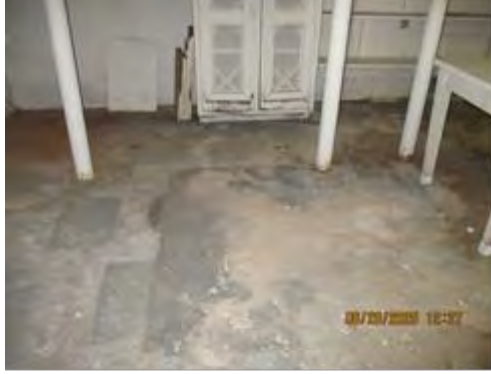
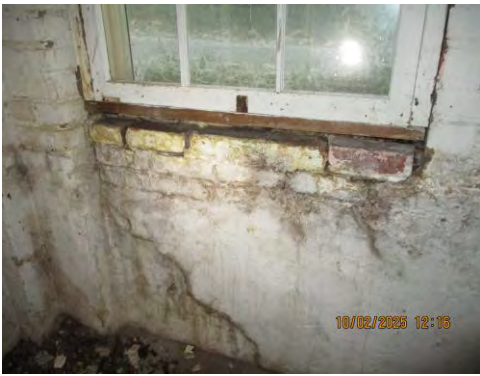
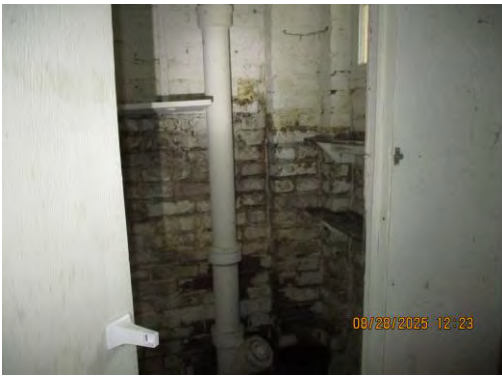
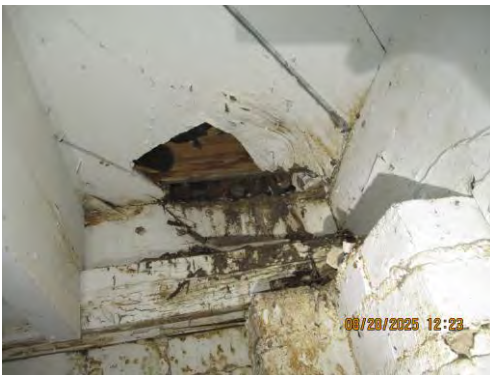
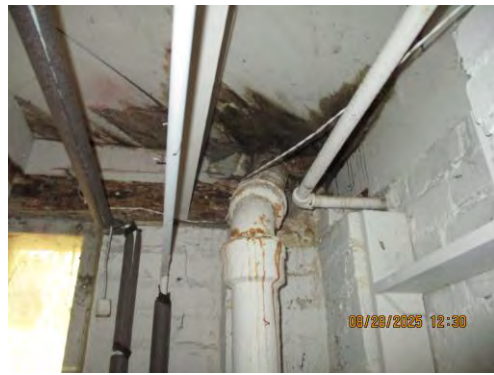
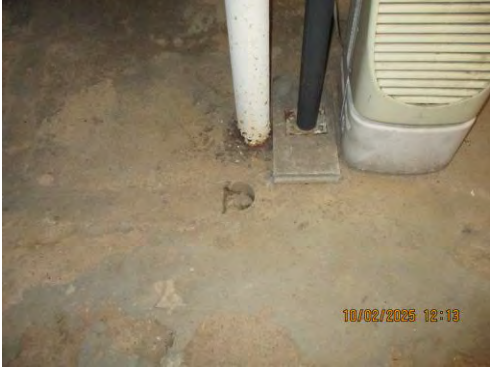
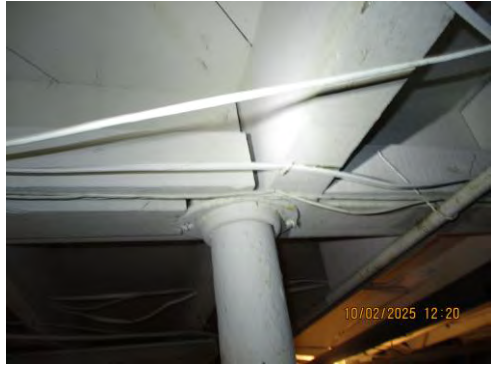
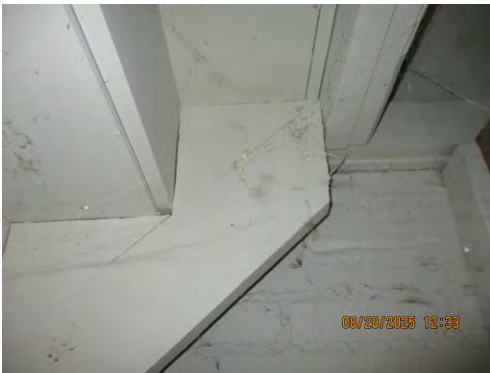
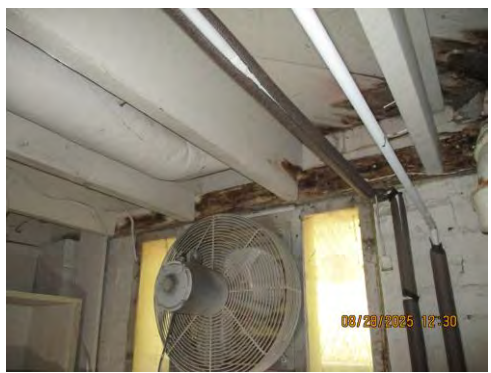
6. Basement

The basement/crawl space wall has cracks in the masonry which has permitted water intrusion into the basement, there is no exterior waterproofing, and the house has no exterior or functional interior perimeter drain.

The steel columns in the basement are rusted and have an unknown support footing under a basement slab that has settlement.

The house was constructed on a continuous spread shallow footing foundation on compacted earth with a partial basement/crawl space. The basement wall is multi-wythe load bearing brick and block masonry, with areas of cracks and loose mortar joints, and indications of water intrusion from the exterior, there is no exterior waterproofing and no drainage on the exterior. The basement slab is uneven, has settlement due to erosion of the earth base, and has an existing drain which is blocked with an unknown outlet. The crawl space is exposed earth with high levels of moisture and no vapor barrier. Standing water was observed in areas of the basement and crawl space. The interior basement columns were rusted steel pipe columns embedded in the concrete slab, the depth and dimensions of the supports under the columns are unknown. Vertical displacement of the columns was observed. A temporary screw jack column was installed adjacent to a failed steel column. Asbestos and high levels of mold were

observed. New columns on new footings, exterior and interior drainage, waterproofing of the perimeter walls, moisture control in the crawl space, and asbestos and mold remediation measures are required.

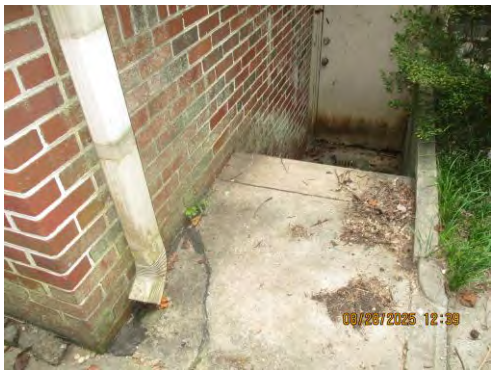
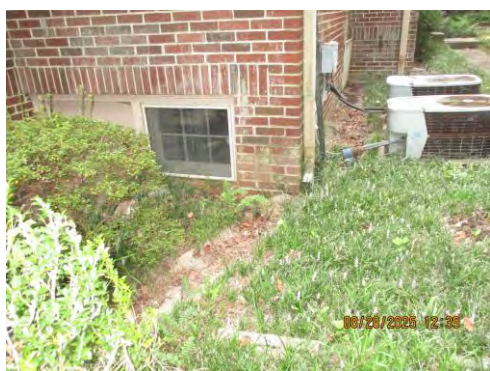
7. Drainage

Moisture levels are high due to water intrusion from exterior and no vapor barrier in crawl space. Standing water was observed in several areas.
