### Application for Certificate of Appropriateness

REF: 168o East Clifton Rd.  
Structural Investigation

SUBJECT PROPERTY PHOTO ADDENDUM

**Location plan**  
1680 E. Clifton rd.  
Atlanta, GA 30307  
block: N/A  
log: 18-003-03-020

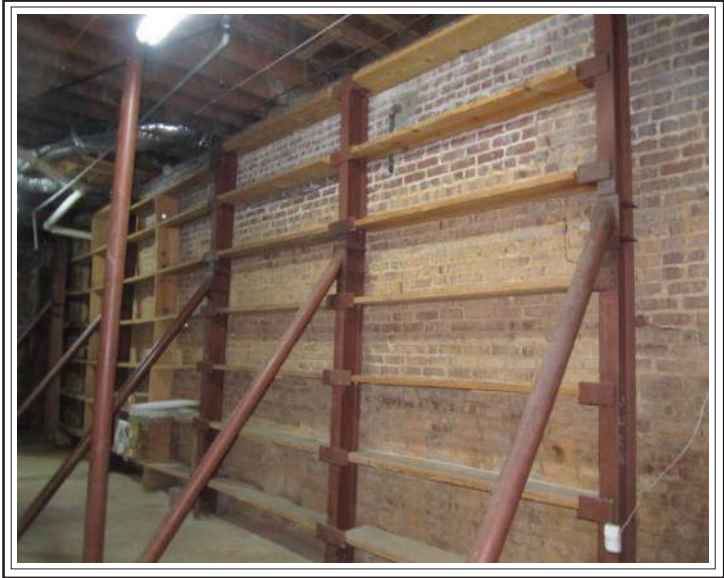
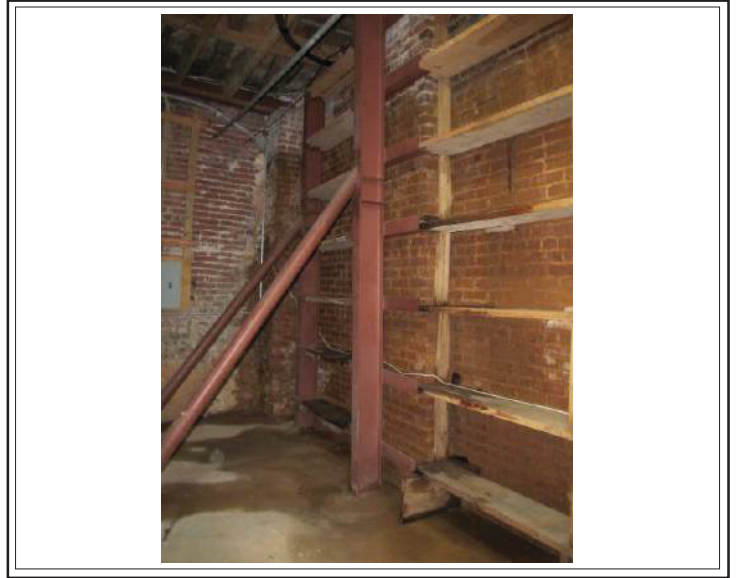
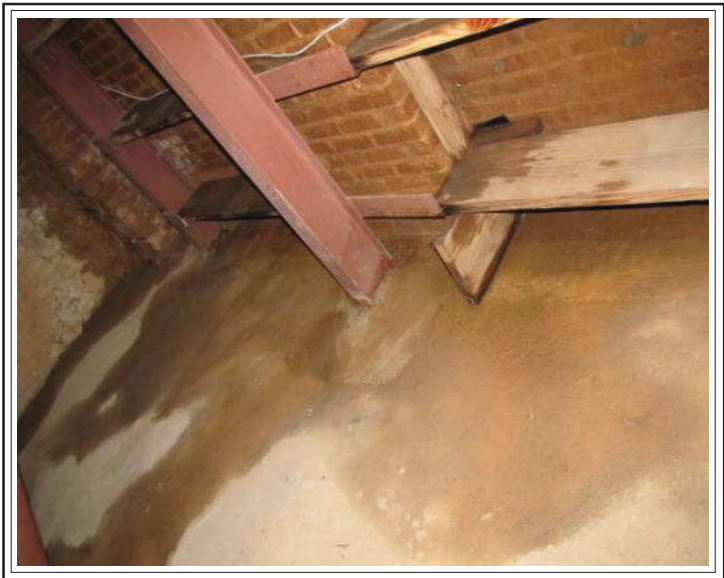
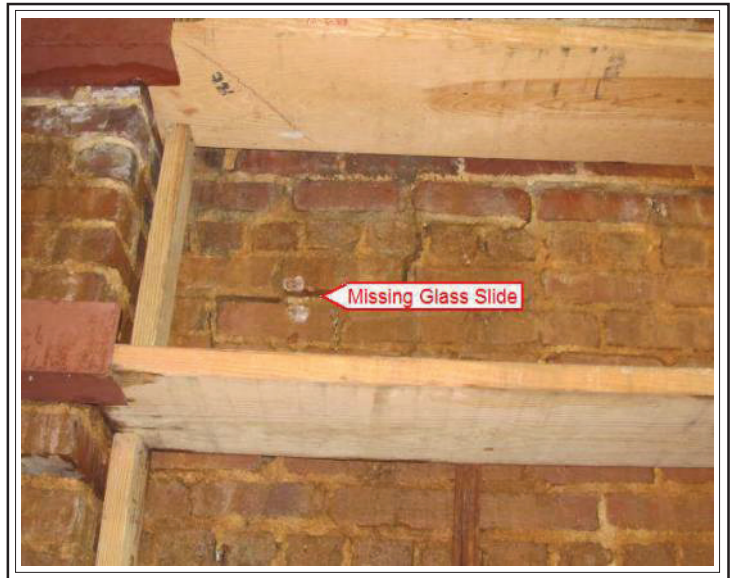
8. Prior to our visit, and by appearance some years ago, someone attempted to add lateral support for this wall, and installed a number of steel "H" columns near the inside face of the wall, along with steel pipe buttresses behind each. The "H" columns and the pipe buttresses have been embedded through the basement floor slab, encased in concrete. As the wall is leaning inward, the columns were installed inward of the upper edge of the foundation wall, and set plumb. We cannot determine from a visual examination the condition or capacity of the concrete anchoring the steel members, or the capacity intended by the designer.

9. Between the columns, which are spaced between 6'-8" and 9'-4" on center, a number of wood beams, 2 x 12, have been installed, oriented flat with edges facing the brick wall. These 2 x 12's are spaced approx. 22" apart, running between the steel posts, from bottom of post to top. Various spacers were originally placed between the inner edge of these 2 x 12's and the inner surface of the brick wall, though many have fallen or been removed. As such, this system is has little or no effect on the stability of the foundation wall system.

10. When we analyzed this bracing system according to the IRC and good engineering practice, we found the 2 x 12's are not adequate to resist the lateral loads imposed by backfill soils against the foundation wall. We conclude this system was never capable of properly stabilizing this wall, and the condition of progressive failure has not been cured.

Basement Structure Reinforcement

We are uncertain that replacing the wood portions of this bracing system can be performed in a safe manner. It is likely any removal of the existing wood lateral supports may cause the wall to move further and precipitate a collapse. Due to the location of the room with the bracing system, and the path of travel necessary to exit the dwelling in the event of danger, we fear any workmen present should a collapse be initiated would not be able to exit to safety in time. This danger cannot be overemphasized.

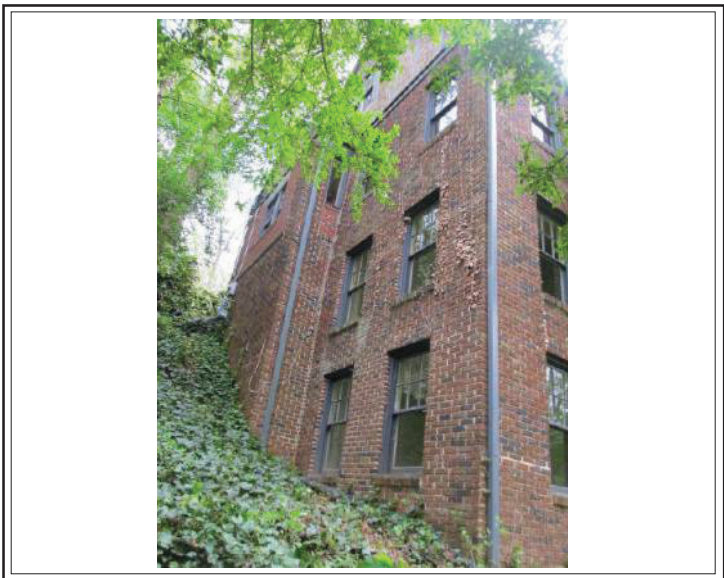
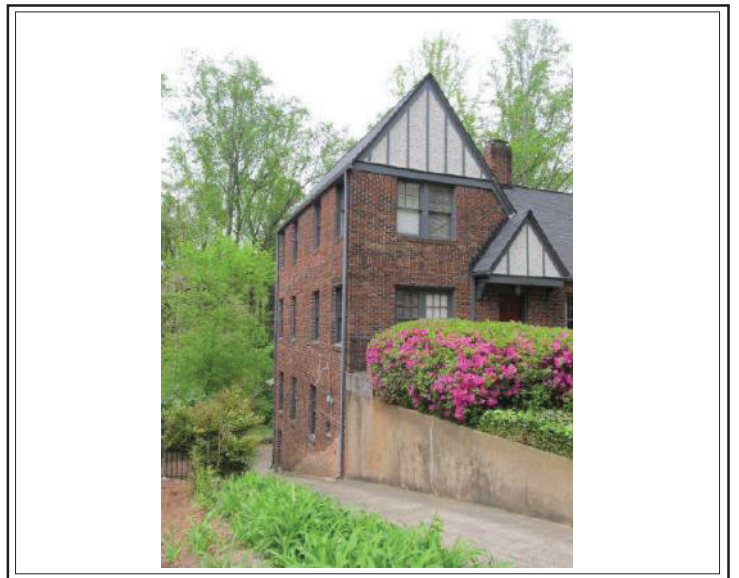
4. The left side foundation wall has had large portions of the brick masonry replaced at and near the driveway pavement. It appears large lateral movements occurred here, and possibly portions of the foundation wall collapsed and were filled in. This is a symptom of severe stress, and in fact indicates failure of the brick wall at this location. We cannot state with any confidence this area has the strength necessary to safely resist the applied vertical and lateral loads, much less the loads imposed by the backfill soils. It is our opinion the left side foundation wall is in danger of collapse. Any attempt to correct the condition of this wall by improving any masonry work is likely to initiate a collapse.

5. Conditions similar to the left foundation wall exist on the right side foundation wall as well, with shear failures, cracking and some patching visible.

Additional Subject Side View

Likewise the condition of the left and right exterior foundation walls show severe stress that attempts to correct in place may result in further severe damage or collapse. An attempt to relieve stress on the foundation system by excavating and removing the soils currently against the walls could also result in a collapse of the front wall, or failure of the side walls, just through the introduction of localized shocks and dynamic or impact loads during excavation and soil removal.
