Application for Certificate of Appropriateness

REF: 1680 East Clifton Rd.
Structural Investigation

SUBJECT PROPERTY PHOTO ADDENDUM

1680 E. Clifton rd.
Atlanta, GA 30307
block: N/A
lot: 18 003 03 020

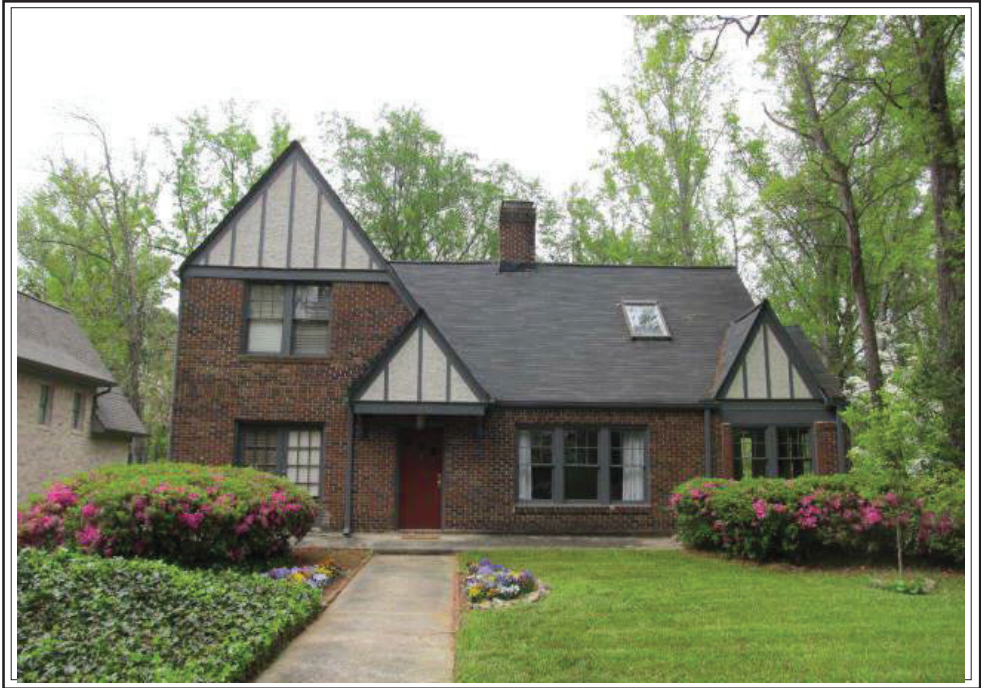
FRONT VIEW OF
SUBJECT PROPERTY

7. The top of the front foundation wall leans inward not less than 8", and has numerous large cracks and open mortar joints. These issues constitute a failure of the foundation wall, rendering it not only unstable, but also evidence this wall cannot safely resist the lateral loads imposed by the soils against it. Evidence of water leaks from left front corner to right can be observed.

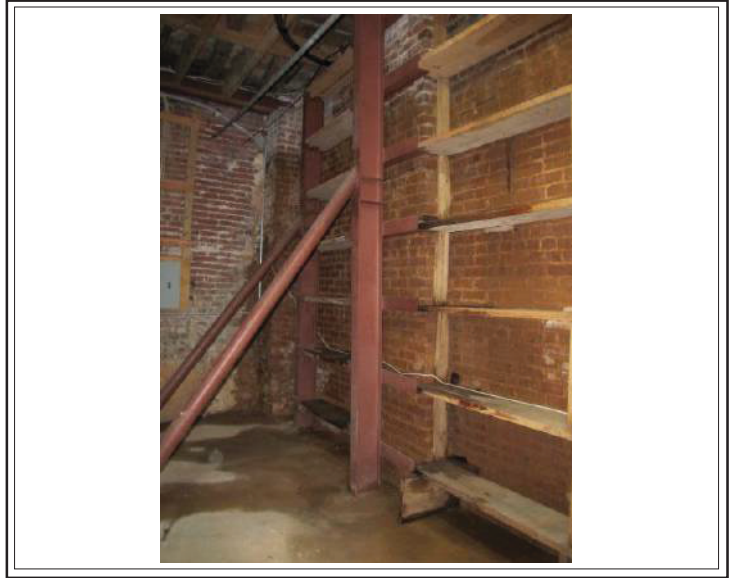
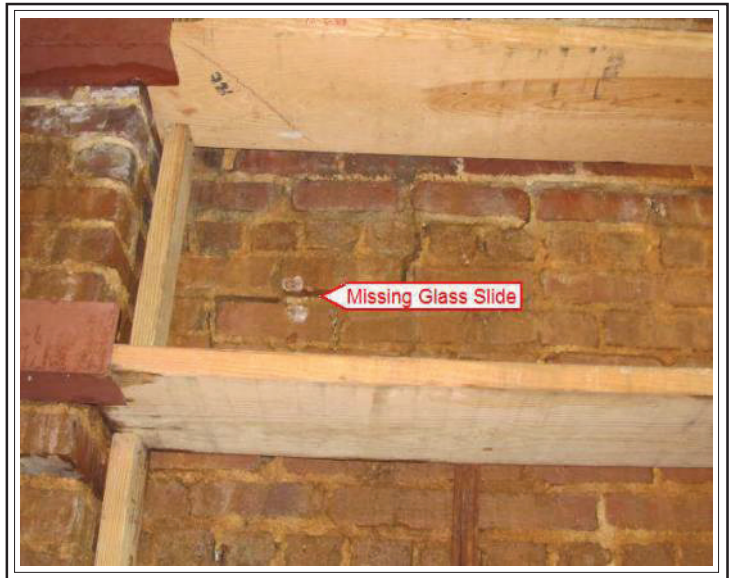
Basement Structure Reinforcement

8. Prior to our visit, and by appearance some years ago, someone attempted to add lateral support for this wall, and installed a number of steel "H" columns near the inside face of the wall, along with steel pipe buttresses behind each. The "H" columns and the pipe buttresses have been embedded through the basement floor slab, encased in concrete. As the wall is leaning inward, the columns were installed inward of the upper edge of the foundation wall, and set plumb. We cannot determine from a visual examination the condition or capacity of the concrete anchoring the steel members, or the capacity intended by the designer.

9. Between the columns, which are spaced between 6'-8" and 9'-4" on center, a number of wood beams, 2 x 12, have been installed, oriented flat with edges facing the brick wall. These 2 x 12's are spaced approx. 22" apart, running between the steel posts, from bottom of post to top. Various spacers were originally placed between the inner edge of these 2 x 12's and the inner surface of the brick wall, though many have fallen or been removed. As such, this system is has little or no effect on the stability of the foundation wall system.

10. When we analyzed this bracing system according to the IRC and good engineering practice, we found the 2 x 12's are not adequate to resist the lateral loads imposed by backfill soils against the foundation wall. We conclude this system was never capable of properly stabilizing this wall, and the condition of progressive failure has not been cured.

We are uncertain that replacing the wood portions of this bracing system can be performed in a safe manner. It is likely any removal of the existing wood lateral supports may cause the wall to move further and precipitate a collapse. Due to the location of the room with the bracing system, and the path of travel necessary to exit the dwelling in the event of danger, we fear any workmen present should a collapse be initiated would not be able to exit to safety in time. This danger cannot be overemphasized.

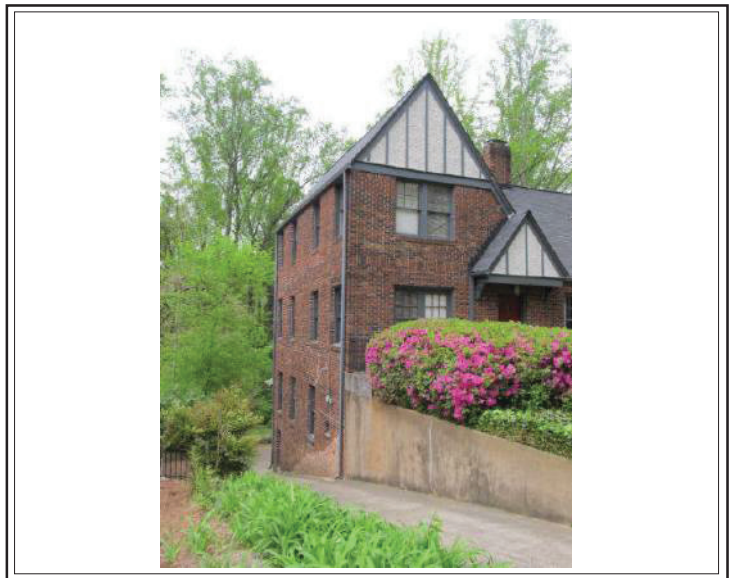
Additional Subject Side View

4. The left side foundation wall has had large portions of the brick masonry replaced at and near the driveway pavement. It appears large lateral movements occurred here, and possibly portions of the foundation wall collapsed and were filled in. This is a symptom of severe stress, and in fact indicates failure of the brick wall at this location. We cannot state with any confidence this area has the strength necessary to safely resist the applied vertical and lateral loads, much less the loads imposed by the backfill soils. It is our opinion the left side foundation wall is in danger of collapse. Any attempt to correct the condition of this wall by improving any masonry work is likely to initiate a collapse.

5. Conditions similar to the left foundation wall exist on the right side foundation wall as well, with shear failures, cracking and some patching visible.
