**Application for Certificate of Appropriateness**

Subject Property Address: 1080 CLIFTON ROAD, NE, ATLANTA, GA 30307

- Demolition and removal of a structurally-unsound 2,184 sq. ft. Tudor house, originally constructed in 1929. Plans and an as-built photo along with a structured analysis and Affidavit from a licensed structured engineer are provided.
- Demolition and removal of structurally-unsound 2-car garage for which a demolition COA was issued in March, 2025.

## SUMMARY OF STRUCTURAL ANALYSIS

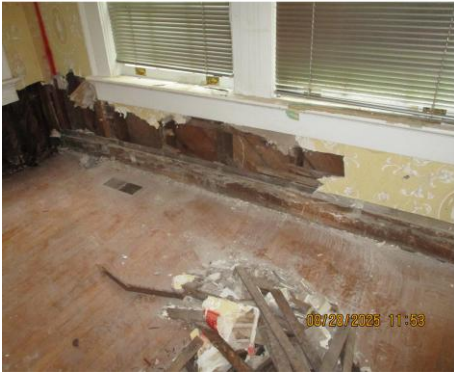
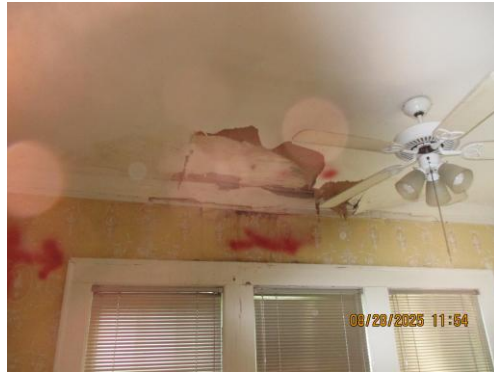
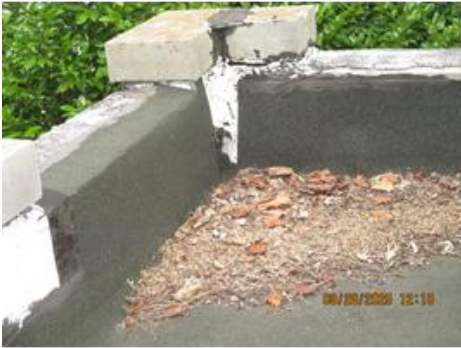
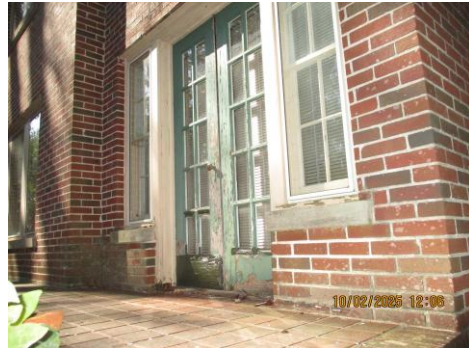
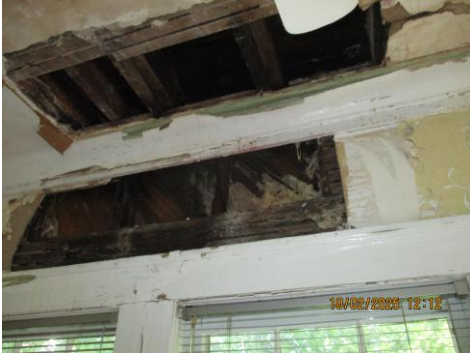
### 1. Side Porch

The plaster and wood lath were removed in the kitchen, breakfast room, living room, dining room, stair landing, side porch to expose the wood framing where water stains occurred. The wall studs, wall plate, and subfloor had areas with significant rot, mold, and deterioration.

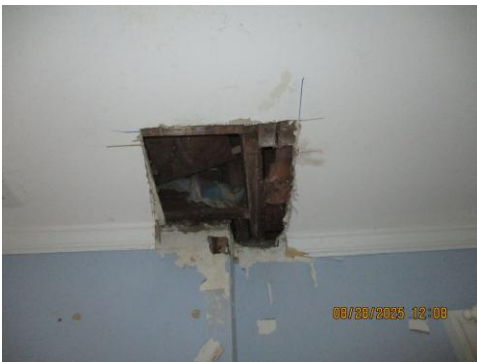
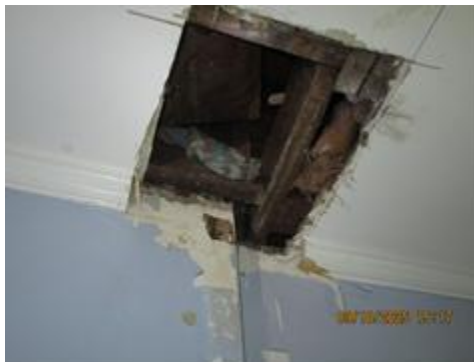
## 3. Upper Floor Ceiling at Chimney

The plaster and lath were removed from the walls and ceiling to observe the conditions of the floor and wall framing where water intrusion was observed. The wall studs, wall plates, joists, and subfloor had areas with significant rot and mold.

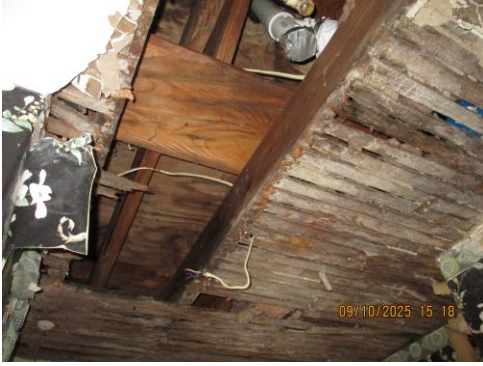
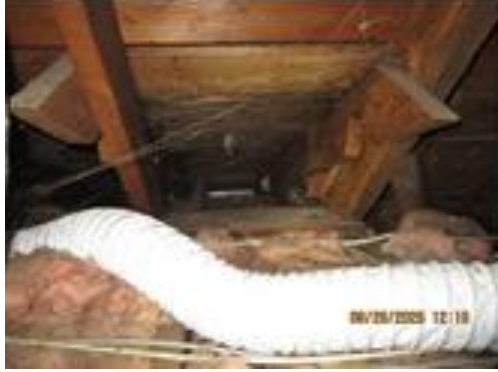
## 4. Attic

The attic flooring and joists had areas of water stains, rot, and mold due to leaks in the roof. Indications of rodent infestation was observed. Soffit ventilation was observed with no screens.

The roof decking had areas of sagging between rafters, water stains were observed indicating roof leaks. In the eaves, rot was observed in the roof framing where water from the gutters had backed up in the roof soffits. The water intrusion from the roof penetrated the stud walls of the second and first floors. Rot and mold in the upper floor ceiling framing adjacent to the chimney are indications improper flashing around the chimney. Gutters and downspouts are not functioning due to neglect, and require cleaning with repairs or replacement.

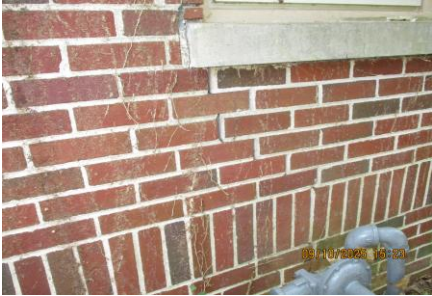
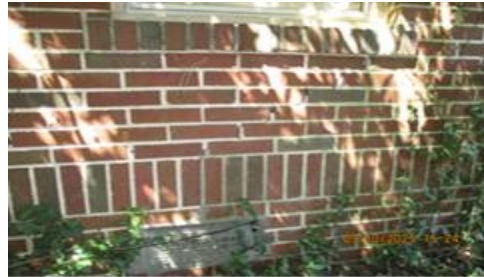
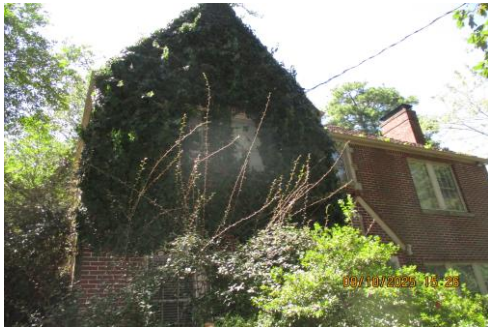
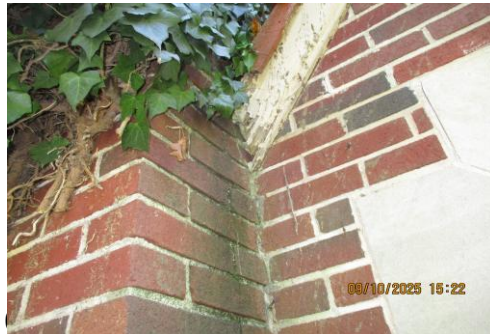
## 5. Brick Veneer

Stair step cracks in the brick veneer indicate settlement has occurred in the foundation. The basement/drawl space area has high levels of moisture, mold, and asbestos.

The brick veneer has areas of missing mortar and cracks in the mortar. Stair-step cracks in the mortar joints was observed at the front left and right corners, an indication of foundation settlement. The tile flooring has cracks due to exposure to the elements.

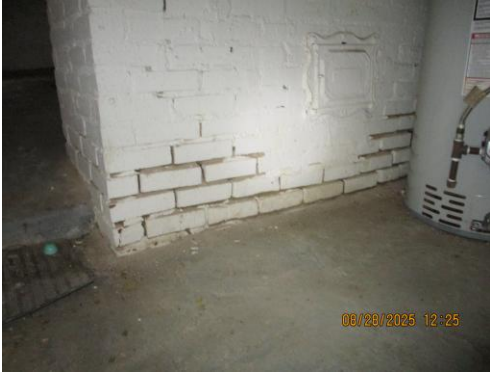
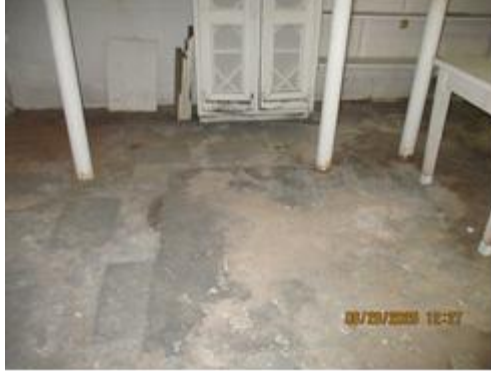
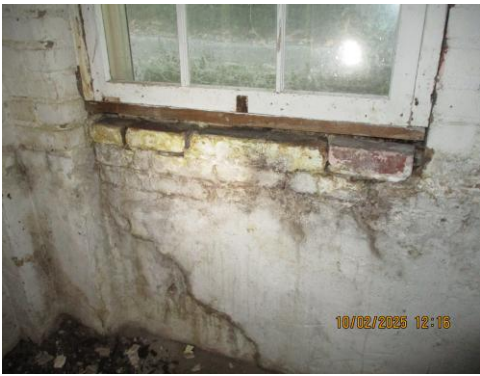
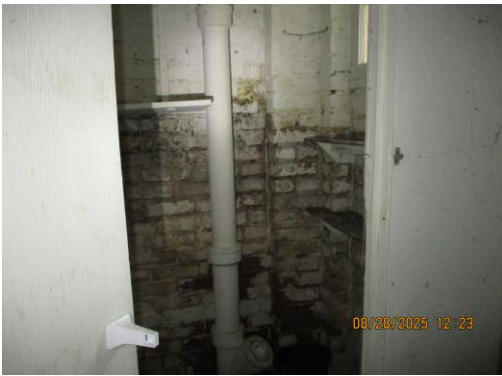
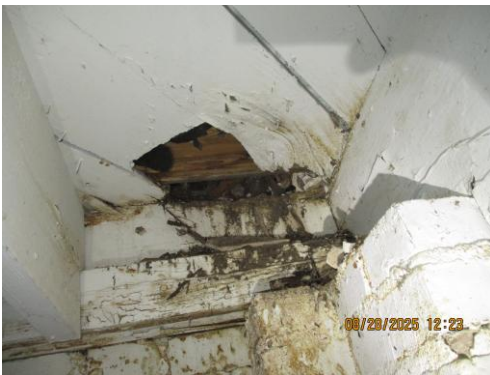
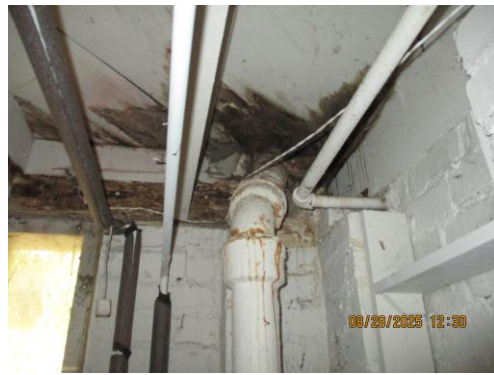
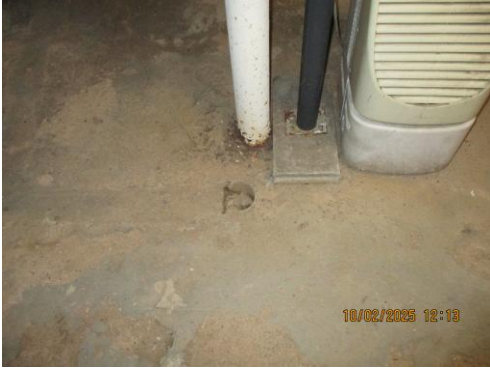
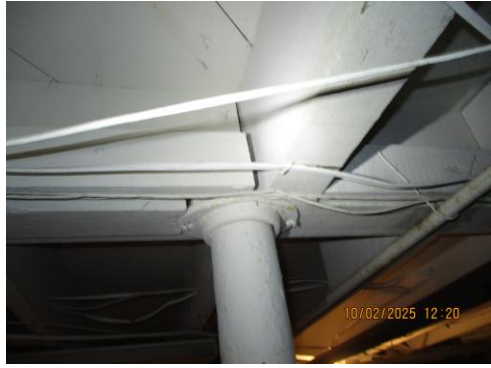
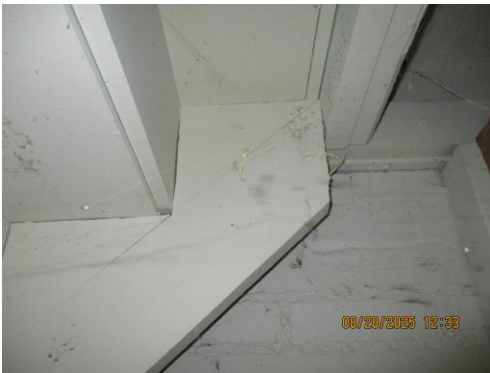
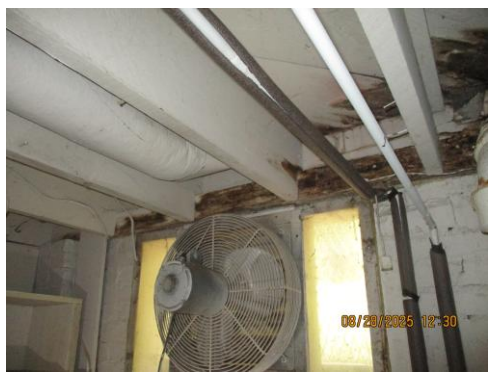
## 6. Basement

The basement/crawl space wall has cracks in the masonry which has permitted water intrusion into the basement, there is no exterior waterproofing, and the house has no exterior or functional interior perimeter drain.

Moisture levels are high due to water intrusion from exterior and no vapor barrier in crawl space. Standing water was observed in several areas.

The steel columns in the basement are rusted and have an unknown support footing under a basement slab that has settlement.

The wood beams are multi-ply and have noticeable deflection. The nails in the ledger boards and beams have slipped due to wood shrinkage, age of the floor and activity, and the beams show separations between multiple members. The wood joists have splits where notched. The subfloor has significant rot and mold where exposed to water intrusion. Where the wood beams bear on the steel columns, the wood has crushed.

observed. New columns on new footings, exterior and interior drainage, waterproofing of the perimeter walls, moisture control in the crawl space, and asbestos and mold remediation measures are required.
