DeKalb County Historic Preservation Commission

Staff Report

H. 1035 Oxford Road, Ben Darmer for Parkwood Living, LLC. Demolish a historic house and construct a new house. **1247316**.

STRUCTURAL ENGINEER INSPECTION REPORT

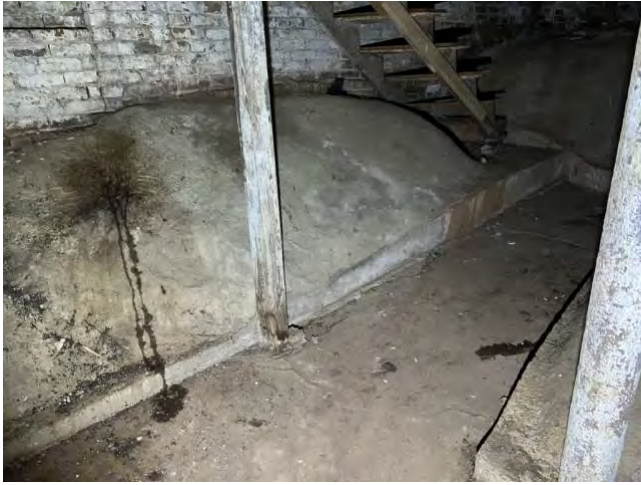
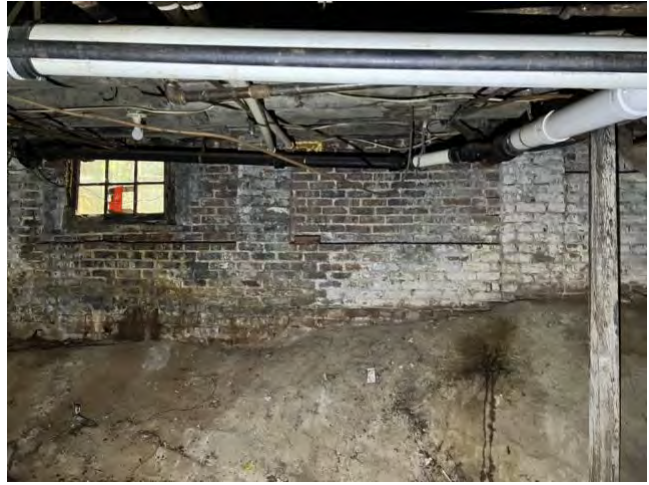
Exhibit 2:

Conclusion: When excavating to convert the low crawl space to a deeper level, the soil within the perimeter is excavated to the desired depth, usually done by hand. Once the footings have been exposed without adequate support or soil stabilization, the structural integrity of the home foundation will be compromised.

Recommendation: It is recommended to support the crawl space wall and middle piers foundation. This can be achieved by adding new supports such as steel posts and footings and stabilizing the soil with concrete flowable fill. Alternatively, creating a "bench ledge" by constructing a small retaining wall inside the perimeter of the foundation can help strengthen the structure and serve as a retaining wall for the soil outside the new foundation.

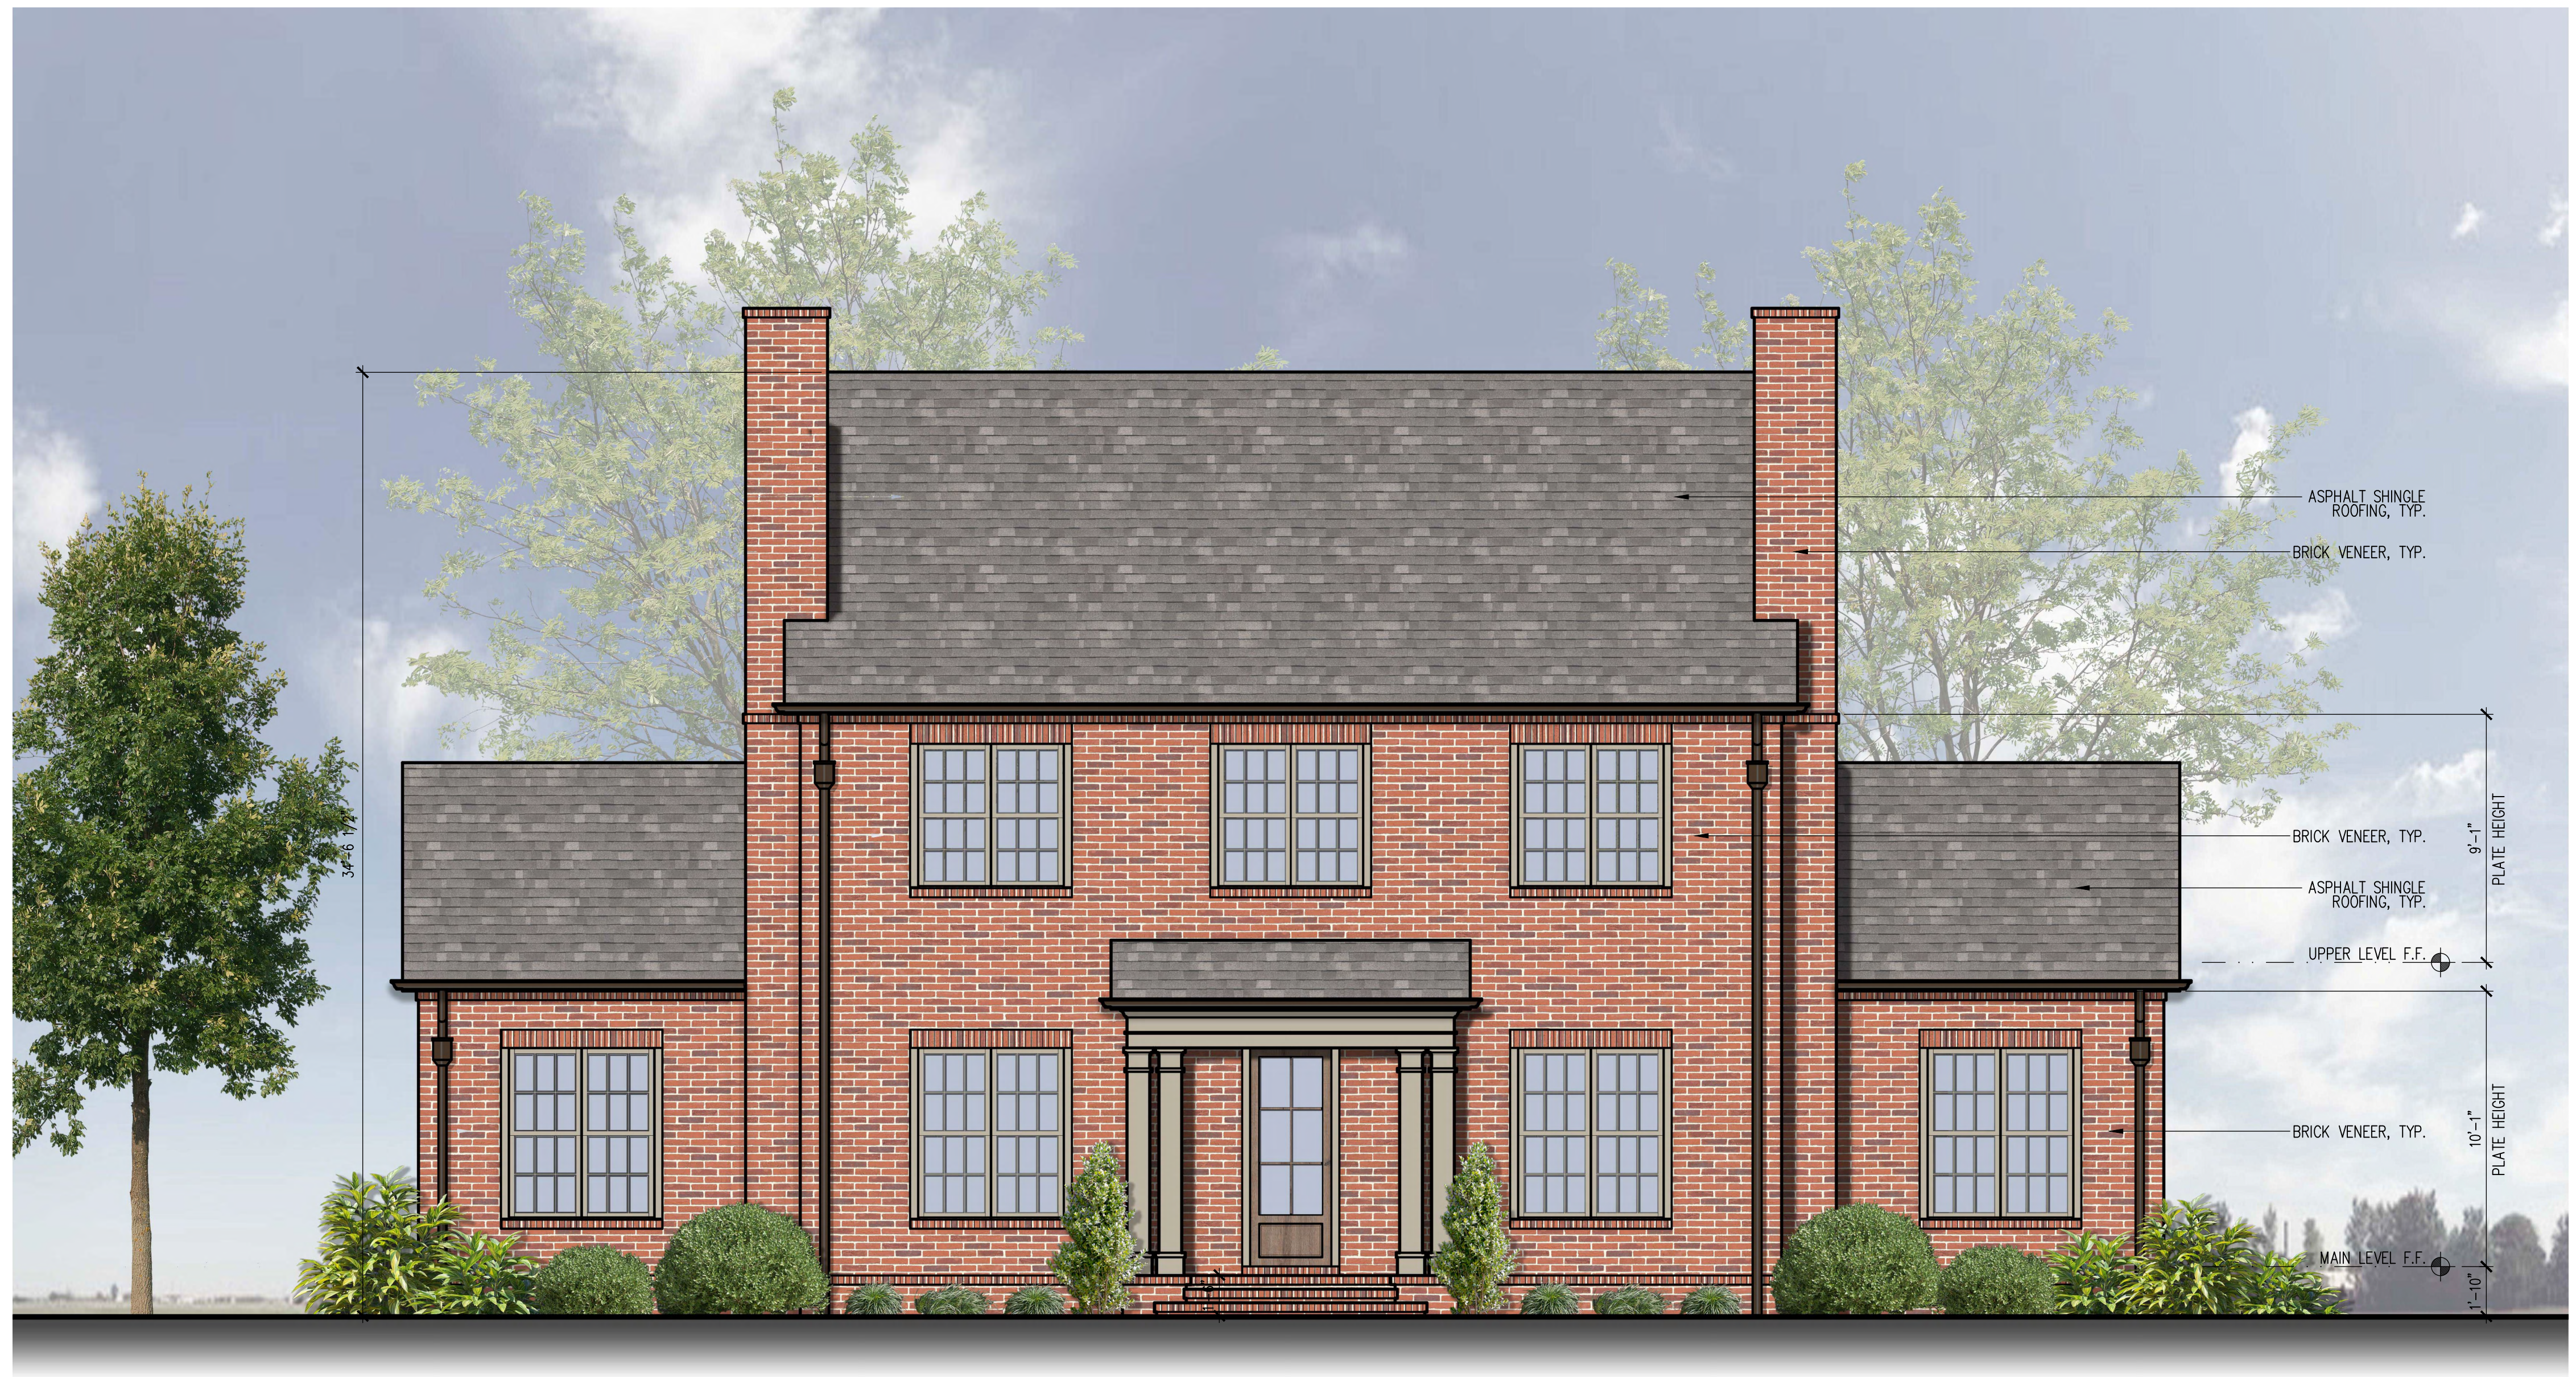
1 FRONT ELEVATION
A201 1/4"=1'-0"

A two-story, brick house with Colonial Revival elements, including two chimneys on either side of the gabled roof, will be constructed in the footprint of the demolished house. The new house will be constructed with a basement, including a garage below grade, and a covered porch on the rear of the property with set of spiral stairs leading to the backyard.
