DeKalb County Historic Preservation Commission

Staff Report

H. 1397 & 1399 Oxford Road, Vickers Design Group. Demolish a nonhistoric and a historic structure, construct a nonhistoric mix use building. **1247410.**

Two-Story Building Built in 1920s; One-Story Building Built in 1960s. (18-053-02-003)

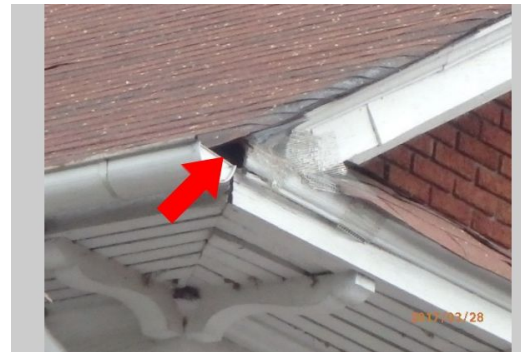
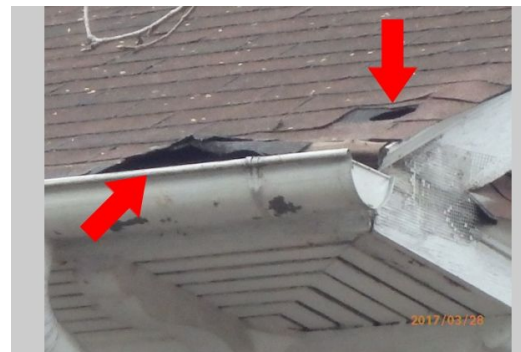
CONDITION #3

Location: Left Rear, Various
Condition: Rodent Activity Noted
Explanation: Rodent tunnels, paths, droppings or nests indicate past or present activity. Rodents can chew wiring and stored items, displace insulation and cause damage to other attic components.
Suggested Action: Consult a pest control specialist for further evaluation and eradication.
Significance: Safety Concern

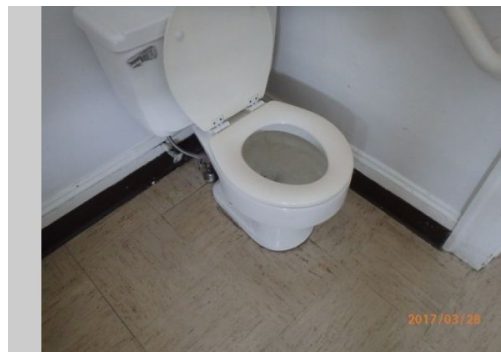
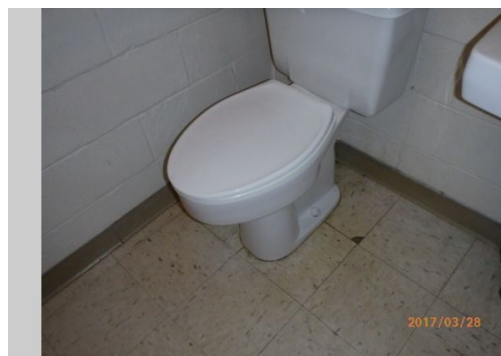
CONDITION #5

Location: House Main Floor

Suggested Action: Modify the configuration as needed.

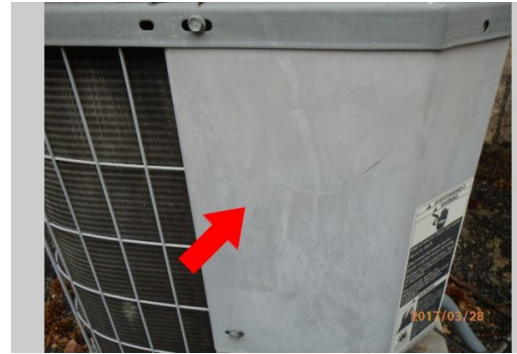
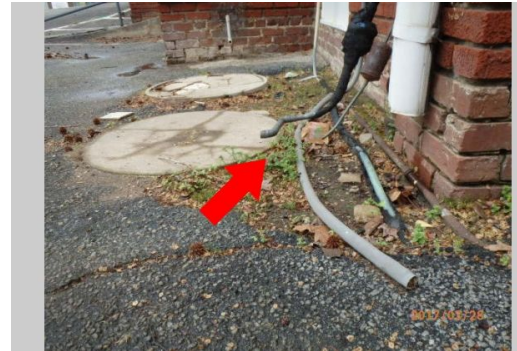
CONDITION #9

| Location: | Front |

| Suggested Action: | This condition may be straightened with a tool called a radiator fin comb. |

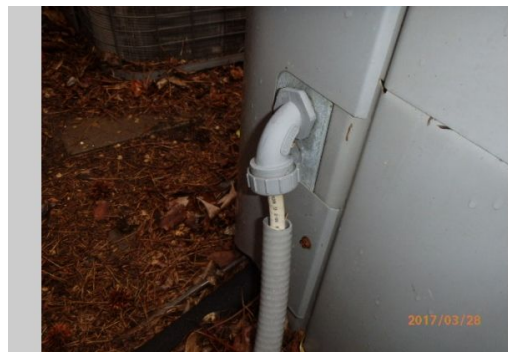
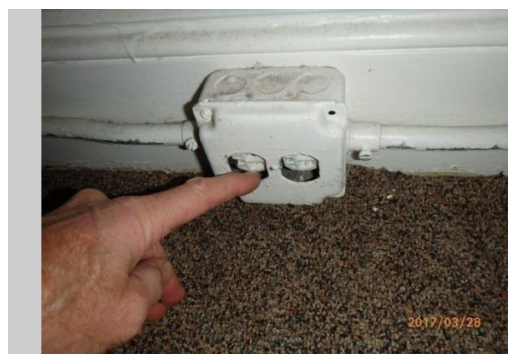
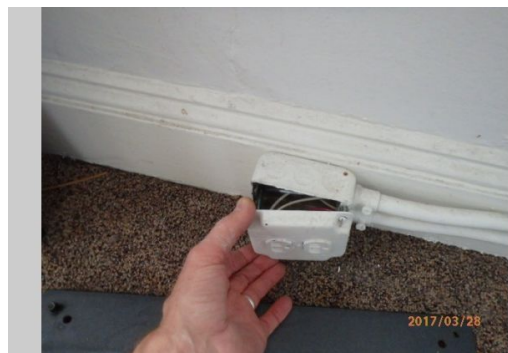
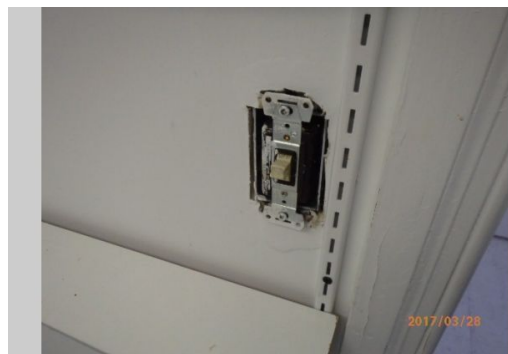
CONDITION #14

Location: House Upper Bath
Condition: Wet Locations Missing GFCI Protection
Explanation: Ground fault devices are required at all electrical devices in close proximity to water, for newer construction. Older homes that upgrade to GFCI devices improve safety and are strongly recommended.
Suggested Action: Consult an electrician for further evaluation and proper ground fault protection at all wet locations.
Significance: Safety Concern

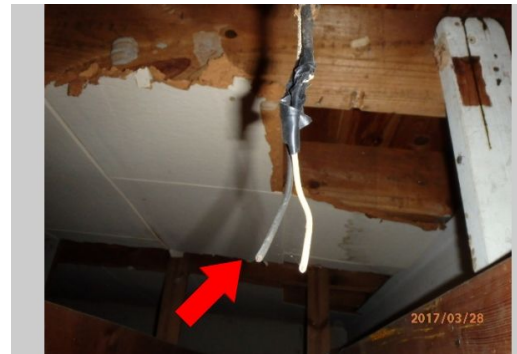
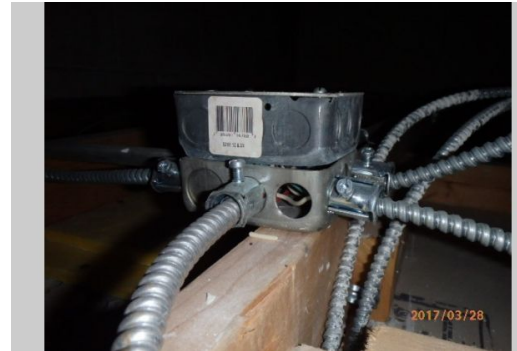
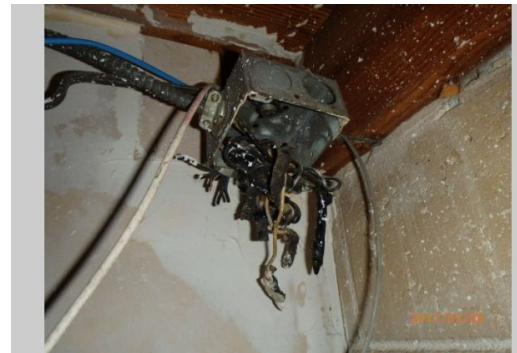
CONDITION #18

Condition: Conduit Missing
Explanation: Conduit is missing at numerous locations. Exposed wiring in the attic left rear is dangerously damaged by rodents.
Suggested Action: Have an electrician add conduit to all wiring locations where missing.
Significance: Safety Concern

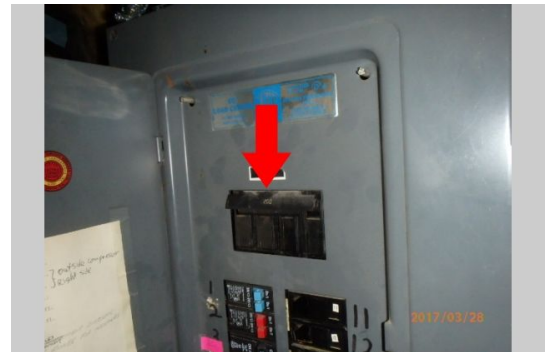
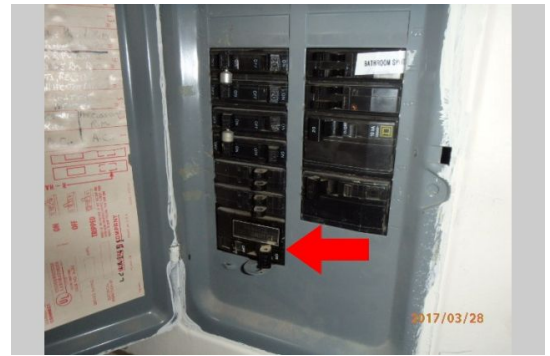
CONDITION #19

Condition: Information Regarding Main Disconnect and Location
Explanation: Many insurance companies are requesting a photo of the electrical main disconnect, so it is provided here as a courtesy. This single breaker will cut off all power to the house in case of emergency. 1- House- lower left hall. 2- Office- upper rear.
Suggested Action: Use as needed.
Significance: Courtesy Information

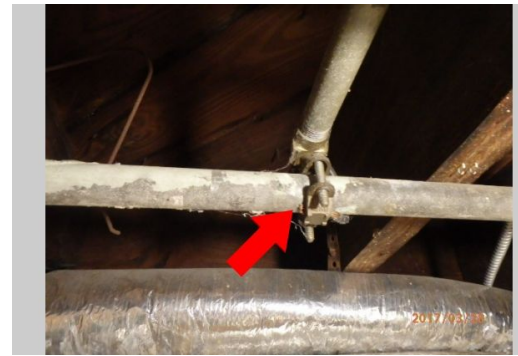
CONDITION #20

Condition: Grounding to Piping Inadequate

Significance: Safety Concern

Suggested Action: Have a licensed electrician reconfigure the connections for adequate grounding.

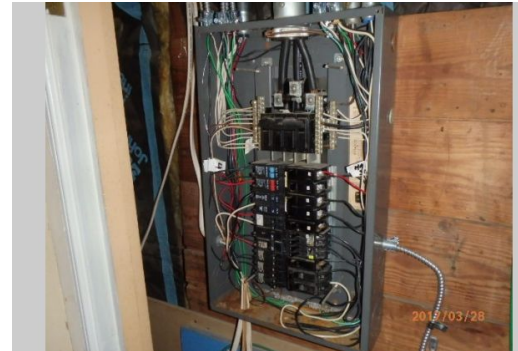
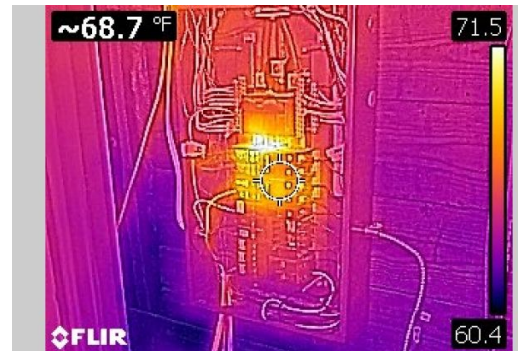
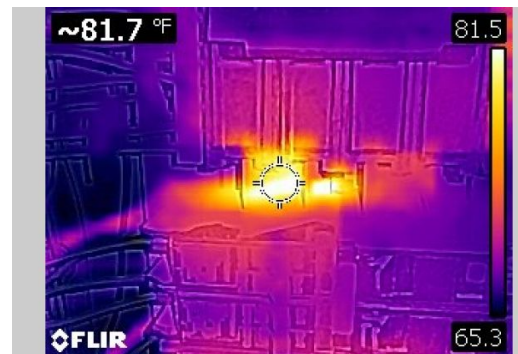
CONDITION #21

Condition: Information Regarding Panel Wiring(Thermal)

Explanation: Many insurance companies are requesting a photo of the electrical panel interior components, so it is provided here as a courtesy. Bottom photo of thermal scan shows normal conditions.

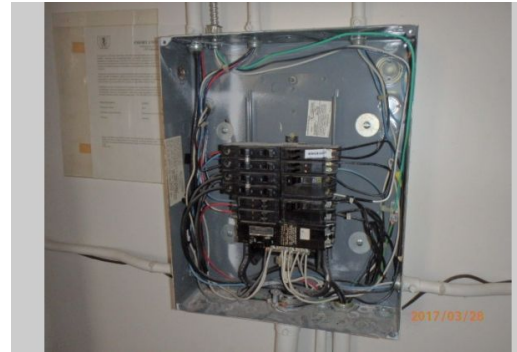
CONDITION #22

Location: Office- Upper Rear
Condition: Information Regarding Panel Wiring(Thermal)
Explanation: Many insurance companies are requesting a photo of the electrical panel interior components, so it is provided here as a courtesy. Bottom photo of thermal scan shows normal conditions.
Suggested Action: Use as needed.
Significance: Courtesy Information

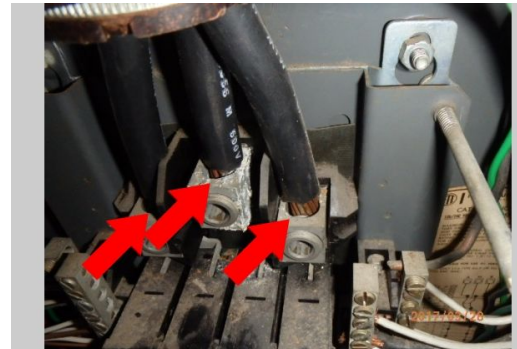
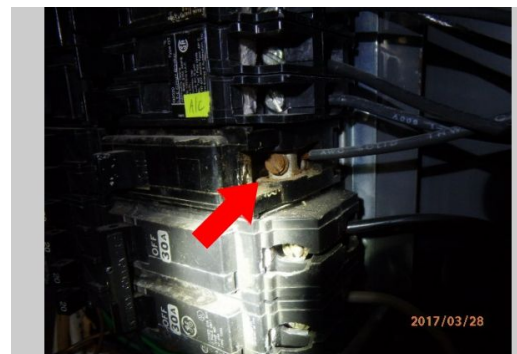
CONDITION #23

Location: House
Condition: Oxide Inhibitor Paste Missing in Panel Connections
Explanation: An oxide inhibitor applied to the aluminum wire connections reduces or prevents oxidation from occurring and should be applied by a licensed electrician. Corrosion was also noted on some breakers.
Suggested Action: Have a licensed electrician replace all compromised components and apply oxide inhibitor.
Significance: Safety Concern

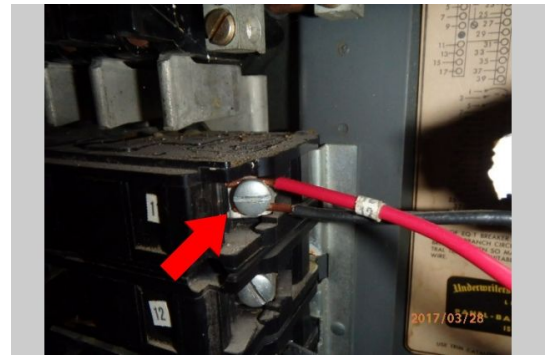
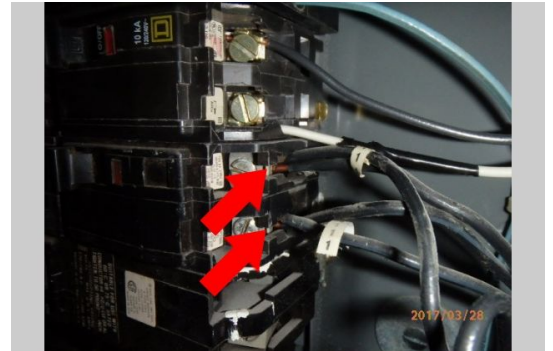
CONDITION #24

Condition: Double Tapped Breaker

Significance: Safety Concern

Suggested Action: Have a licensed electrician properly repair to eliminate all double tapped conditions and oversized breakers.

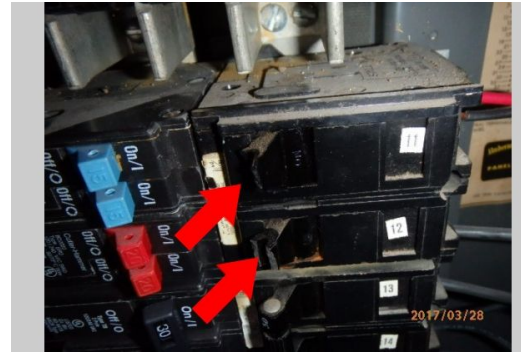
CONDITION #26

Location: Both Panels
Condition: Damaged Breakers
Explanation: Knobs are broken off of some breakers.
Suggested Action: Have all damaged breakers replaced,
Significance: Safety Concern

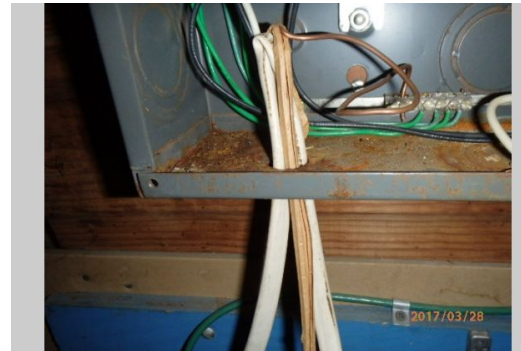
CONDITION #27

Location: House Panel
Condition: Wire Connector(s) Missing
Explanation: As wire circuits enter the electrical panel, they should be secured to the metal with a connector or clamp to prevent chafing on the metal edges.
Suggested Action: Have an electrician add connectors (and conduit) to all unsecured wiring at the panel and distribution system.
Significance: Safety Concern

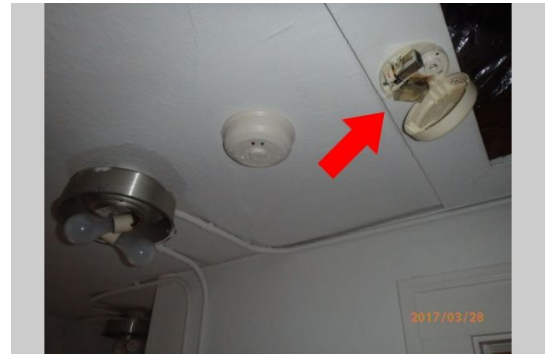
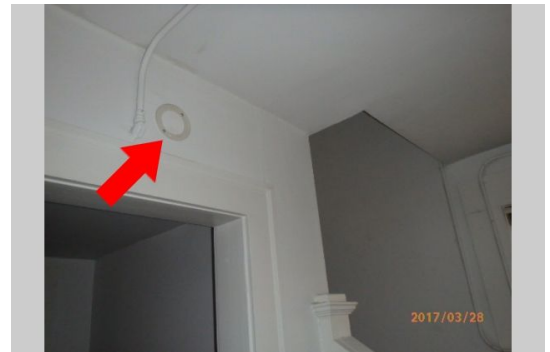
CONDITION #28

| Condition: | Smoke Detectors Limited / Removed/ Advanced Age |
| Explanation: | Newer standards require inter-connected smoke detectors in each sleeping room, along with mechanical rooms and hallways. Installation of both ionization and photo-electric type detectors is recommended to ensure early warning in various types of fires. |
| Significance: | Safety Concern |

| Suggested Action: | Ensure that a viable smoke detector is installed at each area as needed. Smoke detectors should be replaced if manufactured 10 or more years ago. The proper placement and operation of smoke detectors should be verified by all home owners prior to occupying a building. |

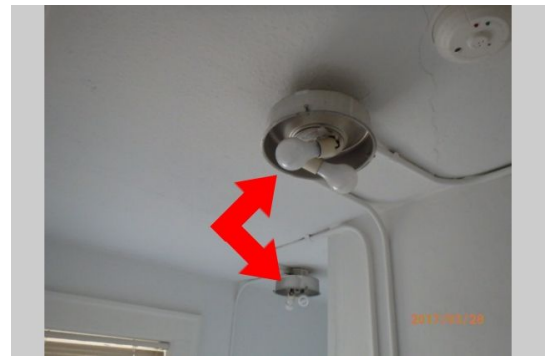
CONDITION #30

Location: House Upper
Condition: Globe Missing at Light Fixtures
Explanation: The light fixture globe helps to protect the bulb, subdue the heat emanating from the bulb and to more evenly displace the light.
Suggested Action: Replace light fixture globes where needed.
Significance: Needs Handy Repair

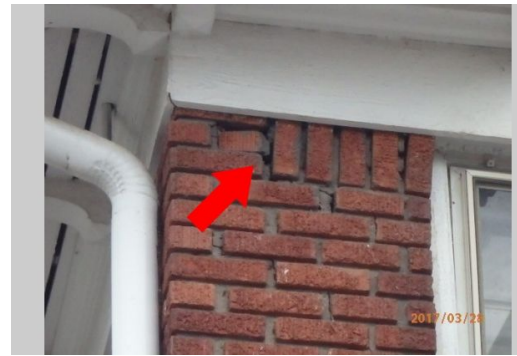
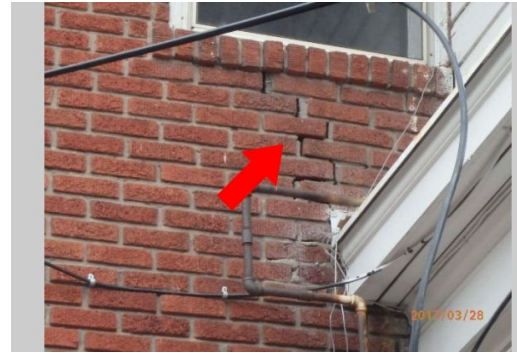
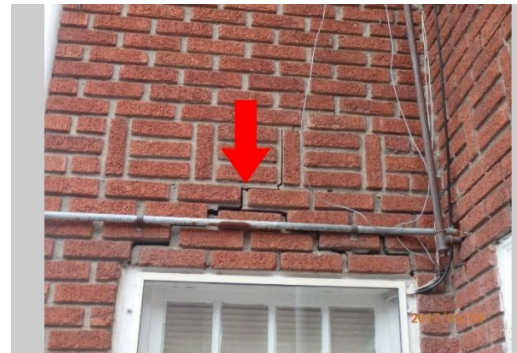
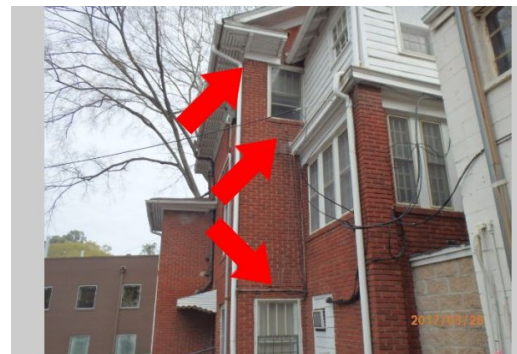
CONDITION #32

Condition: Cracks Noted at Masonry Wall

Explanation: Cracking was noted and is common with masonry structures. The cracking usually occurs early after construction and subsides over time but not always.

Significance: Needs Pro Repair

Suggested Action: Consult brick mason to re-point or re-mortar as needed and monitor for subsequent movement. Obtain second opinion of structural integrity as desired.

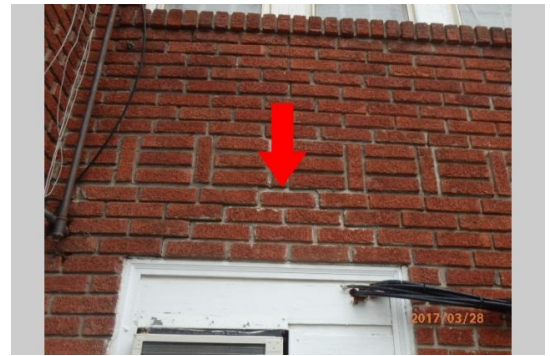
CONDITION #33

Condition: Cracks Noted at Masonry Wall

Explanation: Cracking was noted and is common with masonry structures. The cracking usually occurs early after construction and subsides over time but not always.

Significance: Monitor

Suggested Action: Consult brick mason to re-point or re-mortar as needed and monitor for subsequent movement. Obtain second opinion of structural integrity as desired.

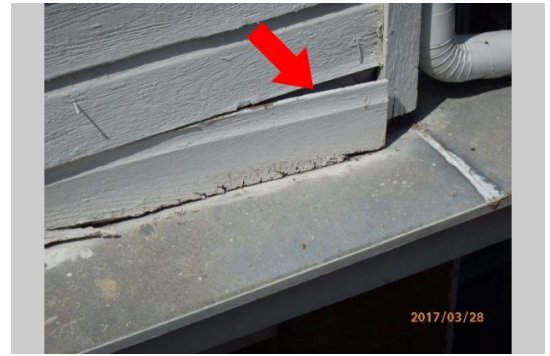
CONDITION #34

Condition: Damage Noted - Siding

Explanation: Damage was noted at areas of the exterior wall cladding.

Significance: Needs Handy Repair

Suggested Action: Repair or replace all damaged exterior components as needed.

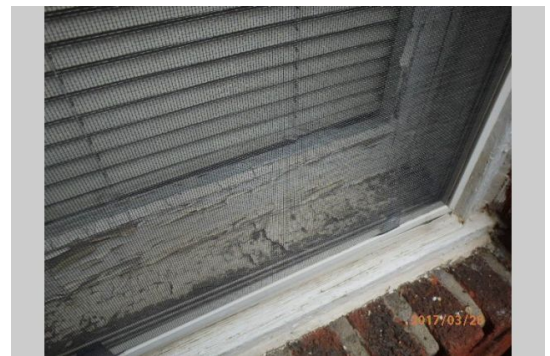
CONDITION #35

Condition: Glazing Cracked and Loose

Explanation: Window glazing (holds the glass in place at the exterior) is loose, cracked and is and/or becoming defective. The glazing holds the glass panes in place and helps in providing efficiency.

Significance: Needs Pro Repair

Suggested Action: Consult a qualified painter to replace all glazing as needed.

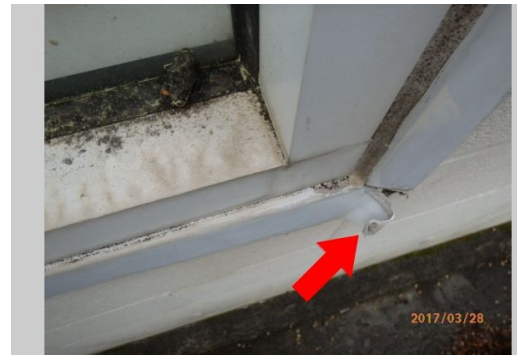
CONDITION #36

Description: Metal Frame
Location: Office Front
Condition: Damage Noted
Explanation: The metal frame is bent with a sharp protrusion presenting a risk of injury.
Suggested Action: Have a contractor provide repair for safety.
Significance: Safety Concern

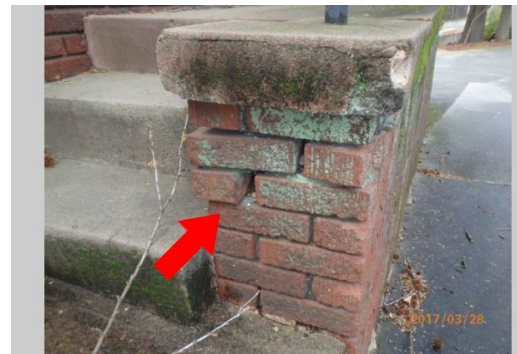
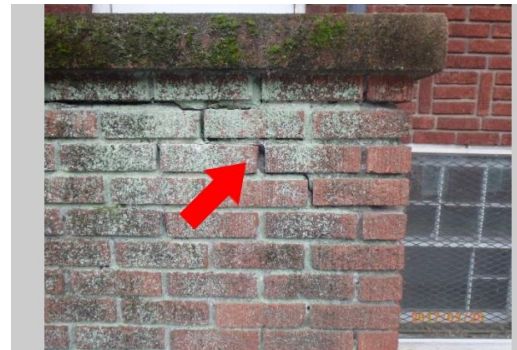
CONDITION #37

Location: House Right
Condition: Cracking and Settling Noted
Suggested Action: Have a qualified masonry contractor evaluate the conditions and make recommendations for repair.
Significance: Needs Pro Repair

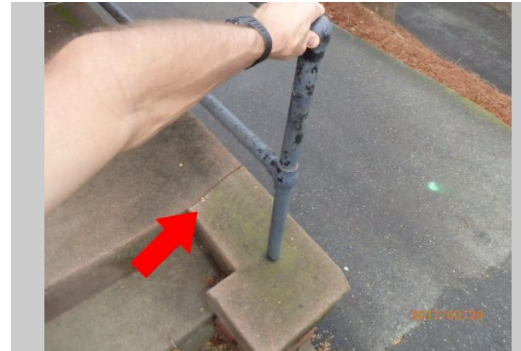
CONDITION #38

Location: House Front
Condition: Concave Post Bases/ Loose
Explanation: 1-Water is allowed to stand at the post bases resulting in rust and a loosening of the handrails, guardrails, and gate post. At least one post is rusted off. 2- At the right walkway, the concrete is broken loose so the post is insecure.
Suggested Action: Clean and grout all post bases as needed to achieve a convex surface to drain water. Repair all loose components. for safety.
Significance: Safety Concern

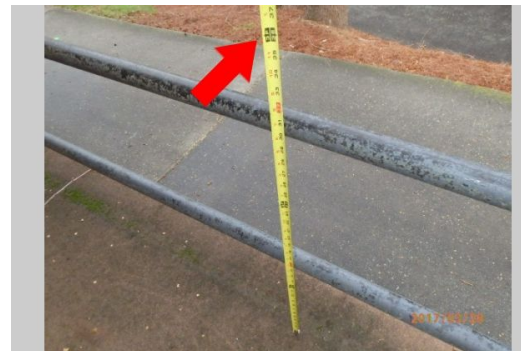
CONDITION #39

Condition: Guardrail Height Too Low
Explanation: Guardrails should be 36 inches high for safety, with gaps no more than 4 inches.
Suggested Action: Consult iron worker to correct this condition.
Significance: Safety Concern

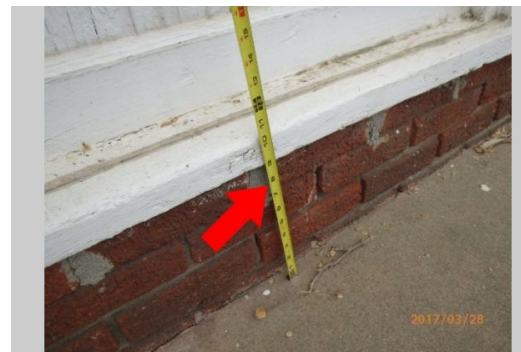
CONDITION #40

Location: Right
Condition: Riser Height Excessive
Explanation: Stair riser heights are limited to 7.75 inches.
Suggested Action: Reconfigure the stairs.
Significance: Safety Concern

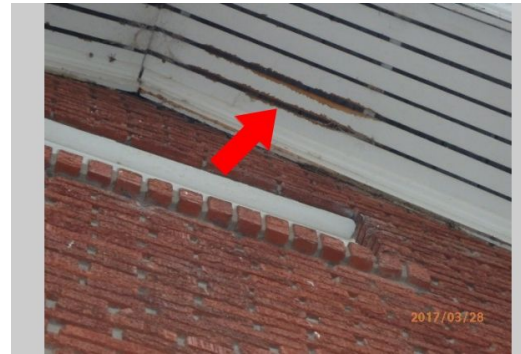
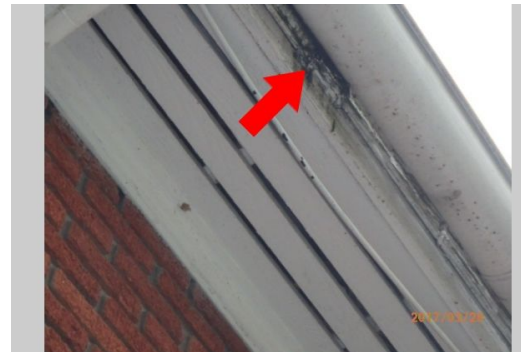
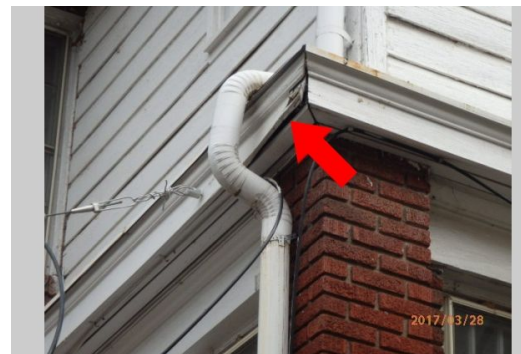
CONDITION #41

| Condition: | Damage Noted |
| Explanation: | Water damage was noted. 1- upper right from rodents. 2- rear- water damage. 3- left rear- Loose trim. |
| Significance: | Needs Pro Repair |

| Suggested Action: | Have a carpenter or qualified contractor evaluate and repair or replace all exterior damage, along with suitable caulking and painting. |

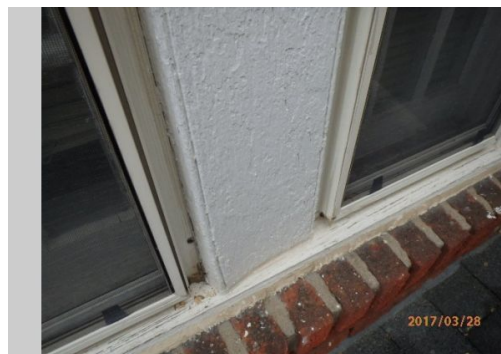
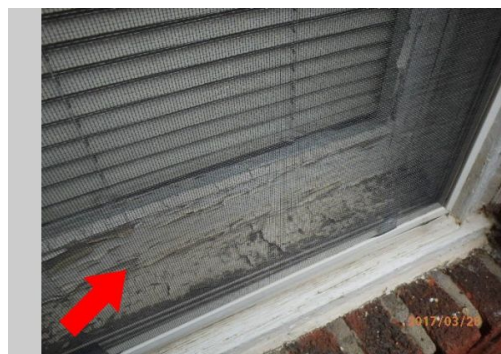
CONDITION #42

| Condition: | Lead Based Paint Hazard |
| Explanation: | Excessive amounts of peeling paint were noted. All contractors working on pre-1978 housing are required to receive training and certification in lead-safe practices, follow strict protocol for testing, containment and clean-up. Soil may not be suitable for growing edible crops. |
| Significance: | Safety Concern |

| Suggested Action: | For any painting or repair which disturbs paint, consult a contractor certified by the GA Environmental Protection Division for lead-safe Renovation, Repair and Painting (RRP). |

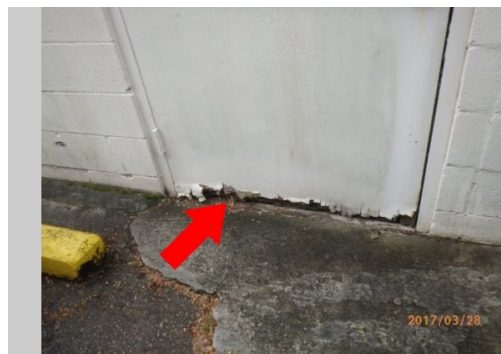
CONDITION #43

| Condition: | Damage Noted on Door(s) |
| Explanation: | Damage was noted. |
| Significance: | Needs Pro Repair |

| Suggested Action: | Have a qualified carpenter replace door(s). |

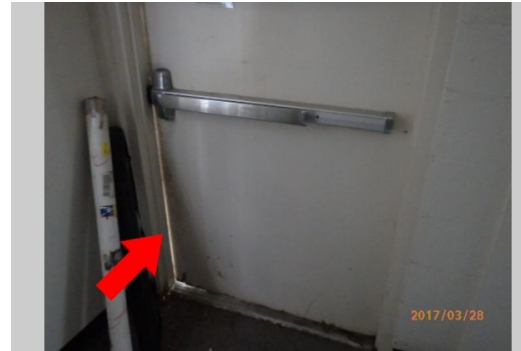
CONDITION #44

Condition: Weatherstripping Poor
Explanation: Air gaps were noted at various exterior doors. Mold growth was noted at the front office door-possibly from condensation.
Suggested Action: Ensure that properly installed weatherstripping is in place and in good condition.
Significance: Upgrade Advised

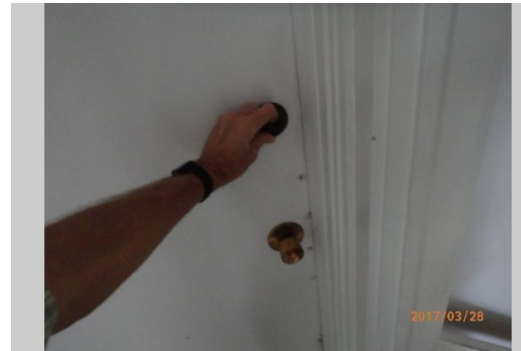
CONDITION #45

Location: House- Main Floor -right Doors
Condition: Egress Limited
Explanation: The 2 right doors are inoperable and do not allow emergency egress.
Suggested Action: Restore operation for safety.
Significance: Safety Concern

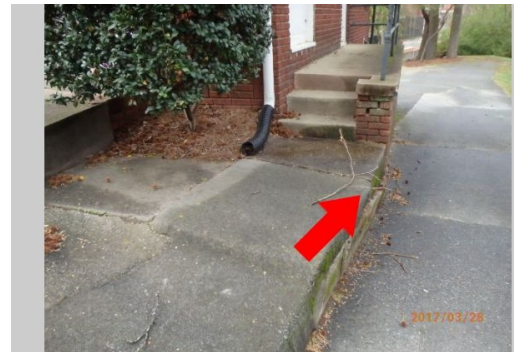
CONDITION #46

| Condition: | Handrail/Guardrail Missing |
| Explanation: | Handrails at exterior steps increase safety and are missing at all exterior steps. In addition, the retaining wall created by the steps is missing a guardrail. |
| Significance: | Upgrade Advised |

| Suggested Action: | Add handrails to all exterior stairs and proper guardrails as needed. |

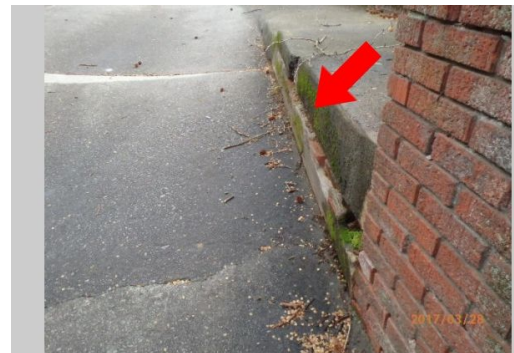
CONDITION #47

| Condition: | Leaning |
| Explanation: | The wall is leaning and some settlement of the concrete walkway was noted. |
| Significance: | Needs Pro Repair |

| Suggested Action: | Repair as needed. |

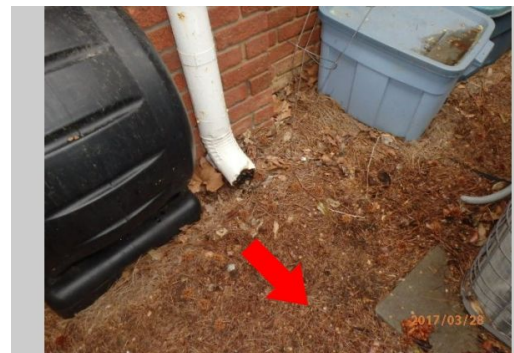
CONDITION #48

| Condition: | Slope Improper |
| Explanation: | Soil should slope downward and away from the foundation for proper drainage. New codes require a minimum of six inches per 10 feet. This improper slope contributes to significant moisture issues in the basements. |
| Significance: | Needs Pro Repair |

| Suggested Action: | Modify the slope for proper drainage or add drains and underground piping. |

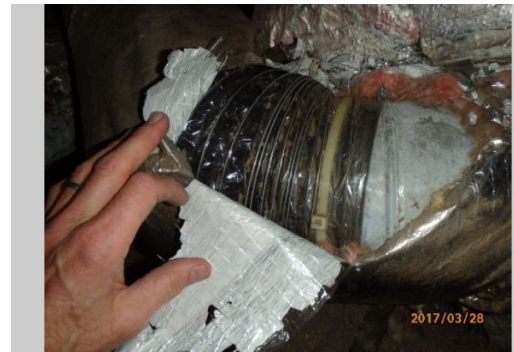
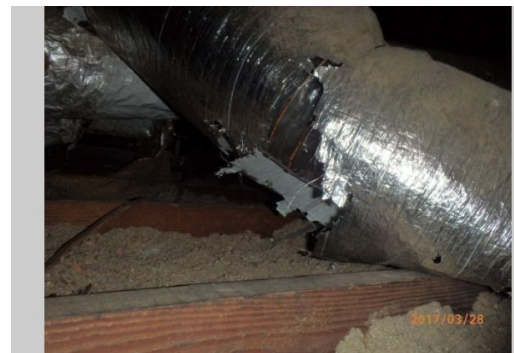
CONDITION #49

Condition: Gaps at Ductwork

Explanation: Flex ducts in the house attic are extensively damaged, likely by rodents. Gaps in ductwork and insulation allow escape of conditioned air.

Significance: Needs Pro Repair

Suggested Action: Have an HVAC contractor replace all damaged ducts, and add insulation where missing on rigid ducts.

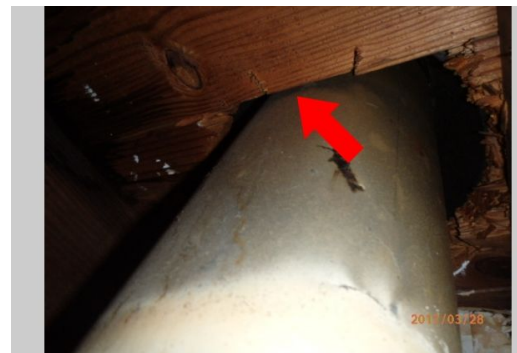
CONDITION #53

Location: Office Rear
Condition: Class B Flue Clearance Improper
Explanation: The flue is too close to combustible components, according to the manufacturer specifications.
Suggested Action: Consult an HVAC contractor for correction. A 1 inch clearance should be provided.
Significance: Safety Concern

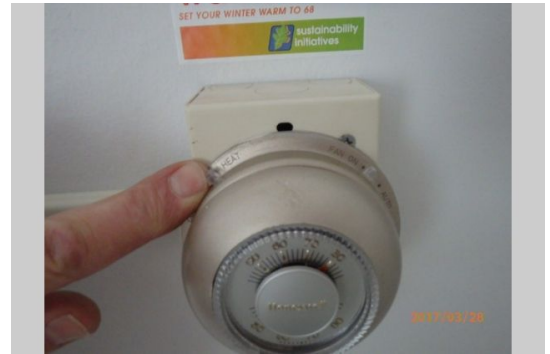
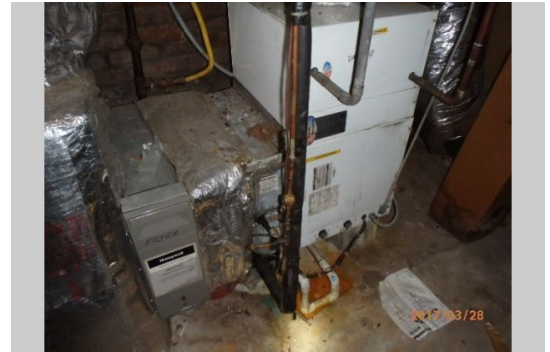
CONDITION #54

| Condition: | Did Not Operate When Tested |
| Explanation: | The circulating fan is defective, so the heat pump serving the main and lower levels of the house did not operate. |
| Significance: | Needs Pro Repair |

| Suggested Action: | Have a mechanical contractor evaluate and repair as necessary restoring intended operating function. |

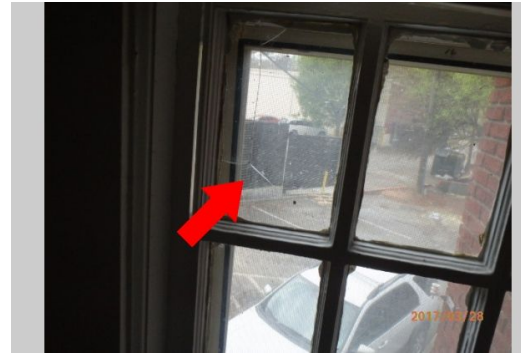
CONDITION #56

Location: Upper Rear
Condition: Cracked Window Pane
Suggested Action: Properly replace all cracked panes.
Significance: Safety Concern

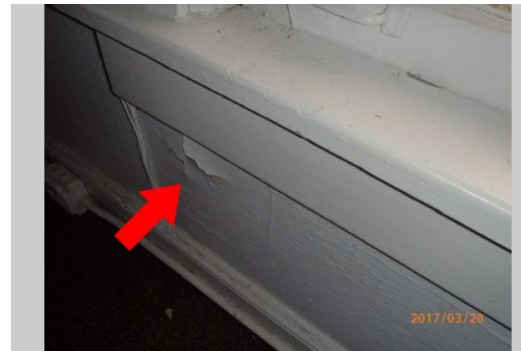
CONDITION #58

Description: Plaster and Wallboard
Location: House
Condition: Spalling Plaster Wall Areas
Explanation: Wall damage was noted.
Suggested Action: Repair all leakage and repair the surface.
Significance: Needs Pro Repair

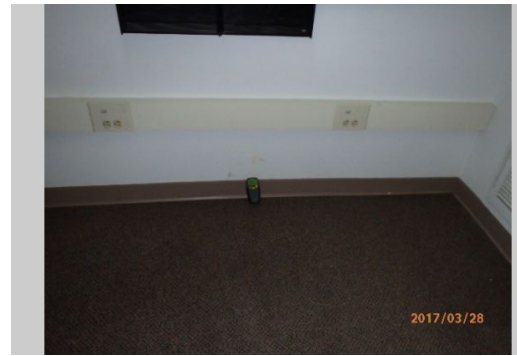
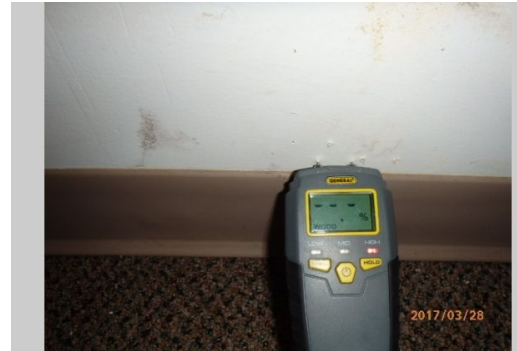
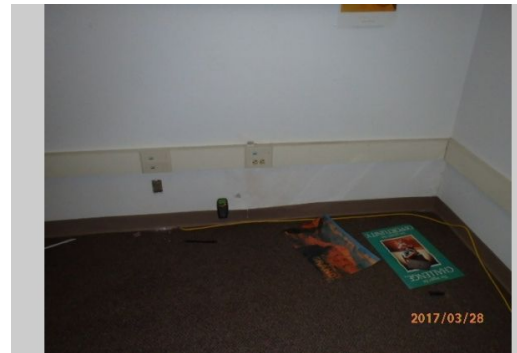
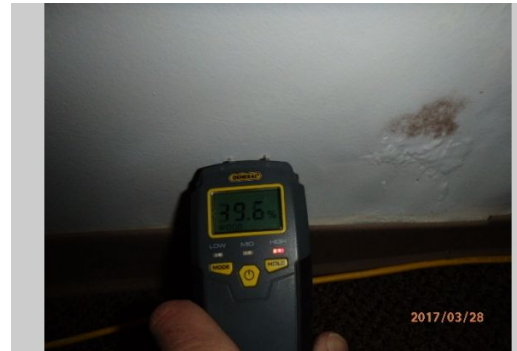
CONDITION #59

Location: Office Lower Level
Condition: Elevated Moisture
Explanation: Moisture in the wall measured very high at most areas of the room- over 50% at some locations. Damage and mold is likely present in the wall cavity.
Suggested Action: Have a mold professional provide further evaluation.
Significance: Safety Concern

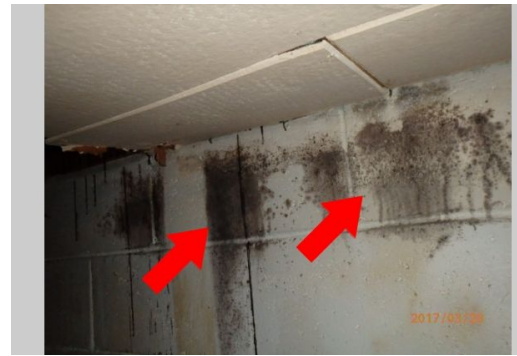
CONDITION #62

Location: Office Attic Front Wall
Condition: Mold Noted
Explanation: Mold was noted on the inside of the front exterior wall.
Suggested Action: Consult a mold specialist for further testing and remediation options.
Significance: Safety Concern

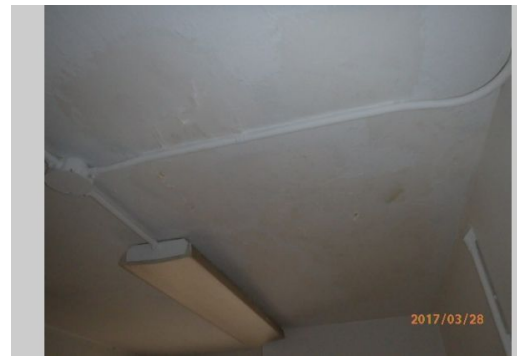
CONDITION #63

Description: Plaster and Wallboard
Condition: Damage Noted
Explanation: Typical cracks were noted in many plaster areas.
Suggested Action: Have a contractor repair the damage as needed.
Significance: Needs Pro Repair

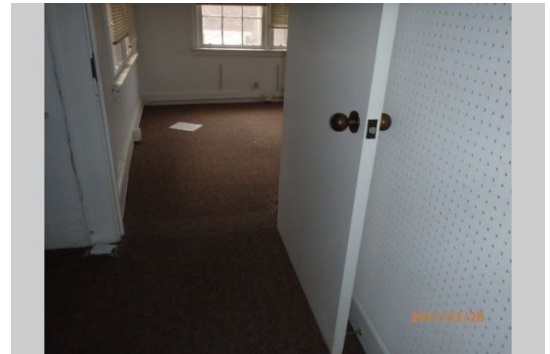
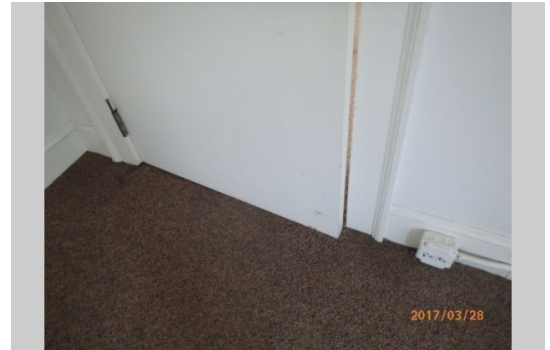
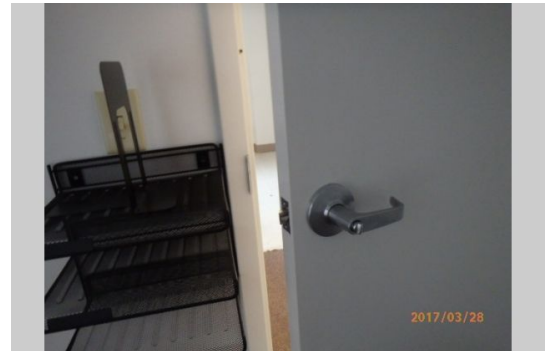
CONDITION #67

Location: Various
Condition: Adjustment Needed
Explanation: Misaligned latches, binding doors, and loose hinges were noted.
Suggested Action: Have a handyman provide adjustment as needed.
Significance: Needs Handy Repair

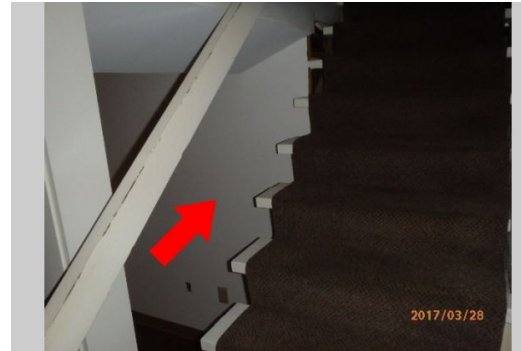
CONDITION #69

Location: Lower Stair
Condition: Guardrail Missing
Explanation: The missing guardrail represents a safety hazard.
Suggested Action: Ensure proper guardrails at all locations.
Significance: Safety Concern

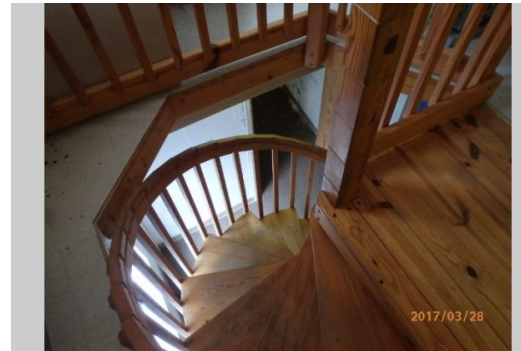
CONDITION #70

Location: Office Rear
Condition: Winder Stair
Suggested Action: Take caution when trying to navigate these stairs. The stairs would have to be rebuilt to conform to today's standards.
Significance: Safety Concern

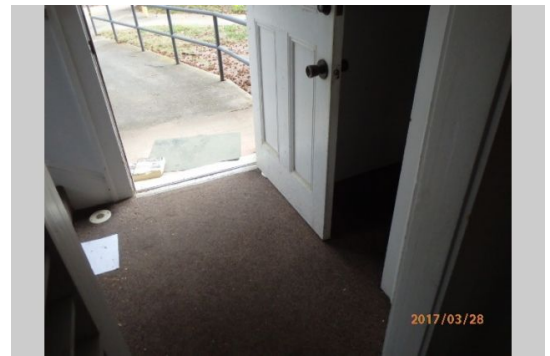
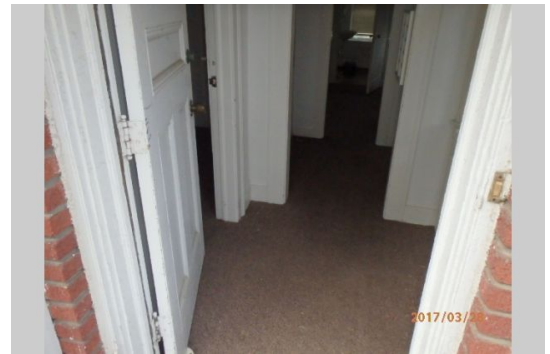
CONDITION #71

Location: House Front Foyer
Condition: Access Limited
Explanation: The small entry area of the house is not suitable for wheelchair access.
Suggested Action: Consider options for compliance.
Significance: Upgrade Advised

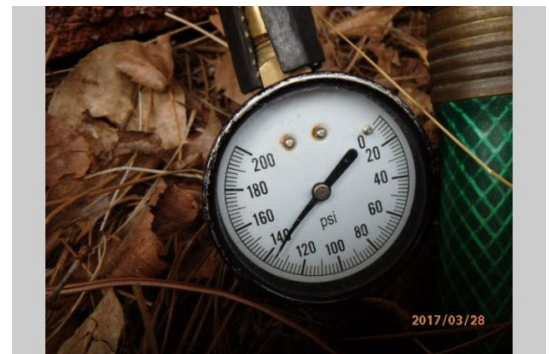
CONDITION #73

| Condition: | Elevated Pressure- 136 PSI |
| Significance: | Needs Pro Repair |

| Suggested Action: | Have a plumber provide further evaluation and adjust or replace the pressure regulator. |

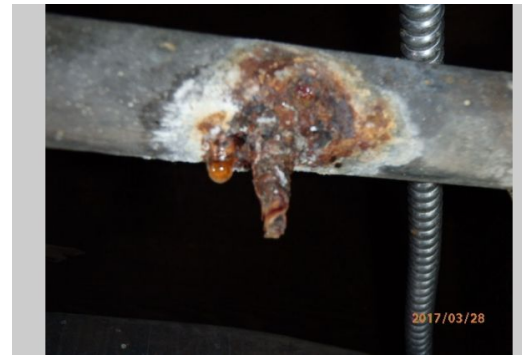
CONDITION #74

| Location: | House- Lower Furnace Room |
| Condition: | Galvanized Supply Pipe Noted |
| Explanation: | Most of the piping appears to be copper, but the underground portion, and this section in the furnace room is galvanized- about to burst. Aged galvanized water supply pipe is prone to deterioration from the inside of the pipe out, increasing potential for leakage. |
| Significance: | Needs Pro Repair |

| Suggested Action: | Consult a licensed plumber for recommendations and costs associated with replacement of all galvanized supply pipe. |

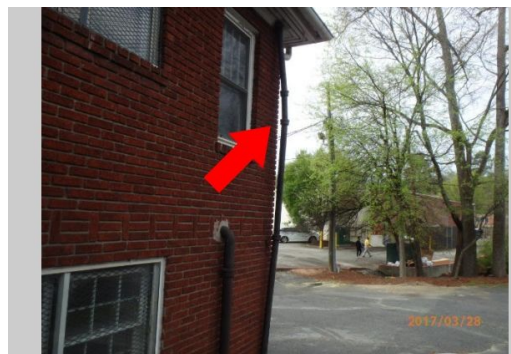
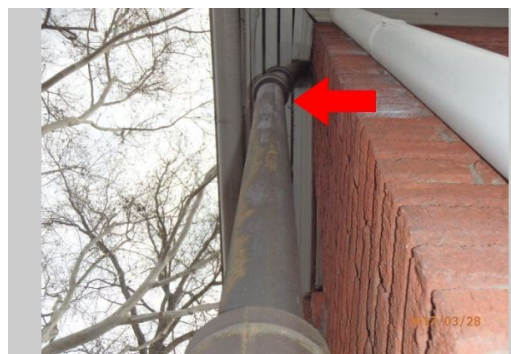
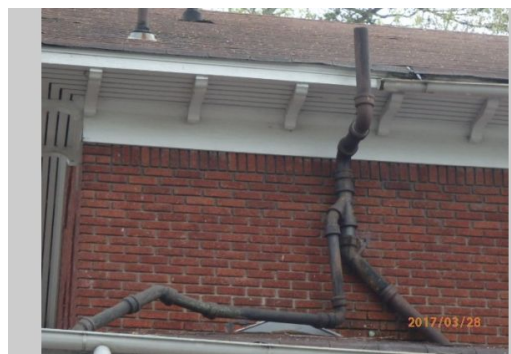
CONDITION #77

| Condition: | Improper Drain Pipe Support |
| Significance: | Needs Pro Repair |

| Suggested Action: | A licensed plumber can make corrections if the overall piping system has been poorly installed. |

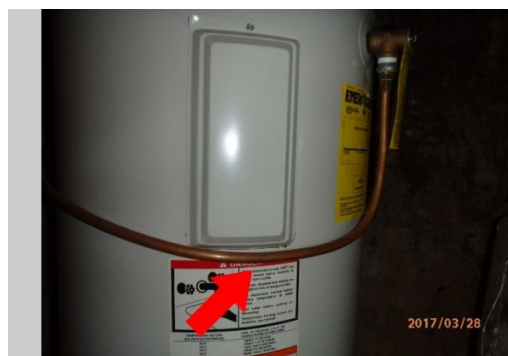
CONDITION #80

Condition: Relief Line - Lowest Point Drain Valve Missing
Explanation: The manufacturers of pressure relief valves require that the piping attached to the valve must pitch downward. Georgia Code allows the line to pitch upward only if an openable valve is provided at the lowest point, before turning upward. This prevents rust due to water standing against the PRV continuously and to assure the valve properly performs its safety function.
Suggested Action: Have a plumber reconfigure the piping to comply with manufacturer specifications and/or local jurisdictional requirements.
Significance: Safety Concern

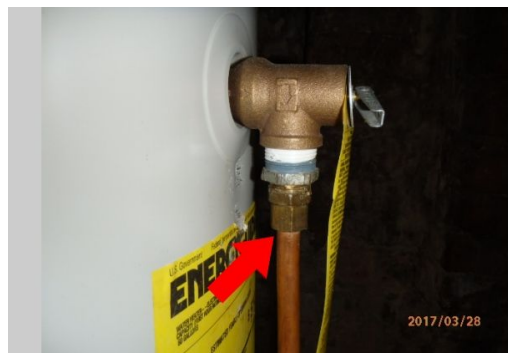
CONDITION #81

Condition: Relief Pipe Undersized
Explanation: The pressure relief pipe is undersized. A reduced diameter pipe can restrict the flow of discharged water, thus the system may not operate safely. The pipe attached to the valve must be no less than 3/4 inch diameter for its entire length.
Suggested Action: Have a plumber replace the piping with copper or CPVC that is 3/4 inch over its entire length.
Significance: Safety Concern

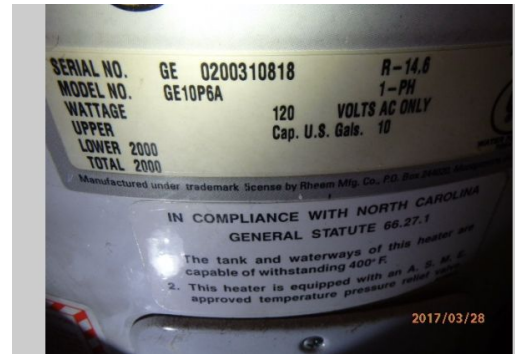
CONDITION #82

Description: 10 Gallon, 17 Years Old, Electric
Location: Office Upper Rear
Condition: Advanced Age- 17 Years
Explanation: Water heaters generally have a life expectancy of 8-12 years.
Suggested Action: Budget for replacement, maintain a home warranty, or replace in advance of failure.
Significance: Monitor

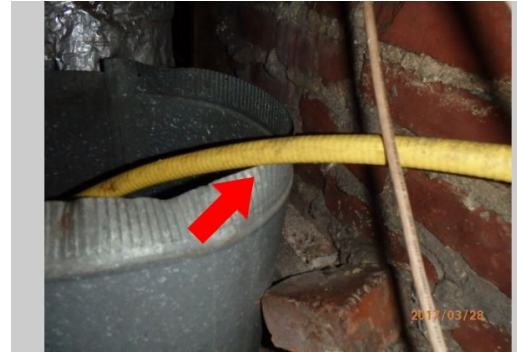
CONDITION #85

| Condition: | CSST Unprotected. |
| Explanation: | CSST (yellow tubing) is in contact with sharp metal and subject to damage. Lighting strikes pose risk to ungrounded gas piping, can cause small holes in corrugated pipe resulting in gas leakage. |
| Significance: | Safety Concern |

| Suggested Action: | Secure the CSST to prevent contact and damage. |

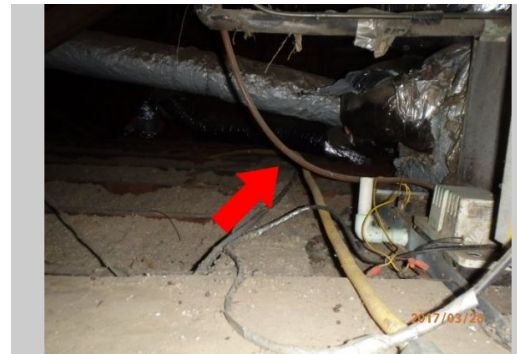
CONDITION #86

| Location: | House Attic |
| Condition: | CSST Not Supported |
| Significance: | Safety Concern |

| Suggested Action: | Have a plumber provide securing. |

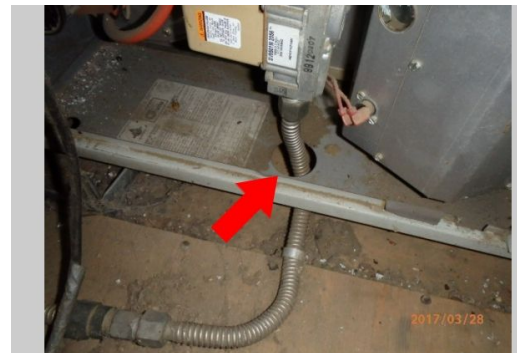
| Condition: | Flexible Gas Line Inside Furnace |
| Explanation: | A flexible gas line should connect the furnace to rigid piping, but should only be located outside the furnace housing. Otherwise, the piping can chafe on the furnace and leak gas. Hard pipe should be installed. |

| Suggested Action: | Have a plumber or HVAC contractor add a short section of hard pipe from the gas valve inside the furnace to outside the furnace housing. |

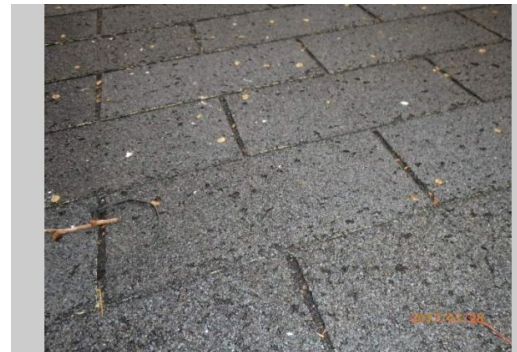
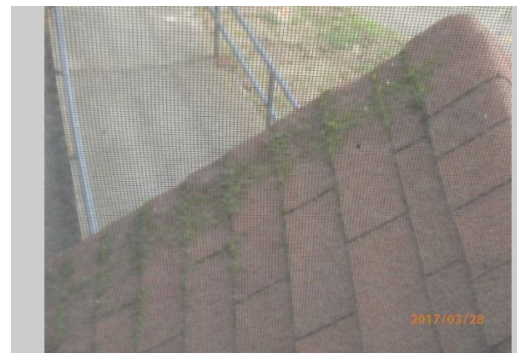
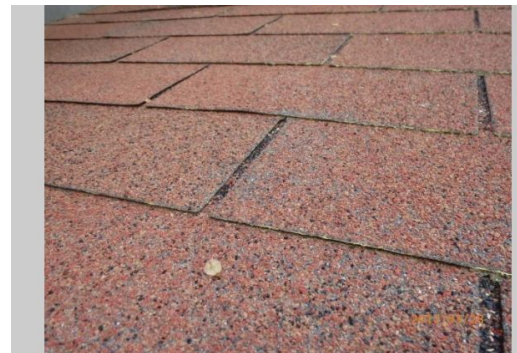
CONDITION #88

Condition: Advanced Age

Significance: Needs Pro Repair

Suggested Action: Budget for roof replacement or replace in advance of leakage or deterioration.

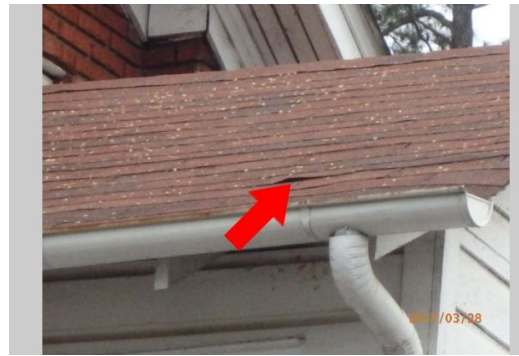
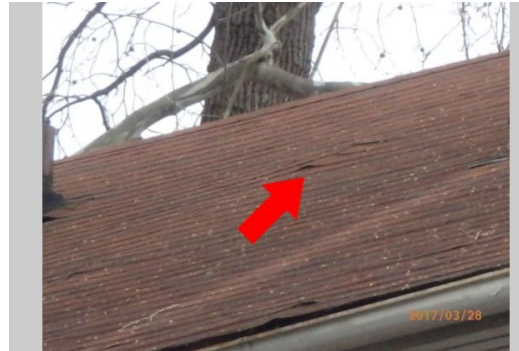
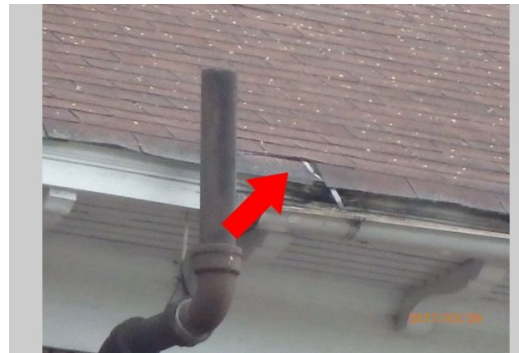
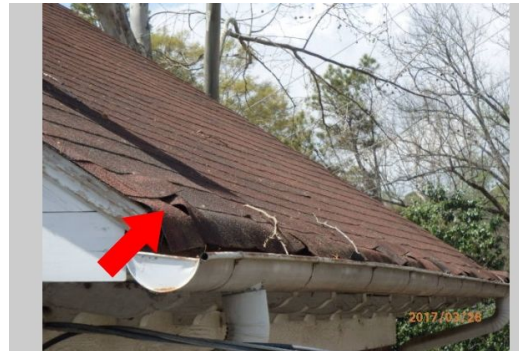
CONDITION #89

Condition: Damaged Roofing
Explanation: Damaged or missing shingles were noted, which can contribute to leaks.
Suggested Action: Have a roofing contractor replace the roof.
Significance: Needs Pro Repair

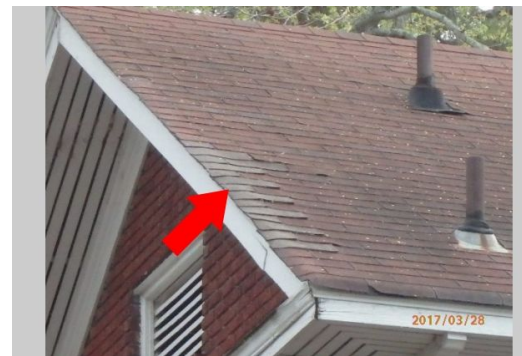
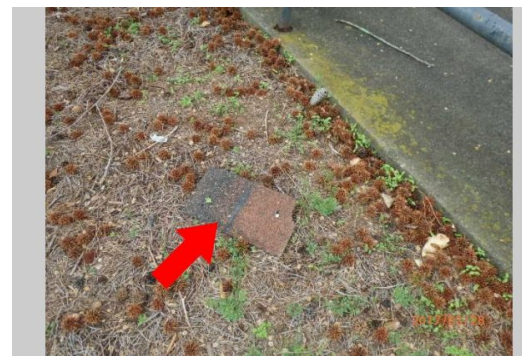
CONDITION #90

Condition: Additional Photos
Explanation: These photos further inform the previous condition.
Suggested Action: Follow recommendations at the previous item.
Significance: Needs Pro Repair

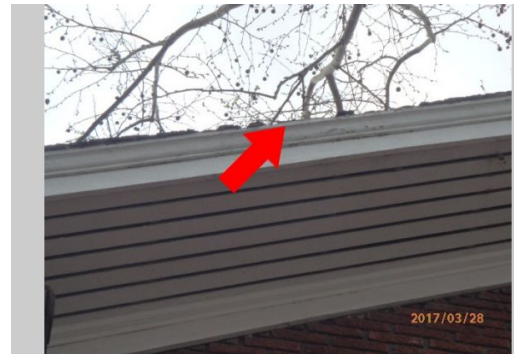
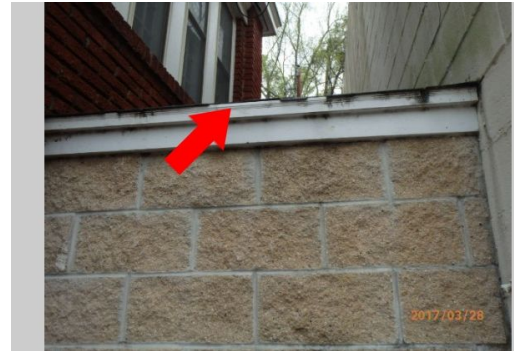
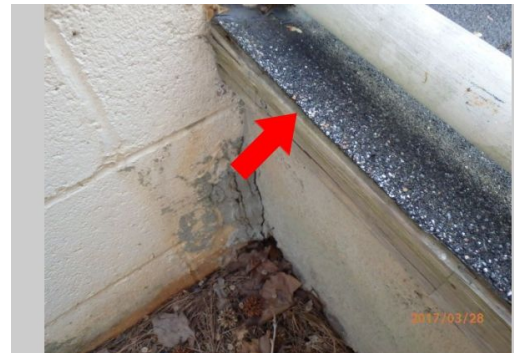
CONDITION #91

Location: Various
Condition: Overhang Insufficient
Explanation: Shingles that do not extend sufficiently beyond the edge of the sheathing expose the sheathing to damage.
Suggested Action: Have a qualified roofer ensure that all roofing has a minimum one inch over hang.
Significance: Needs Pro Repair
