DeKalb County Historic Preservation Commission

Staff Report

H. 1397 & 1399 Oxford Road, Vickers Design Group. Demolish a nonhistoric and a historic structure, construct a nonhistoric mix use building. **1247410.**

Two-Story Building Built in 1920s; One-Story Building Built in 1960s. (18-053-02-003)

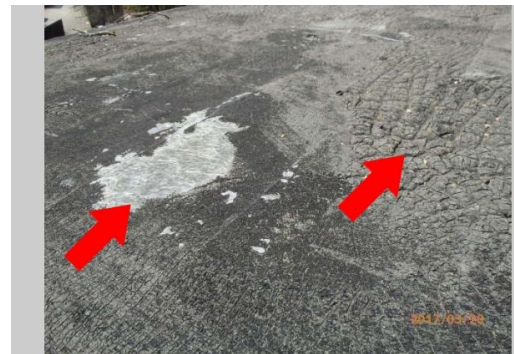
CONDITION #92

Location: Office- Low-slope Roof
Condition: Advanced Age
Explanation: The subject roof appears beyond the normal life expectancy.
Suggested Action: Budget for roof replacement or replace in advance of leakage or deterioration.
Significance: Needs Pro Repair

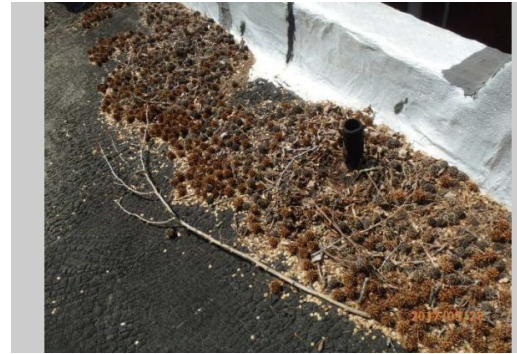
CONDITION #93

Location: Office
Condition: Debris Noted
Explanation: Debris obstructs proper drainage.
Suggested Action: Clean the roof of all debris.
Significance: Maintenance Item

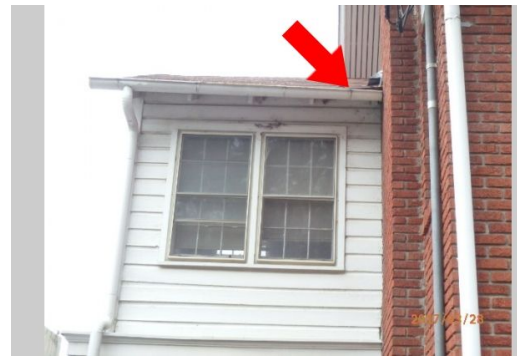
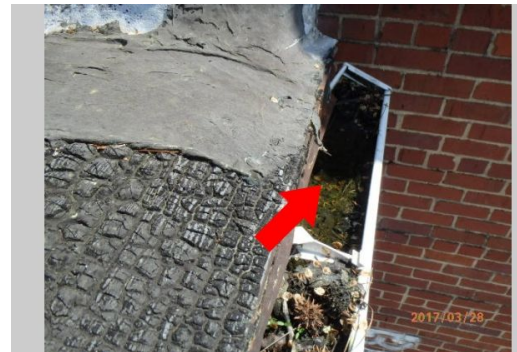
CONDITION #94

Location: Front at Sunroom; Left Rear of Office
Condition: Slope Improper
Explanation: Gutters should slope properly toward the downspouts to prevent premature deterioration, habitat for mosquitoes, clogging and overflowing.
Suggested Action: Have a gutter contractor remove the affected sections and re-install with proper slope.
Significance: Needs Pro Repair

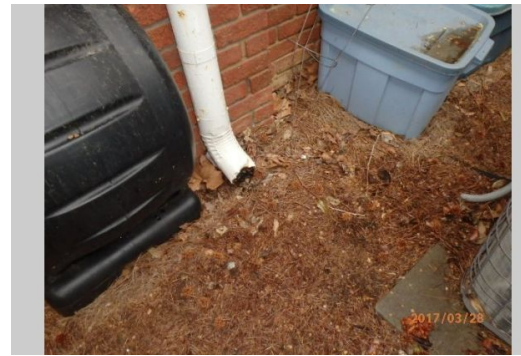
CONDITION #95

Location: Front Left of House
Condition: Downspouts Discharge at Foundation
Explanation: This contributes to the extensive moisture issues in the basement. Roof drainage should be discharged well away from the foundation to reduce under structure water entry or undermining of foundation components.
Suggested Action: Extend all downspouts well away from the foundation with appropriate piping. Make sure the grade slopes downward from the point of discharge.
Significance: Needs Pro Repair

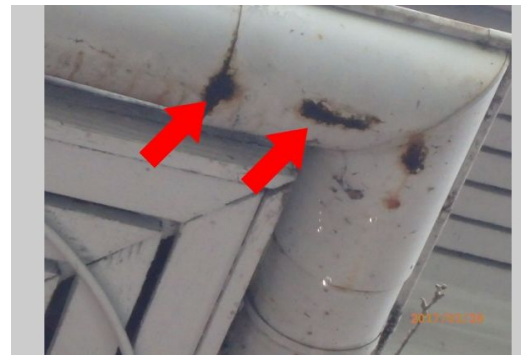
CONDITION #96

Location: Rear of House
Condition: Rust Noted
Explanation: Rust leads to failure/leakage of the gutters.
Suggested Action: Replace all deteriorated fasteners and sections.
Significance: Needs Pro Repair

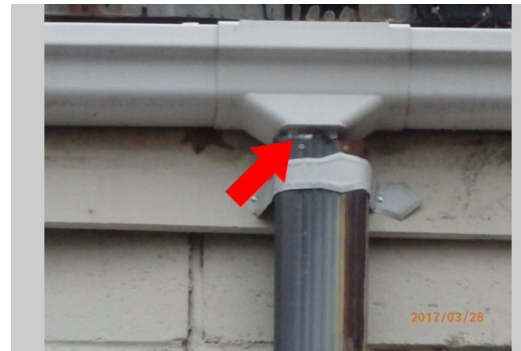
CONDITION #97

Location: Rear of Office
Condition: Disconnected Parts
Explanation: Disconnected gutter, downspout and piping components can promote foundation leakage and other problems.
Suggested Action: Reconnect all loose sections of piping and insure proper drainage.
Significance: Needs Pro Repair

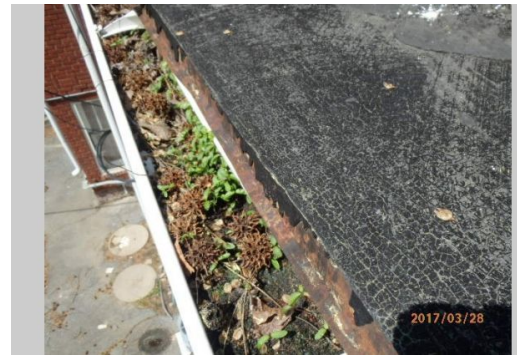
CONDITION #98

Location: Office Rear
Condition: Accumulated Debris in Gutters
Explanation: Leaves and other debris prevent the gutter system from operating properly, and can contribute to gutter deterioration, foundation leakage and other problems.
Suggested Action: Ensure that all gutter components are free of debris.
Significance: Maintenance Item

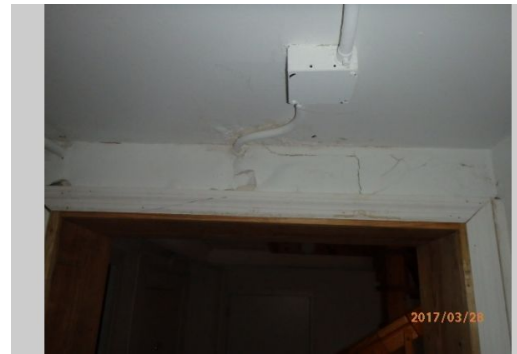
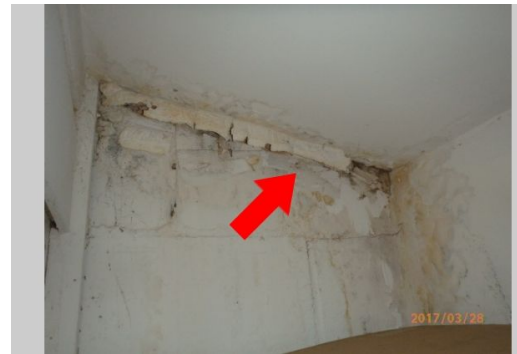
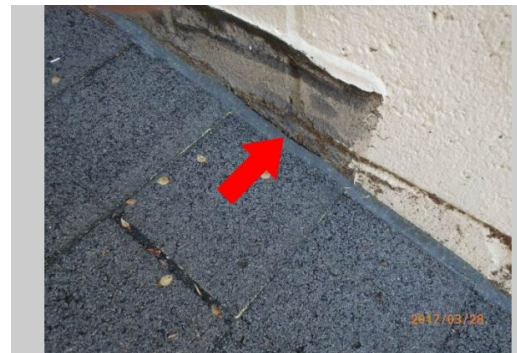
CONDITION #99

Location: Lower Rear Hallway
Condition: Flashing Missing
Explanation: 3- Missing flashing can cause leakage into the structural components or the interior. 1-2
Suggested Action: Have a roofer or qualified contractor replace flashing where missing.
Significance: Needs Pro Repair

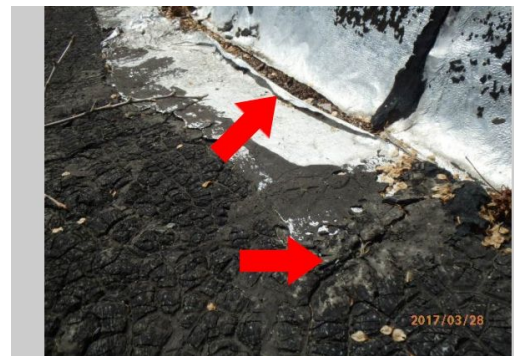
CONDITION #100

Condition: Damaged Flashing
Explanation: Damaged flashing was noted at some areas of the parapet.
Suggested Action: Consult a roofer for repair of all damaged components.
Significance: Needs Pro Repair

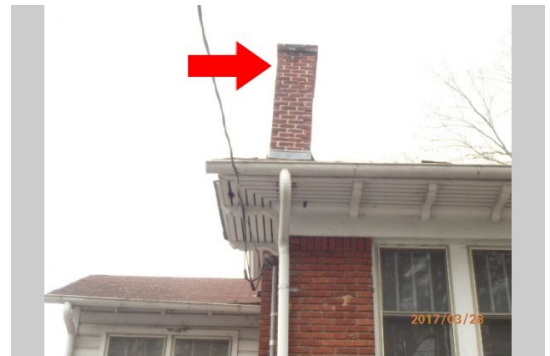
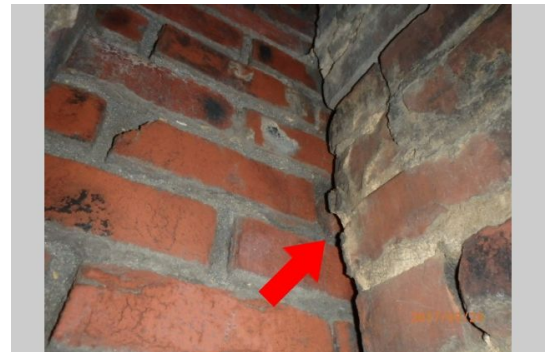
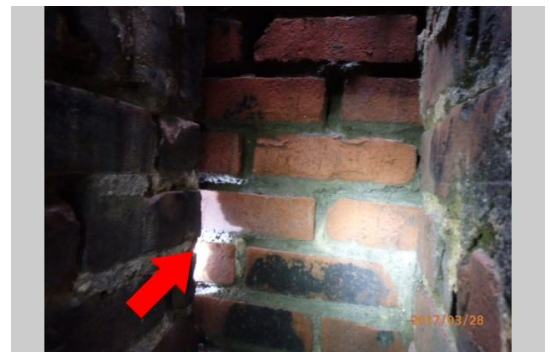
CONDITION #101

| Condition: | Leaning/Displacement |
| Explanation: | The chimney is not plumb and leans toward the roof. Displacement was noted within the masonry structure of the chimney. (as viewed from the attic) The structure may be dangerously compromised. |
| Significance: | Safety Concern |

| Suggested Action: | Consult a structural engineer and/or chimney repair contractor for further evaluation and recommendations for shoring or rebuilding. |

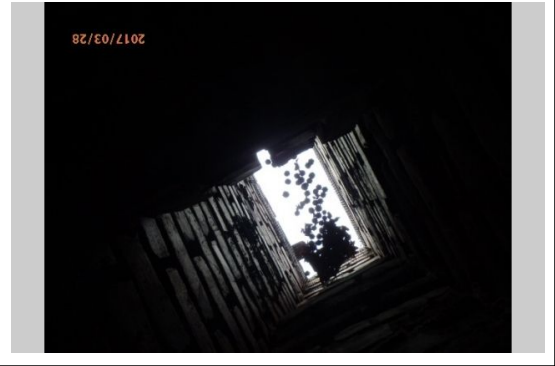
CONDITION #103

Condition: Rain Cap Missing
Explanation: Metal rain caps protect the chimney from the effects of weather, along with mechanical systems that vent through chimneys
Suggested Action: Consult a fireplace specialist for fabrication and installation as desired.
Significance: Upgrade Advised

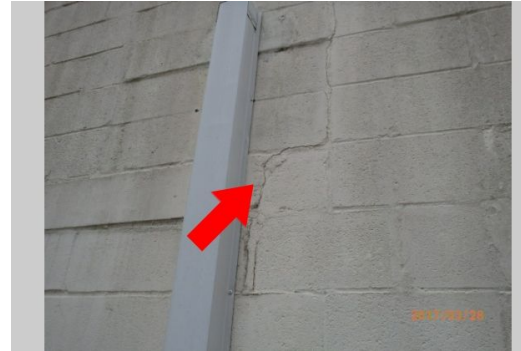
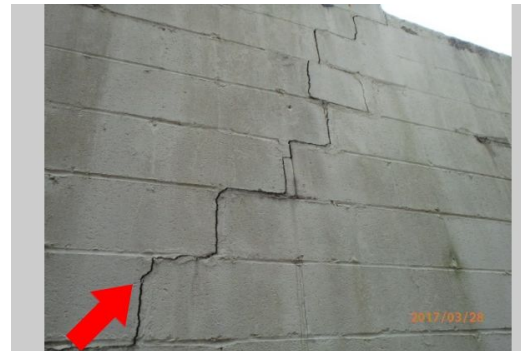
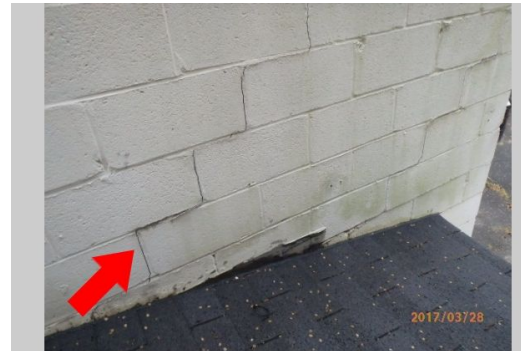
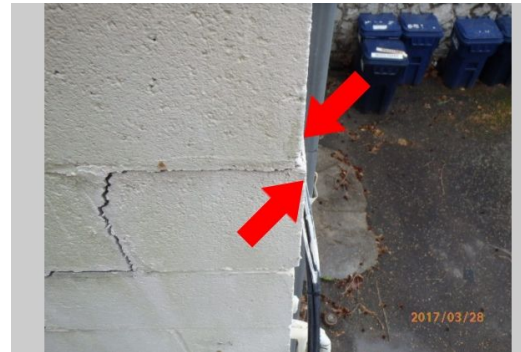
CONDITION #104

Location: Office Right Rear
Condition: Cracking and Settlement Noted
Explanation: The significant wall cracks appear abnormal.
Suggested Action: Have a structural engineer provide further evaluation.
Significance: Needs Pro Repair

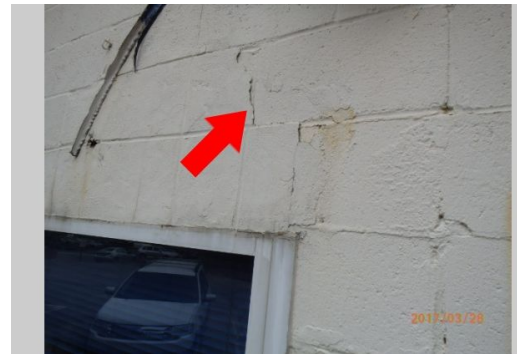
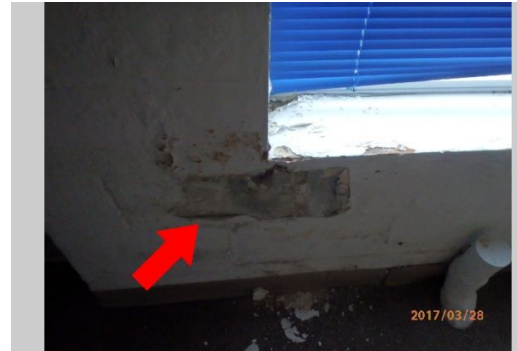
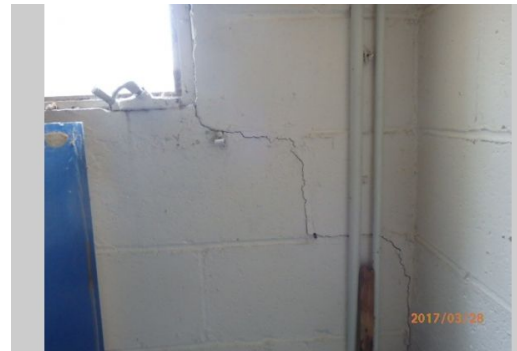
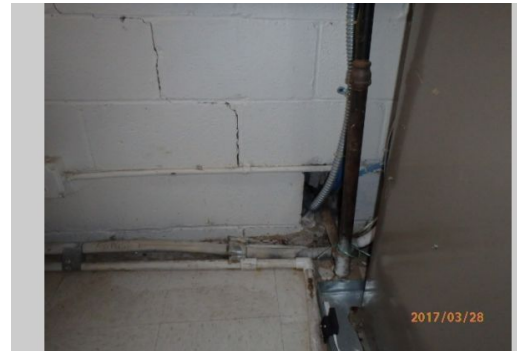
CONDITION #105

Location: Rear
Condition: Cracks Noted
Explanation: 1-Cracks may be allowing water penetration into 2- the rear wall below. 3-4- additional interior cracks correspond with exterior.
Suggested Action: Seal all cracks. Monitor for subsequent changes.
Significance: Needs Pro Repair

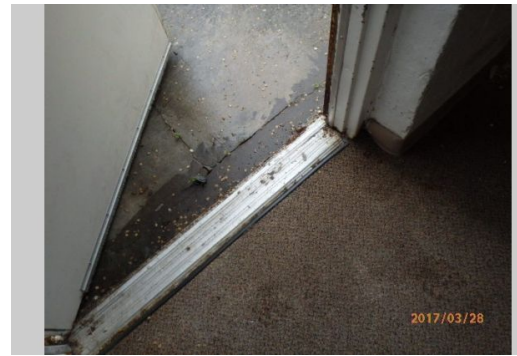
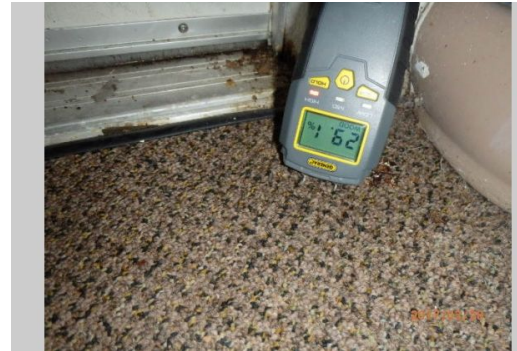
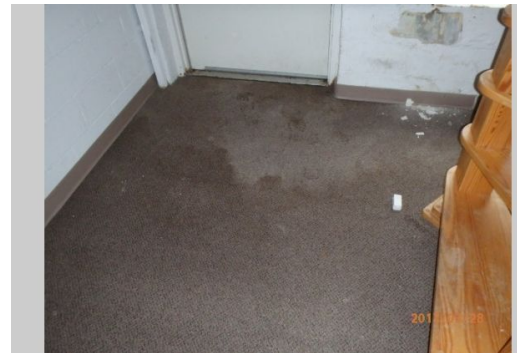
CONDITION #106

Location: Lower Rear Office Door
Condition: Water Damage Noted
Explanation: The exterior pad should be lower than the slab. Water permeates the doorway and into the carpet.
Suggested Action: Modify the exterior slope and grade.
Significance: Needs Pro Repair

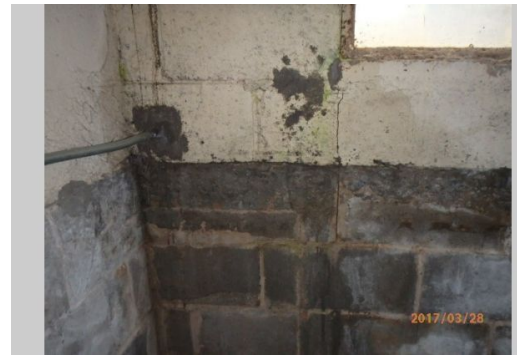
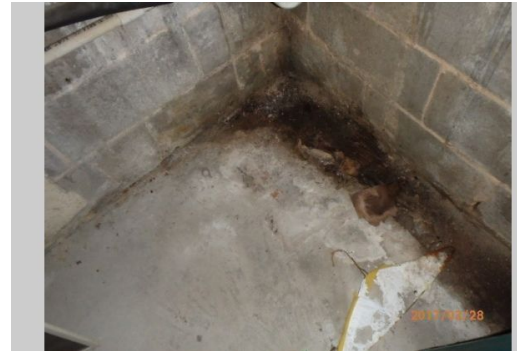
CONDITION #107

Location: Office- Lower Left Mechanical Closet
Condition: Water Staining Noted
Explanation: Staining was noted as a result of water leakage.
Suggested Action: Ensure operation of the gutter above this area. Consider options for waterproofing.
Significance: Needs Pro Repair

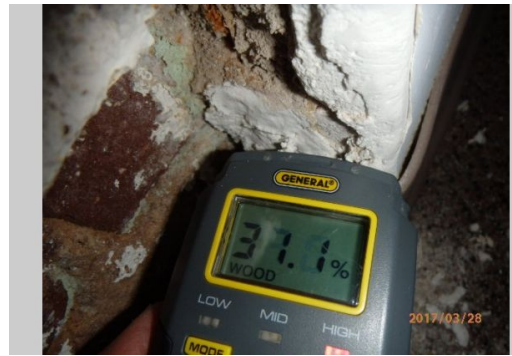
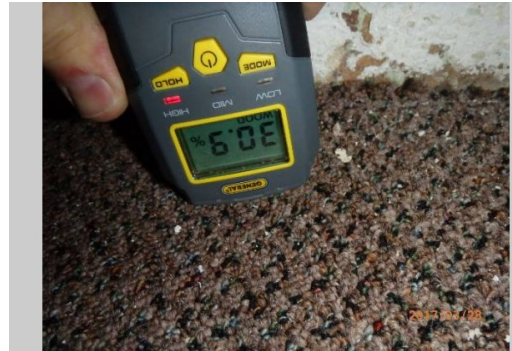
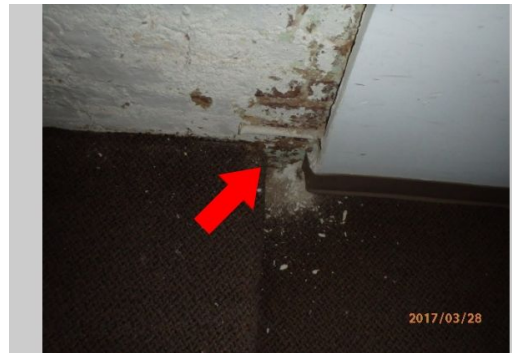
CONDITION #109

Location: House- at Basement Steps
Condition: Dampness Noted
Explanation: Evidence of significant dampness was noted as a result of water penetrating at the foundation. This was the case at all front and left foundation walls. These conditions may have accelerated mold growth in the wall cavity. Repair, remediation and waterproofing could mean major expense.
Suggested Action: Clean and insure proper gutter function, adjust the grade to accommodate proper slope away from the structure, monitor for subsequent water penetration. Consult a waterproofing contractor for evaluation and remediation options as needed.
Significance: Safety Concern

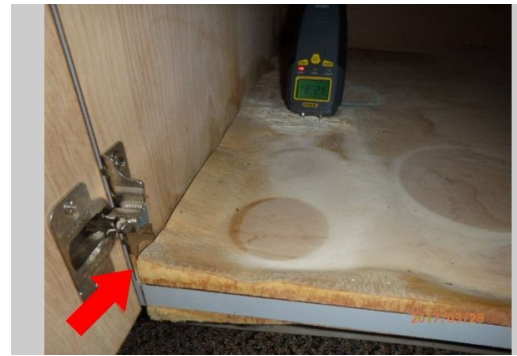
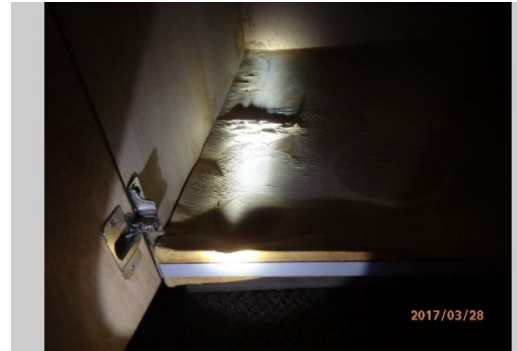
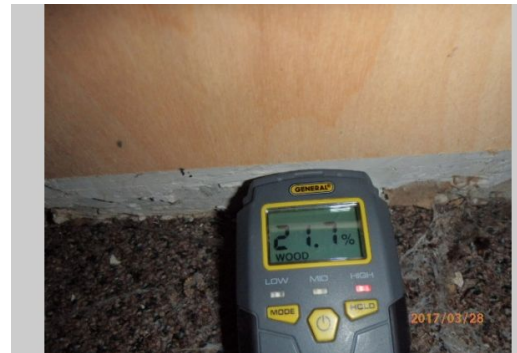
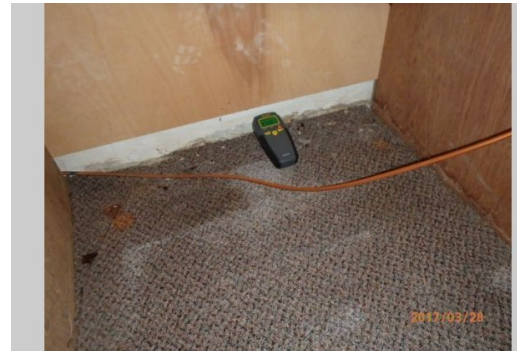
CONDITION #110

Location: Lower Kitchen Cabinet
Condition: Moisture Damage Noted
Explanation: Considerable swelling and damage form moisture was noted.
Suggested Action: Clean and insure proper gutter function, adjust the grade to accommodate proper slope away from the structure, monitor for subsequent water penetration. Consult a waterproofing contractor for evaluation and remediation options as needed.
Significance: Needs Pro Repair

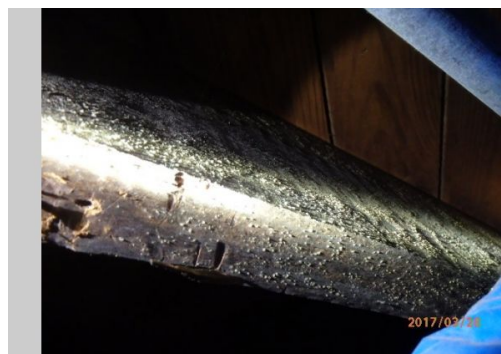
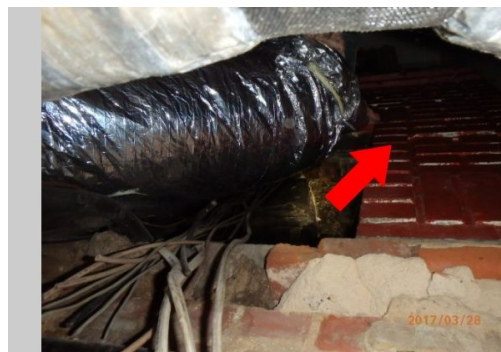
CONDITION #112

Location: Above Furnace
Condition: Mold-Like Spores Noted
Explanation: 1- Mold like spores were noted on some joists.
2- The open chimney may hinder heating efficiency.
Suggested Action: Consult a mold remediation specialist for further evaluation and treatment as necessary.
Significance: Safety Concern

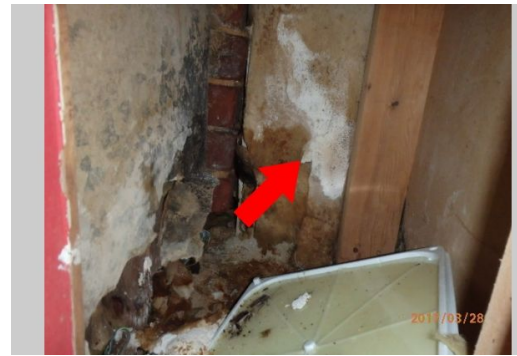
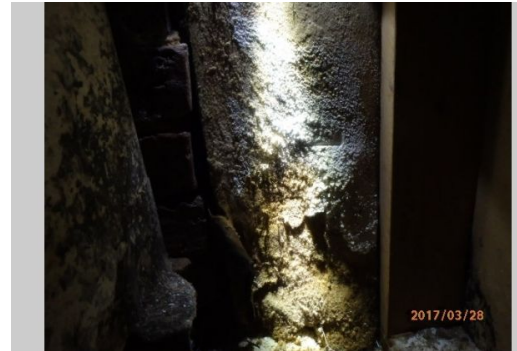
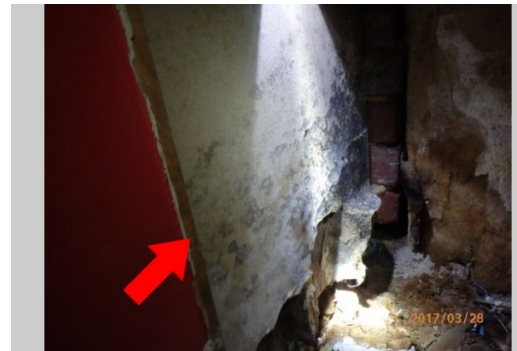
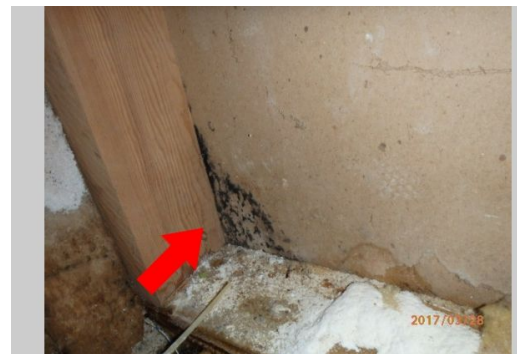
CONDITION #113

Location: Hall Closet at Electric Panel
Condition: Mold-Like Spores Noted
Explanation: Mold like spores were noted on floor and wallboard.
Suggested Action: Consult a mold remediation specialist for further evaluation and treatment as necessary.
Significance: Safety Concern

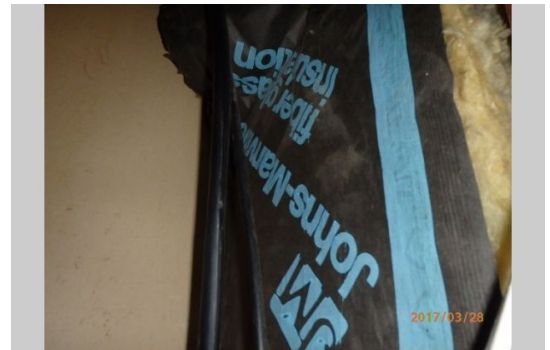
CONDITION #115

Location: Hall Closet at Panel
Condition: Reversed Vapor Barrier
Explanation: The insulation is backward, according to the manufacturer label printed on each batt. The exposed facing is also flammable and a fire safety hazard.
Suggested Action: Reverse the batts so that the vapor barrier is installed against the heated surface.
Significance: Safety Concern

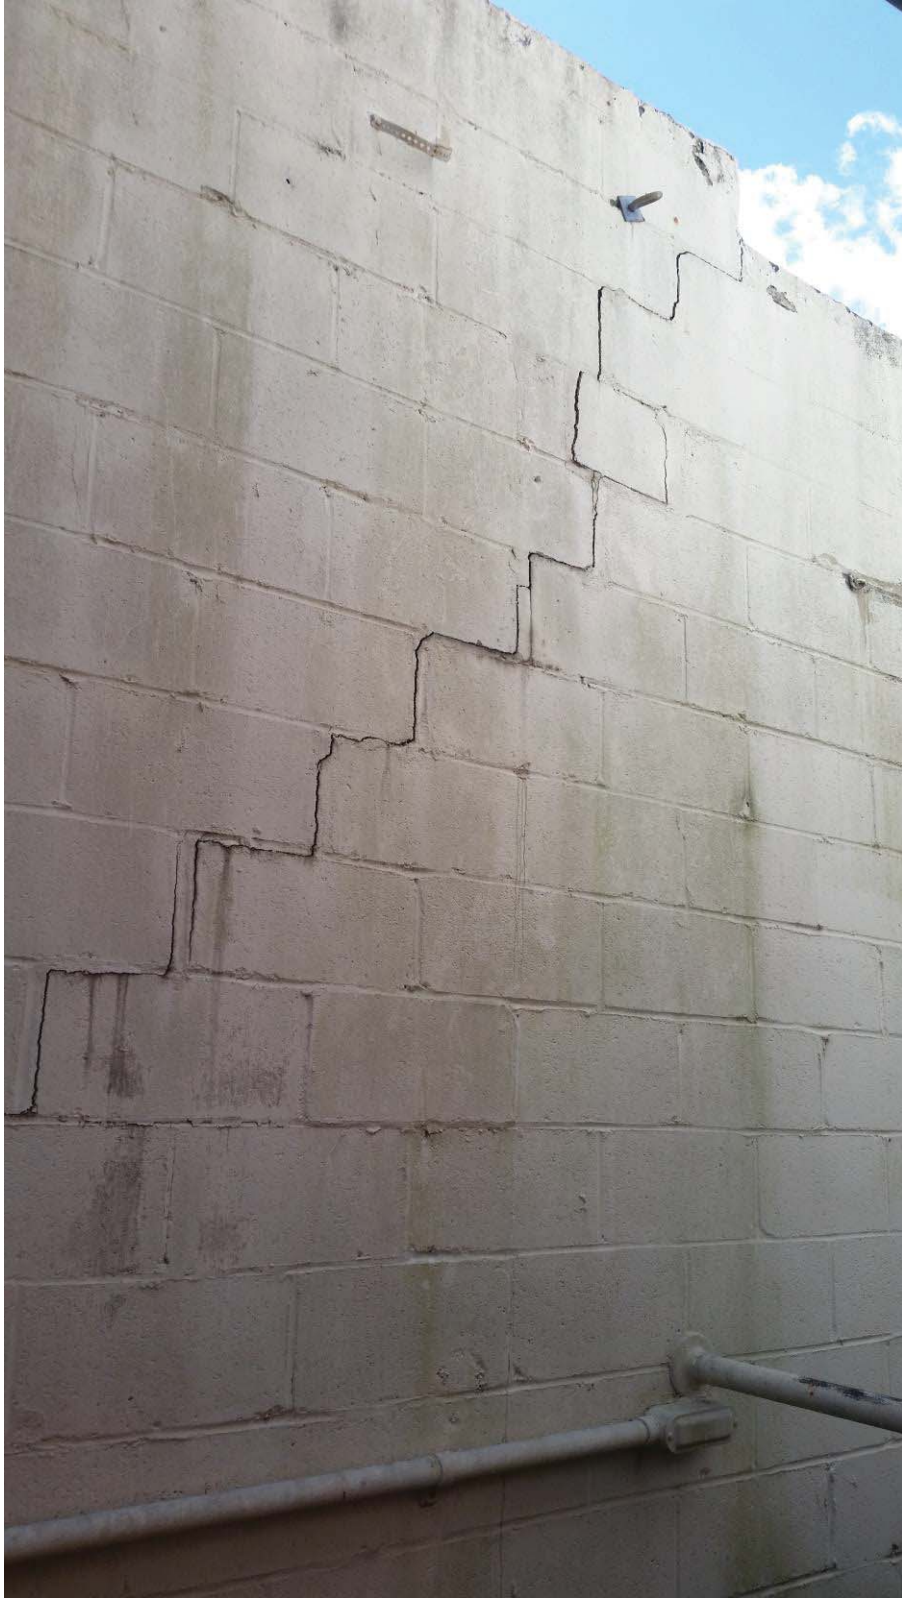
Figure 1

Most of the framing is covered so inspection was limited. The basement slab is extremely deflected in multiple areas. In one room the floor has heaved more than 3". A large diagonal crack was found in the right exterior wall (Figure 1) indicative of significant settlement of the rear right corner. There is evidence of extreme moisture intrusion.

If the building is to be occupied I recommend consulting with a mold expert and a water proofing expert. It is likely that a new membrane will have to be installed on the surface of all foundation walls retaining soil. This would require a significant amount of excavation. Additionally, the 1st floor slab would have to be exposed and inspected to make sure the settlement has not damaged the slab. The basement floor slab would have to be exposed as well and repaired to relevel. Helical piers would need to be added to prevent future settlement and the drainage in the rear of the property would need to be corrected.

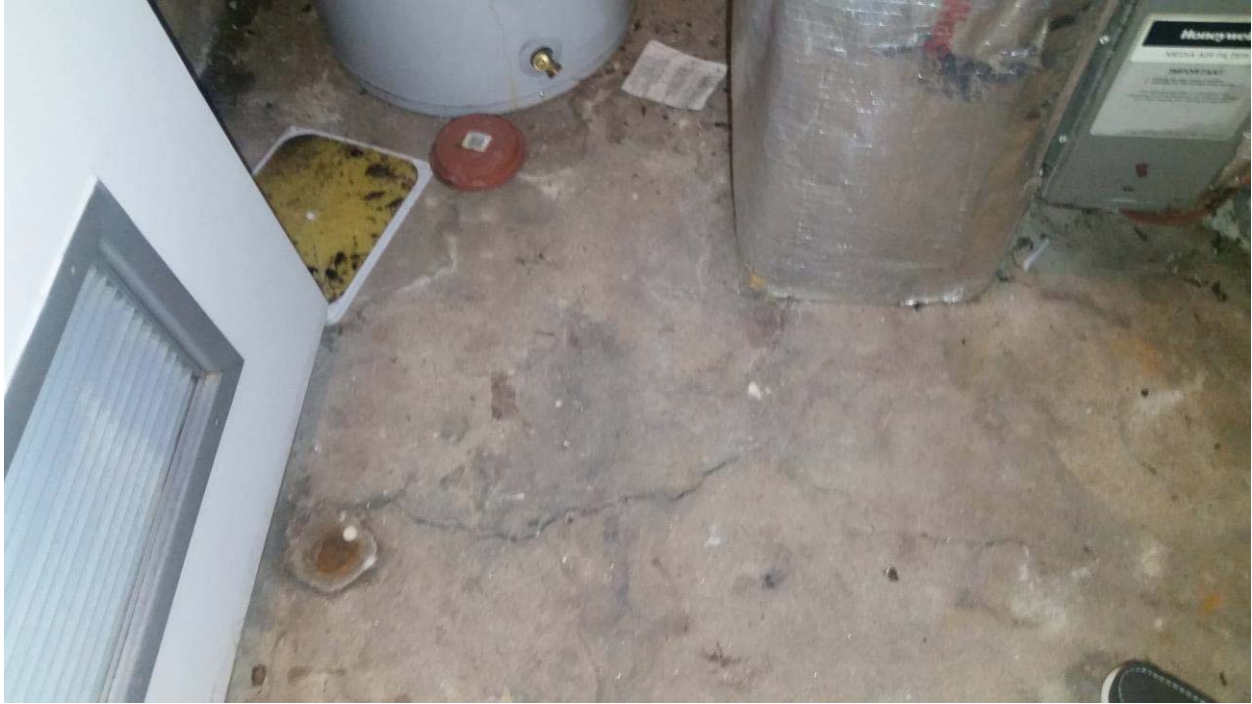
Figure 2

Most of the framing and structural components were covered so inspection was limited. The mechanical room (the only room that provided reasonable visibility of 1st floor framing and foundation) revealed that the foundation slab is cracked and deflected (Figure 2). The slab drops approximately 2" over a 4'-0" length in the mechanical room. The 1st floor joists above consist of 2x10 members spaced approximately 16" o.c. The 2nd floor is likely similar.

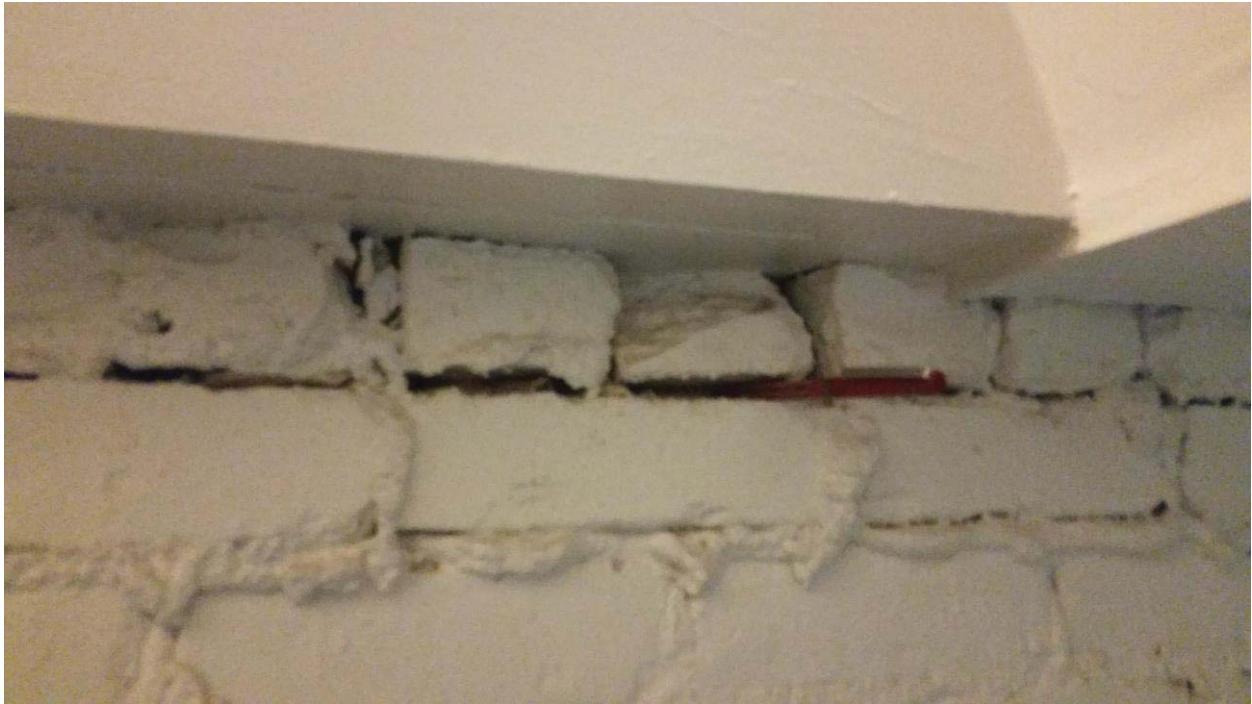
Figure 3

The interior surface of foundation walls was covered in most places. The exposed area at the stair revealed mortar that has severely deteriorated in several bed joints (Figure 3). Large voids were also present in mortar joints (Figure 4).

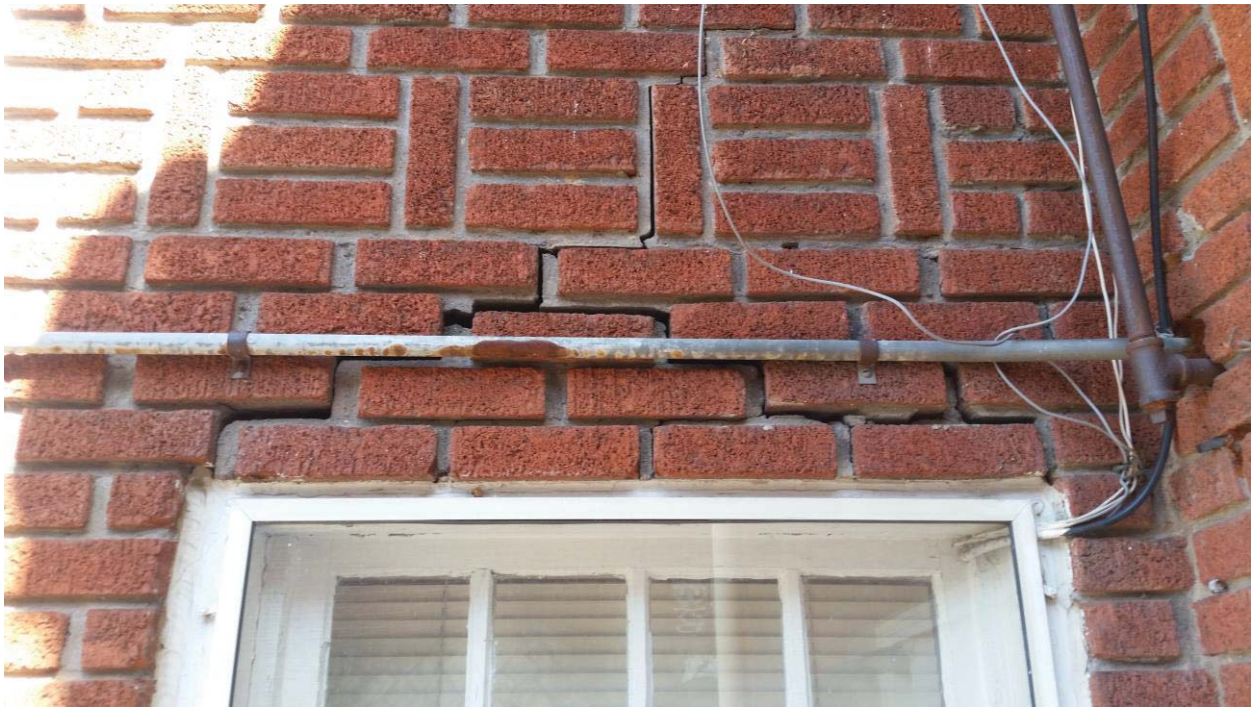
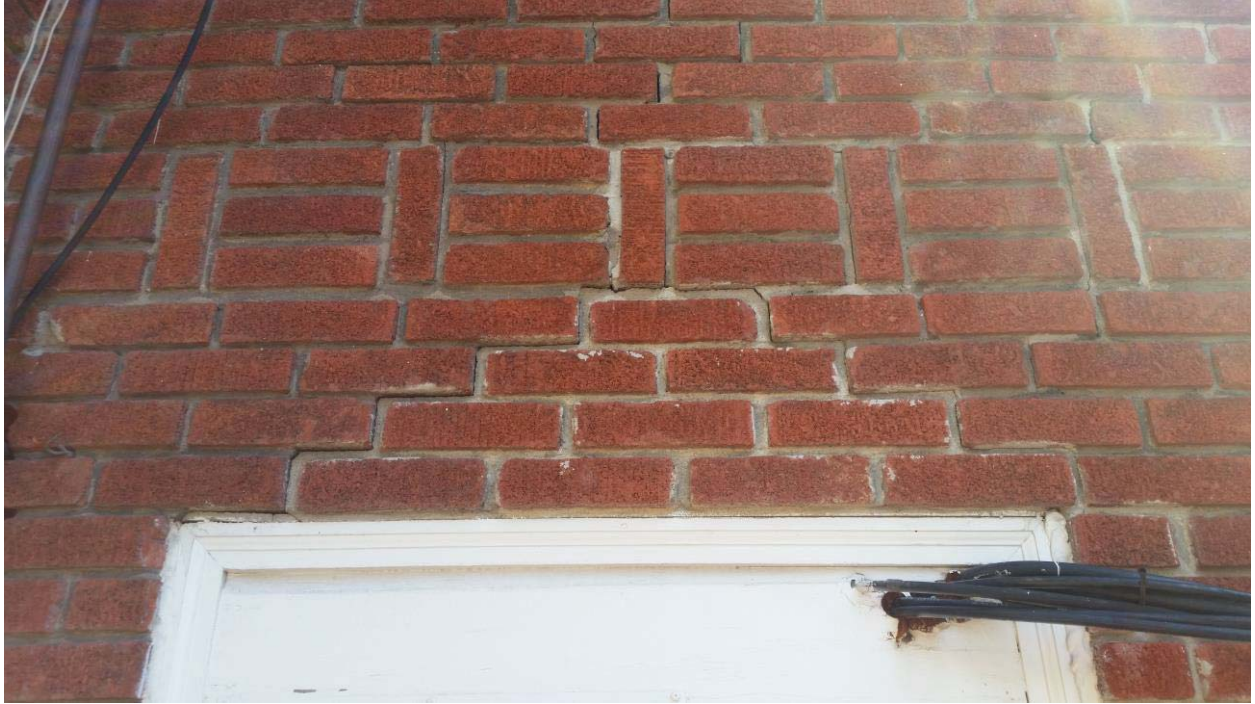
The exterior surface of the veneer is also in very bad condition. There are significant cracks and voids throughout. There are multiple inadequacies above window and door openings. Some steel lintels are excessively deflecting (Figure 8 & 12). Some openings do not have a continuous lintel (Figure 7). Some openings have no lintel at all (Figure 5 & 6). The brick chimney is severely leaning (Figure 13).
