DeKalb County Historic Preservation Commission

K. 1080 Clifton Road, Brian E. Daughdrill. Demolish a historic house, remove a nonhistoric garage, and construct a nonhistoric house. **1248160.**

Subject: **Structural Assessment**
1080 Clifton Rd
Atlanta, GA
CERM Project No. 2025-0862F-017F

STRUCTURAL ASSESSMENT

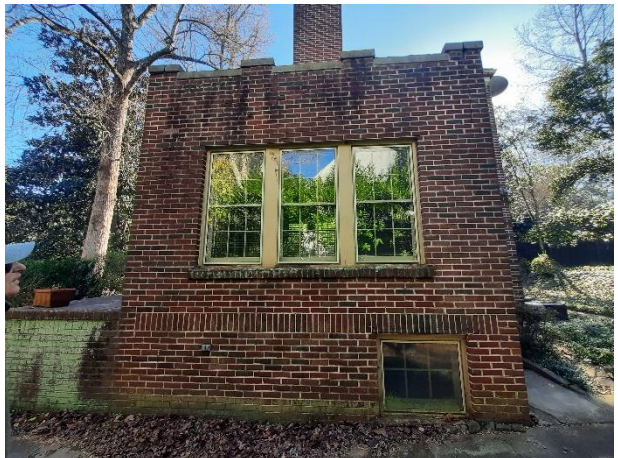
Photo 4
Sunroom / Enclosed Porch (North Façade)

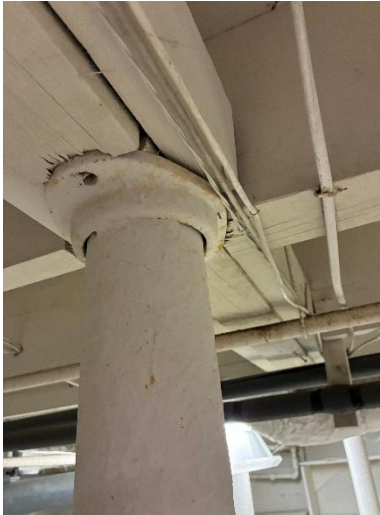
- ii. First floor framing was visible from the basement. See **Photo 25**.
 - 1. Floor joists are supported by wood ledgers. A few joists show cracking at the notch.
 - 2. The ledgers are nailed to beams / rim joists. Some ledgers have slight separation from the support member.
 - 3. There is floor damage directly below the northwest corner of the Breakfast Nook. See **Photo 26**. This damage extends from the roof to the basement in this location.
 - 4. Beams are supported by multiwythe brick or CMU walls, by other beams, or on columns.
 - a. No metal connectors were observed
 - b. The header beam at the stairs has been cut to allow for piping. See **Photo 27**.
 - c. Some beams at the columns show signs of crushing at the column caps. See **Photos 28 and 29**.

2. One column has an adjacent shoring post. The bottom of the beam is at least 1/2 inch above the column cap, so the column is no longer load bearing. A slight indentation is visible where bearing occurred indicating compression of the wood possibly due to inadequate bearing area. See **Photos 29 and 30**.

Photo 29
Top of Pipe Column

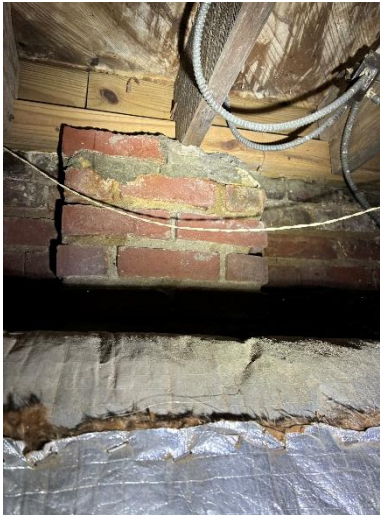
1. The accessible portion of the crawlspace (under the front patio) was dry at the time of Sykes' visit. Some localized water stains were observed on the exterior brick wall and the interior CMU wall. See **Photos 33 through 35**.

Photo 34
Brick Pilaster at Crawlspace

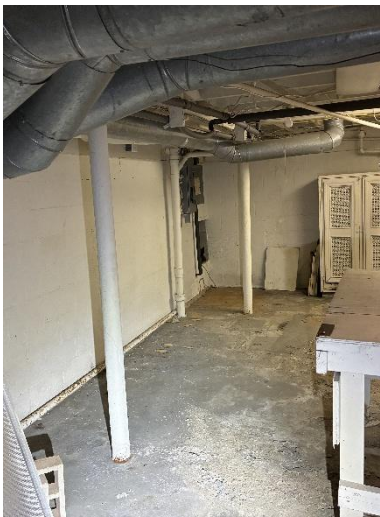
- v. Slab on Grade
 - 1. The thickness of the slab on grade is unknown.
 - 2. No standing water at the time of Sykes' site visit; however, there is damage to the slab on grade due to continuous water intrusion and prior patching. See **Photos 36 and 37**.
- vi. Exterior Entrance
 - 1. There is an exterior entrance to the basement that allows water to enter. See **Photo 38**.
- vii. A mold assessment is recommended. See **Public Safety Considerations** Section

Photo 36
Slab on Grade

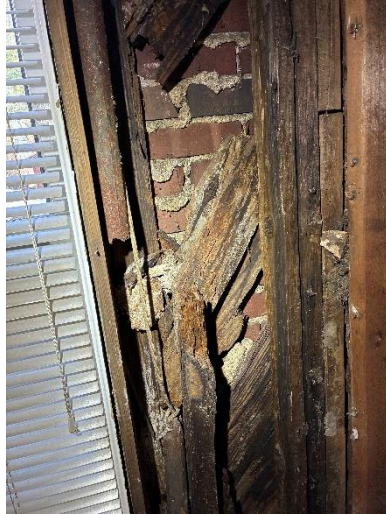
- iii. The wall in the northwest corner has extensive damage and rot. Some of the wall studs and exterior diagonal sheathing have partially rotted away and the exterior brick veneer is visible. See **Photos 43 through 45.**
- iv. The floor shows signs of water damage but most of the framing below appears sound. See **Photos 46 and 47.**

Photo 43
Northwest Corner Framing
At Sunroom / Enclosed Porch

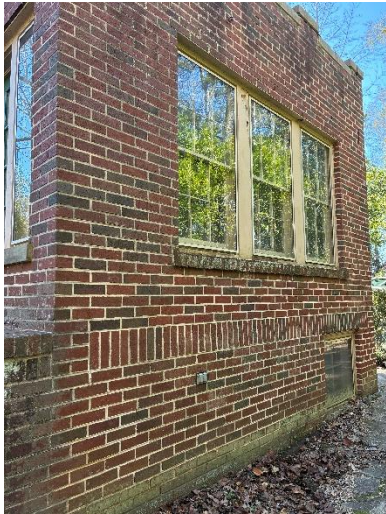
North Exterior Wall of Sunroom / Enclosed Porch

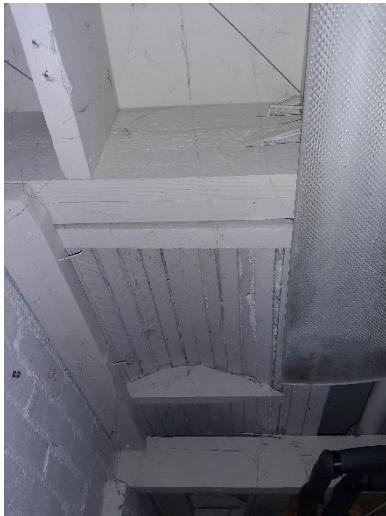
Framing Under Hearth

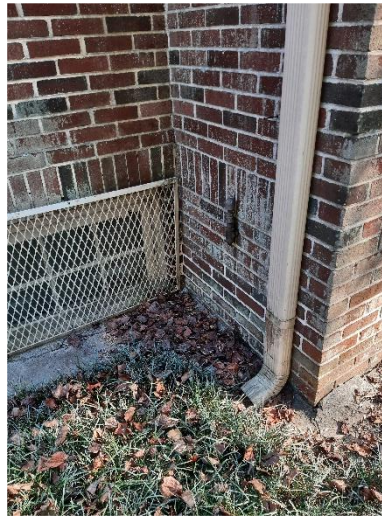
Downspout Near
Basement Window
