DeKalb County Historic Preservation Commission

Staff Report

G. 1035 Oxford Road, Ben Darmer for Parkwood Living, LLC. Demolish a historic house and construct a new house. **1247316.**

STRUCTURAL ENGINEER INSPECTION REPORT

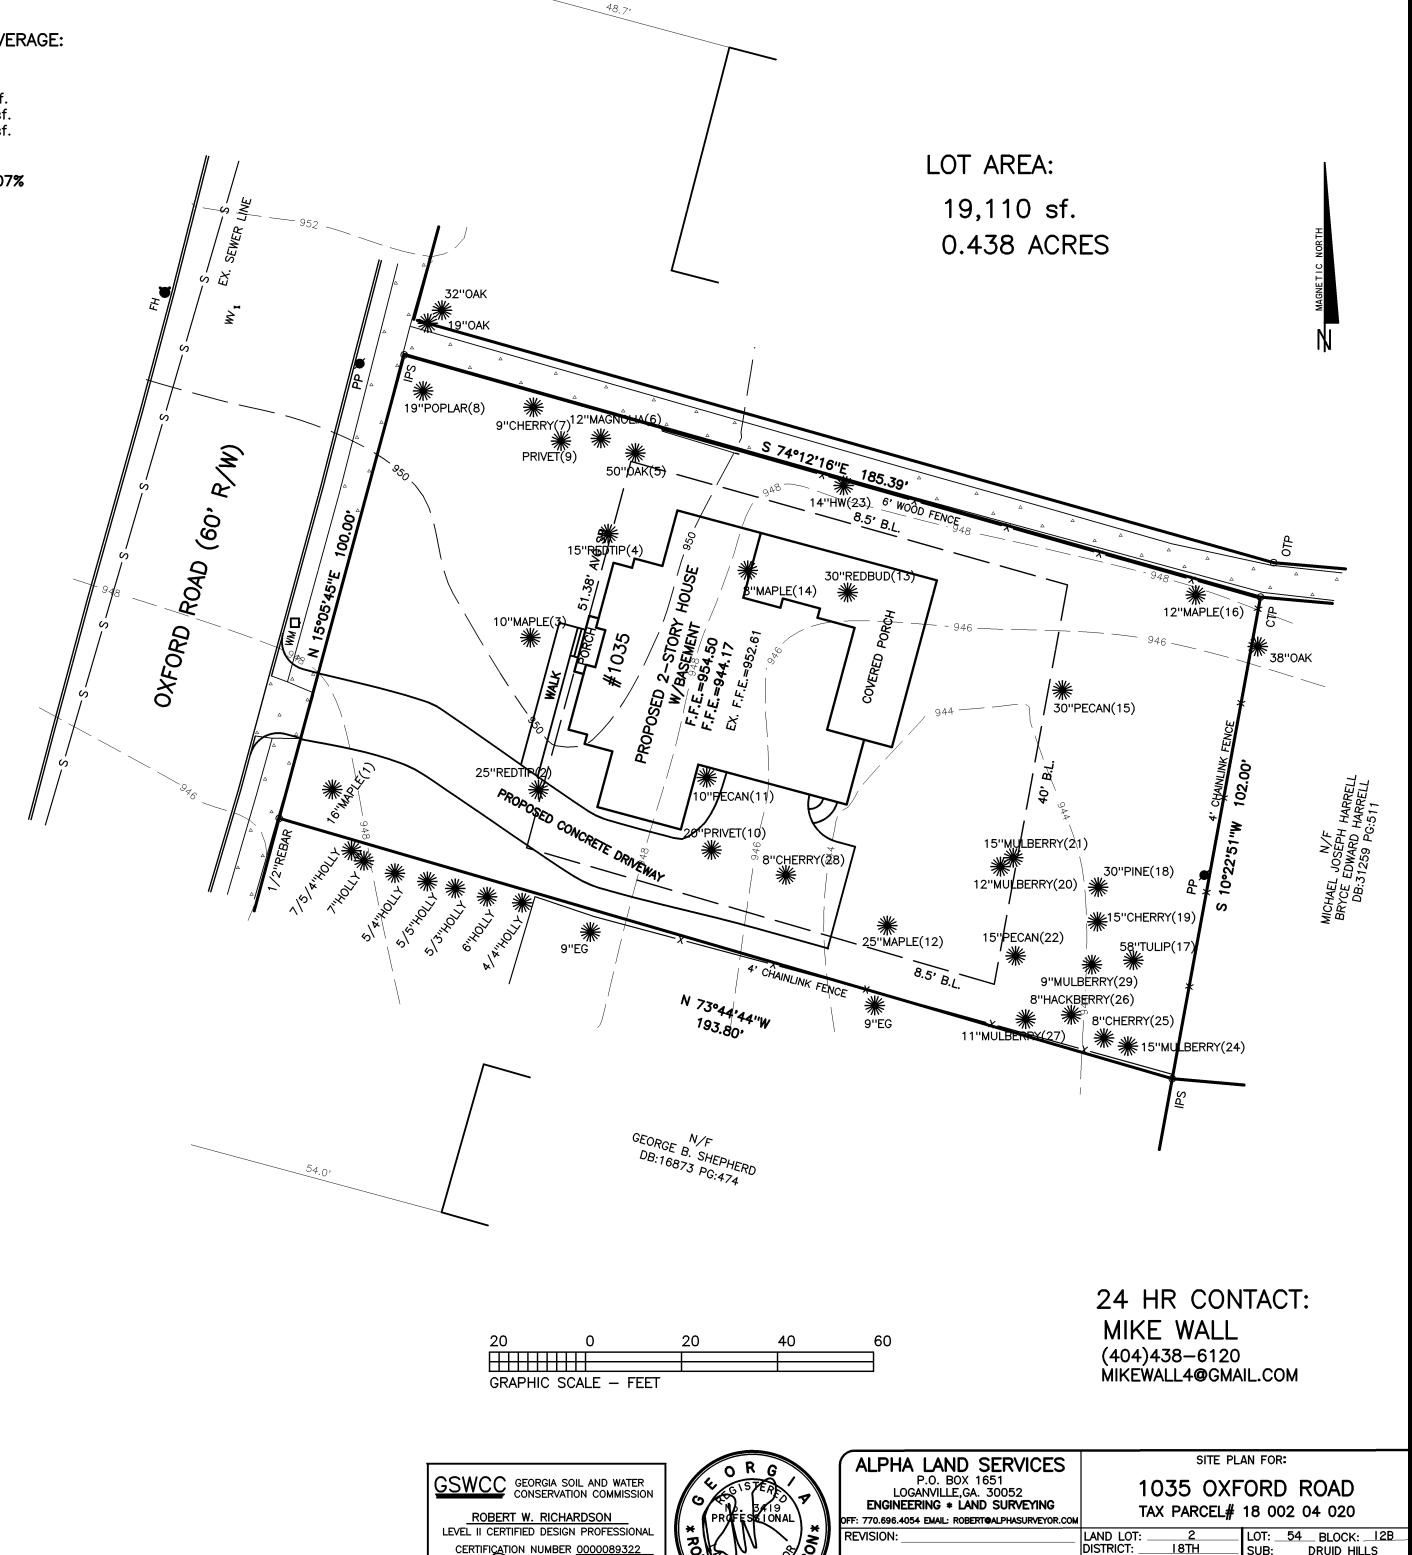
LOT COVERAGE = 29.07%

The field data upon which this plat is based has a closure precision of one foot in 15,000 feet and an angular error of 03" seconds per angle point and was adjusted using the Compass Rule. This plat has been calculated for closure and is found to be accurate within one foot in 100,000 feet.

Equipment used: Topcon GTS-213 Total Station.
