RE: Clean Water Act Consent Decree 1:10cv 4039-SDG
July 30, 2026 2nd Quarterly Report Submittal

2nd Quarter 2026 Quarterly Report

April 1 to June 30, 2026
Civil Action No. 1:10cv4039 - SDG

DeKalb County
Department of Watershed Management

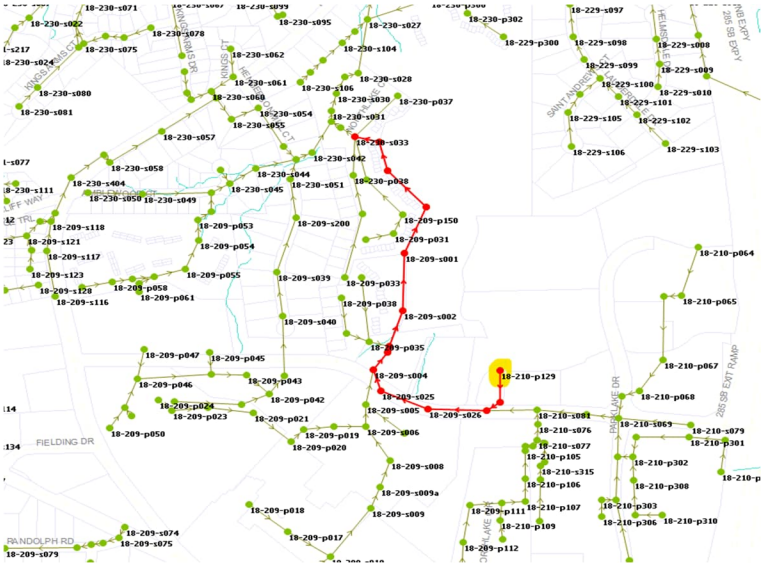
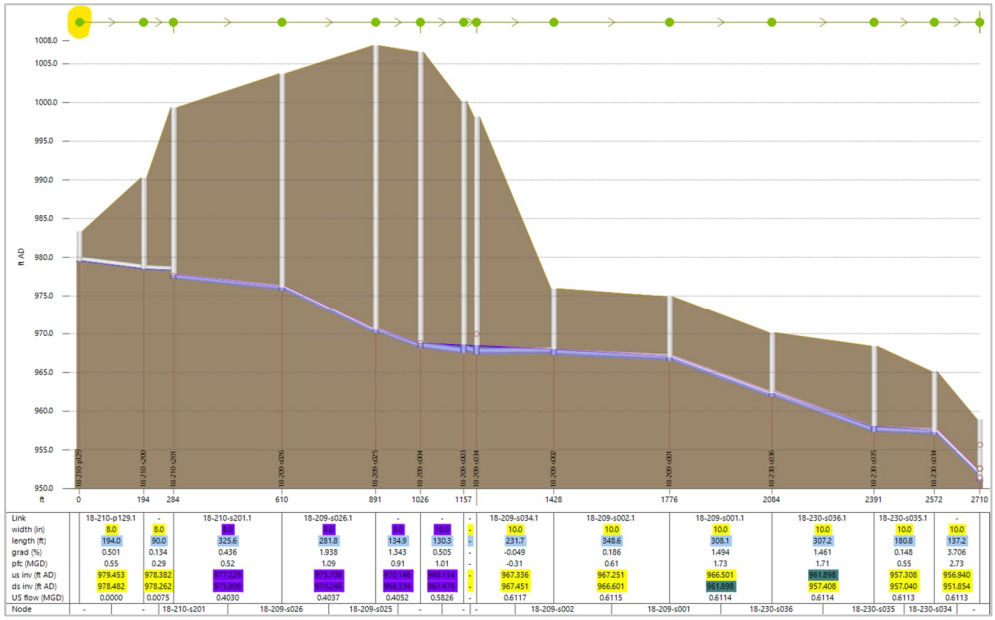
Spill 68

68	5/7/2026	16:38	N	N	100	3330 Northlake Parkway	Atlanta	I-IG12	210-P129	8	CC/PMP FLR	Found manhole #18-210-p129 spilling into the storm drain, into the creek due to a county contractor's bypass pump failure.	Non-Capacity	RGSFORK2, (0.82) *See Attachment A	North Lake	Unnamed	5/7/2026	17:10	The bypass pump(s) was restarted which contained the spill and restored flow.	5/8/2026	5/12/2026	Cleaned up spill site. Placed public notification on spill site.
69	5/14/2026	8:47	N	N	985	1815 South Ponce De Leon Avenue	Atlanta	Not in a PASARP	N/A	8	DB	Found manhole #15-238-s202 surcharging. A debris blockage in the 8(in) sewer main caused pressure to build-up in the line, resulting in a spill from a weak pipe joint.	Non-Capacity	RGSHO2, (0.00)	South Fork Peavine Creek	Unnamed	5/14/2026	12:04	Pressure washed the 8(in) sewer main 54(ft) to remove the unknown debris blockage at 50(ft) which restored normal flow.	5/14/2026	5/19/2026	CCTV work order created for Keith/CDPMT. Cleanup work order completed. Posted public notifications work order completed.

Date	Address	City	Time Reported	Time Stopped	Est. Vol. (gal)	Rec. Water
5/7/2026	3330 Northlake Parkway	Atlanta	4:38 p.m.	5:10 p.m.	100	North Lake
Cause Due to Capacity				Rain Gauge	Rain (in)	Priority Area
Non-Capacity - PMP FLR – Bypass Pump Failure				RGSFORK2	0.82	I-IG12
Comments						
Found manhole #18-210-p129 spilling into the storm drain, into the creek due to a county contractor's bypass pump failure. (WO- 26009551)

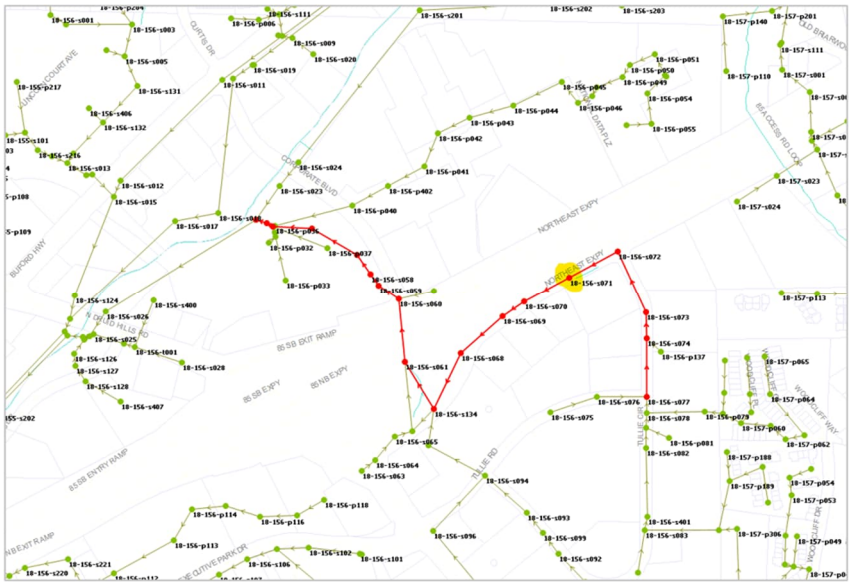
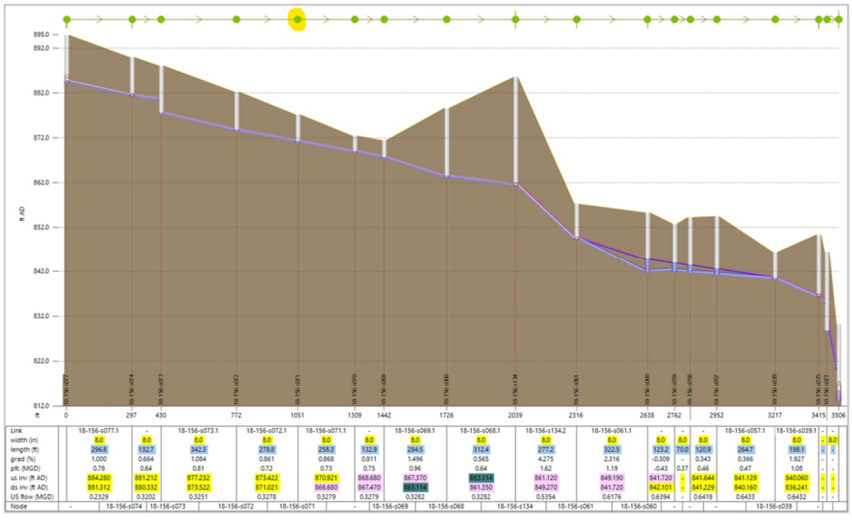
Spill 82

82	6/18/2026	12:08	N	N	200	2174 North Druid Hills Road	Atlanta	Not in a PASARP Area	156-s071	8	UNK/DB	Found manhole #18-156-s071 surcharging with evidence of a spill due to unknown debris blockage.	Non-Capacity	RGNFORK4, (0.98) *See Attachment A	North Fork Peachtree Creek	Unnamed	6/18/2026	13:01	Checked upstream and downstream manholes. Pressure washed the 8(in) sewer main 200(ft) from manhole 18-156-s070 to 18-156-s071.	6/18/2026	6/20/2026	CCTV work order created for Keith/CDPMT. Cleanup work order completed. Posted public notifications work order completed.
83	6/22/2026	15:11	N	N	120	1194 Oxford Road	Atlanta	Not in a PASARP Area	002-S005	8	UNK	Found a 6(in) row cleanout with evidence of spill into a storm drain due to an issue in the row lateral.	Non-Capacity	RGSFORK3, (0.00)	Peavine Creek	Unnamed	6/22/2026	15:35	Pressure washed the row 6(in) lateral from manhole 45(ft) unable to restore flow. A repair lateral work order was created (wo#26066240) and CCTV work order #26066268 was created.	6/22/2026	6/26/2026	CCTV work order created for Keith/CDPMT. Cleanup work order completed. Posted public notifications work order completed. The repair lateral work order was completed 06/26/2026

Date	Address	City	Time Reported	Time Stopped	Est. Vol. (gal)	Rec. Water
6/18/2026	2174 North Druid Hills Road	Atlanta	12:08 p.m.	1:01 p.m.	200	North Fork Peachtree Creek
Cause Due to Capacity				Rain Gauge	Rain (in)	Priority Area
Non-Capacity - UNK/DB – Unknown Debris Blockage				RGNFORK4	0.98	N/A
Comments						
Found manhole #18-156-S071 surcharging with evidence of a spill due to unknown debris blockage. (WO- 26012418)
