Application for Certificate of Appropriateness

Address of Subject Property: 1320 Harvard Road Atlanta, GA 30306

Renovate existing accessory building with ADU above garage/crawlspace. The existing dilapidated screened porch will be removed and replaced further to rear on the same side. Many structural deficiencies will be repaired that will require replacing the existing lap siding with Hardiplank siding. All windows and doors will be replaced with some slightly modified in size or location. Garage door will be replaced. Fiberglass shingles will be replaced. Other than its porch, the accessory structure itself will remain the same size / shape. No work to main house.

RE: Structural Assessment for 1320 Harvard Road, Atlanta, GA 30306

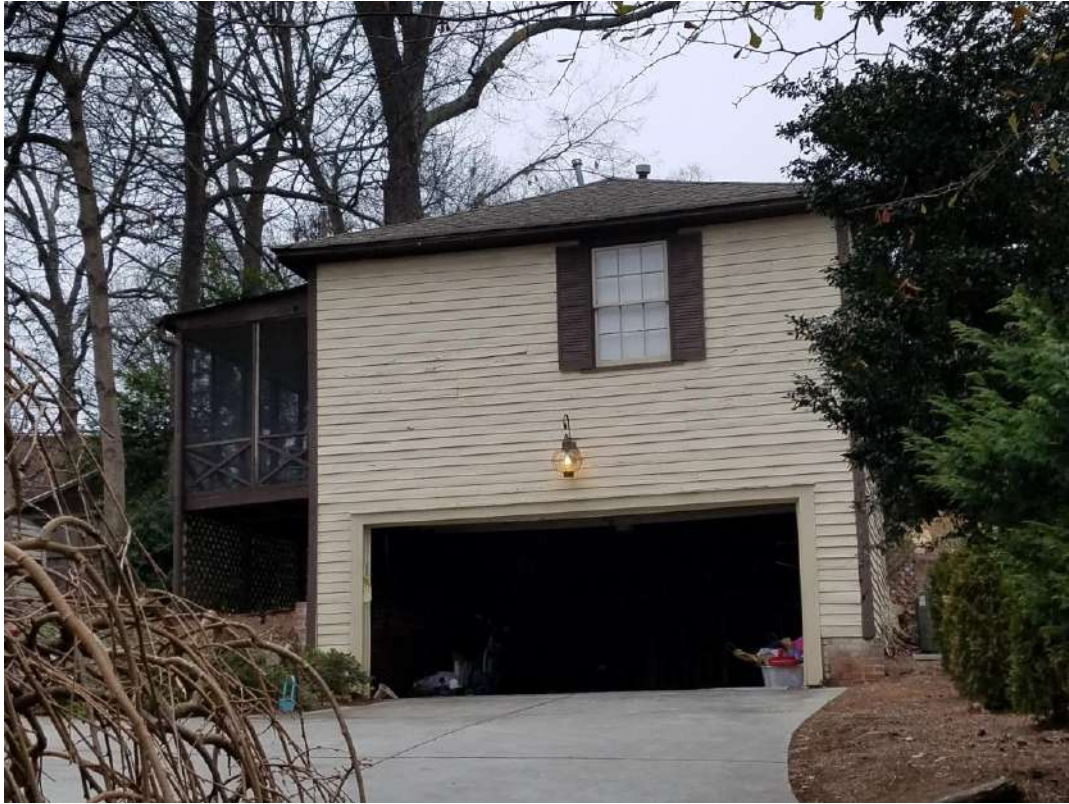
Front garage wall. New footings and portal framed header required.

4. Provide new footings at front corners of garage. Add new portal frame with LVL header for lateral bracing per code.
5. Add approximately 4 concrete footings under "left" side brick foundation wall @ 48", cut in to slab and underpin wall.

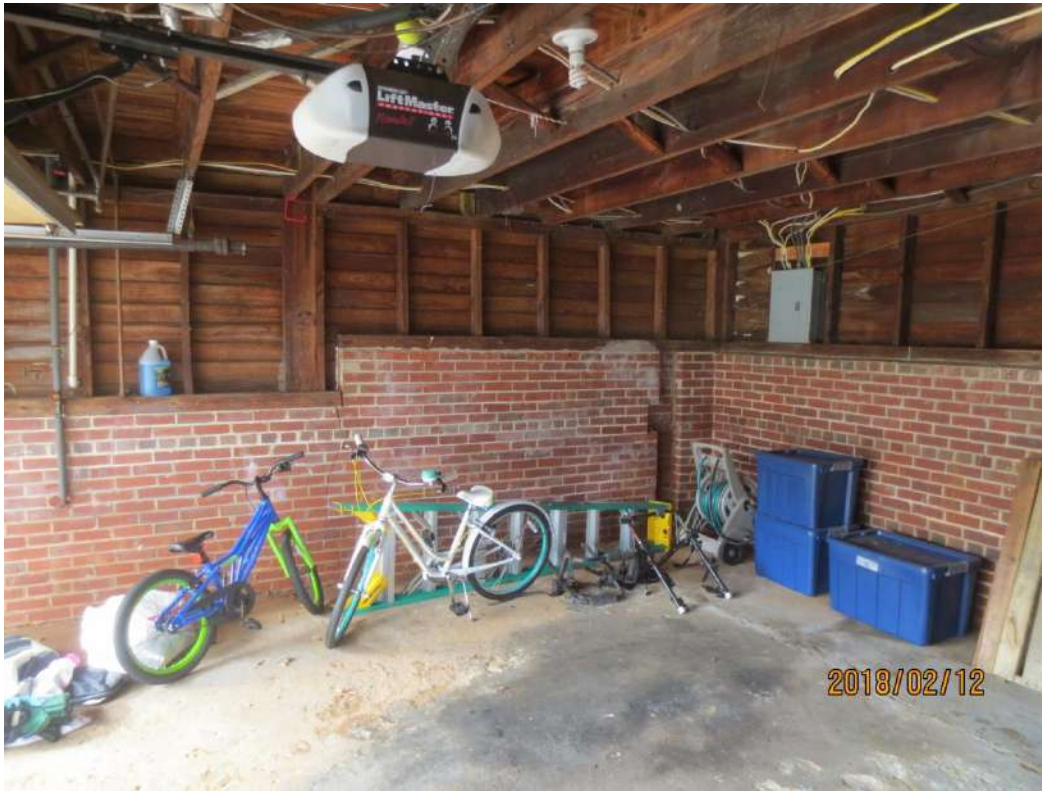
Left foundation wall and over-spanned 2x12 joists

2. The floor joists over the garage are over-spanned and need to be stiffened by sistering new joists to the existing joists. New (2) 2x12 should be added to each existing joist to span the garage.

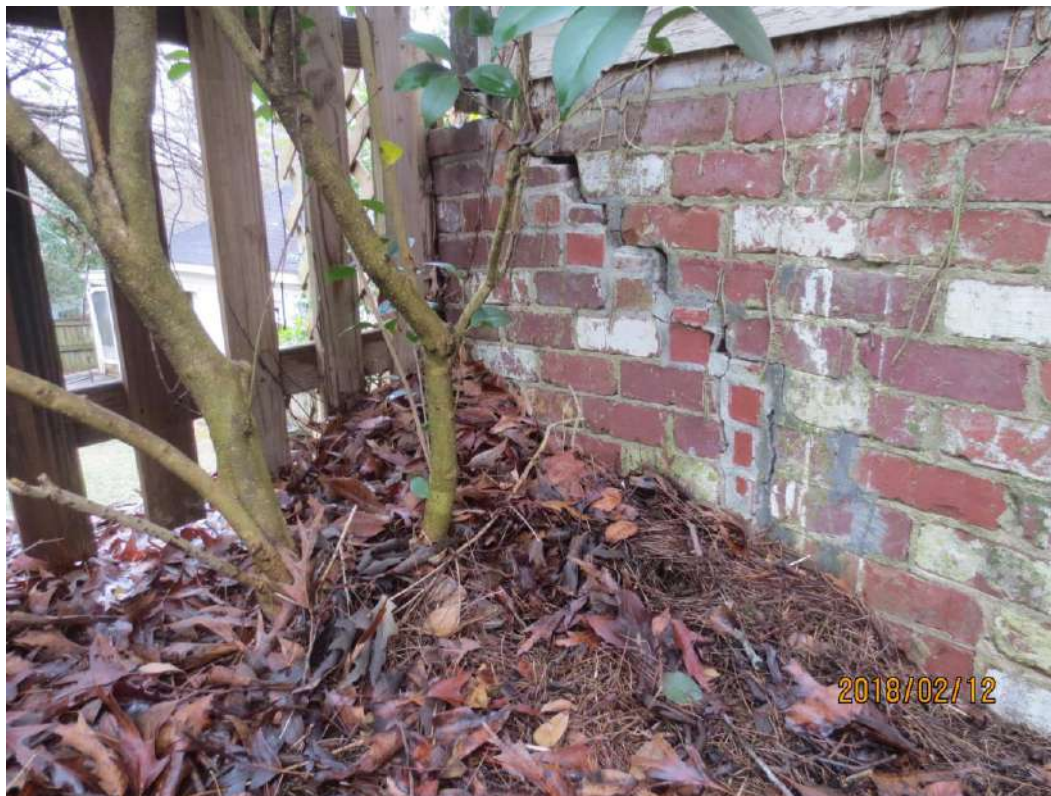
Rear addition corner settlement to be re-built with new footing and wall

1. Rear "addition" foundation wall (approximately 12 feet long) at the north\east side needs to be replaced. A new footing at the rear corner is required, which will have to be excavated down approximately 3 feet to firm soil, or supported on a helical pier.

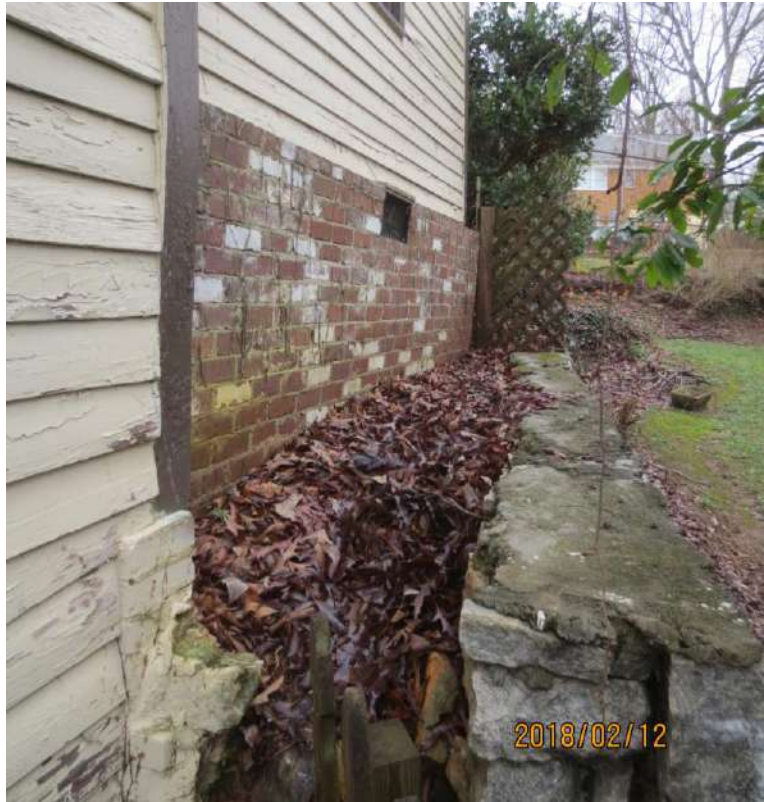
Addition side wall to be replaced

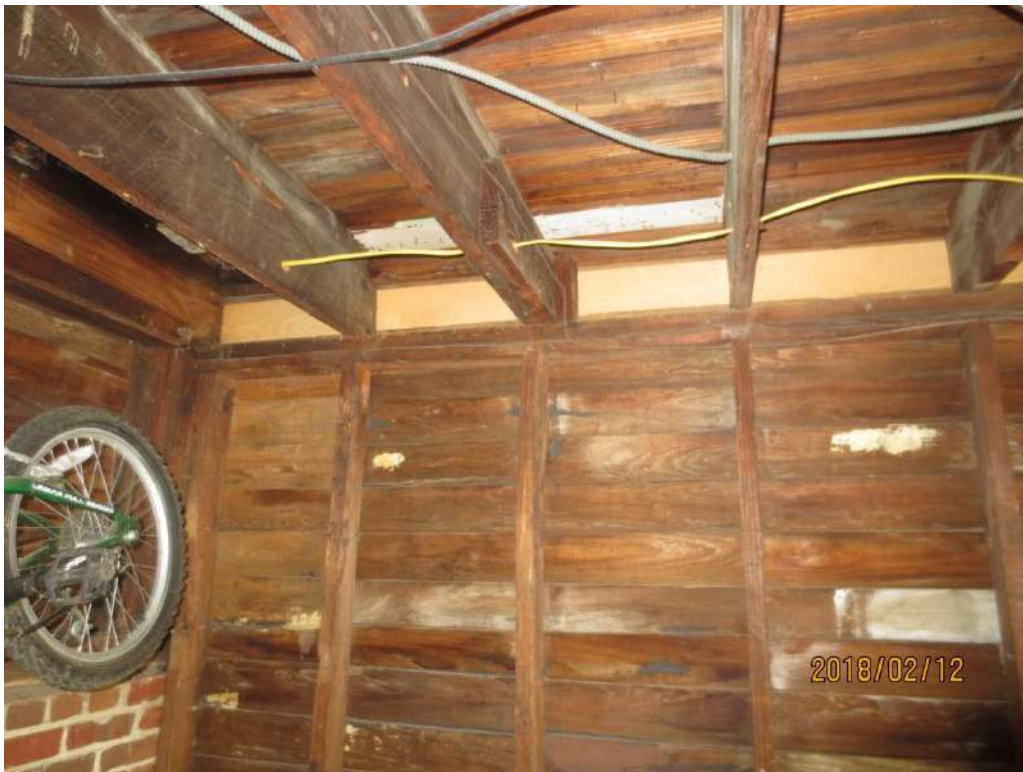
Damaged wall framing to be replaced

3. Rebuild exterior garage walls with 2x4 @ 16" with 7/16" OSB sheathing to replace existing wall with termite damage and no lateral bracing. This will require shoring support for the existing floor and walls above.

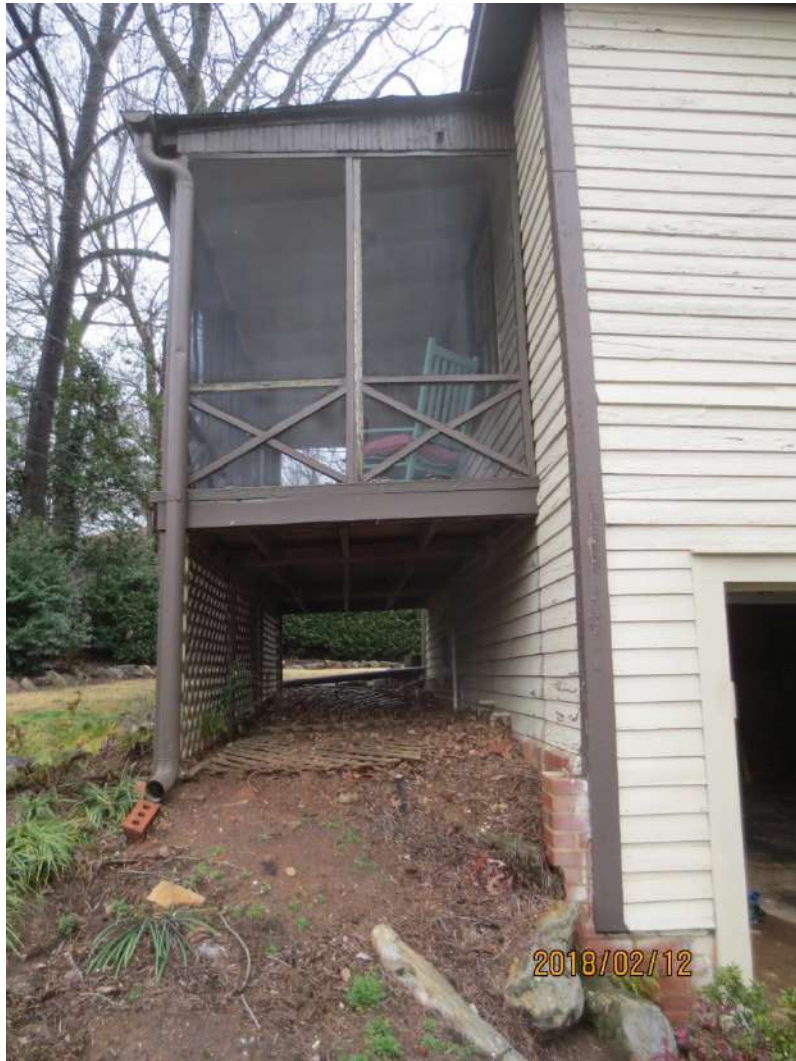
Side porch to be re-built

6. Add approximately 5 to 6 helical piers below brick stem wall @ 48" on "right" side of garage along eastern property line.
7. Add ± 45 linear feet of new retaining wall, approximately 4 feet tall, along property line to replace existing failing granite wall.
8. Tear down and rebuild of side porch, which does not meet code as-is and has structural deficiencies. New framing to meet IRC 2012 GA deck amendments with appropriate connections to garage and diagonal bracing at columns.
9. Recommend re-pouring existing garage slab which is currently cracked, unlevel, and deteriorated.
10. The roof framing does not meet current code but can remain "grandfathered" if untouched. No damage observed.
