RE: Clean Water Act Consent Decree 1:10cv 4039-SDG
Annual Report #14 Submittal due March 2, 2026

Annual Report No. 14

January 1, 2025, to December 31, 2025
Civil Action No. 1:10cv4039 - SDG

DeKalb County
Department of Watershed Management

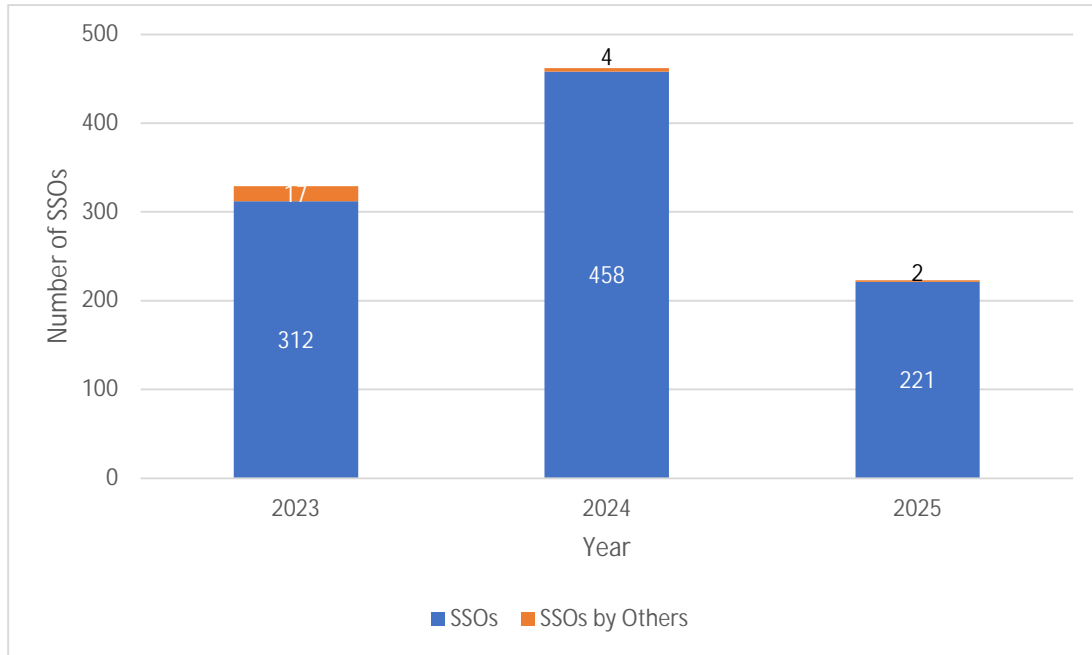
Figure ES-1 Reported SSOs per Year (2023–2025)

Overall, the number of SSOs per year has decreased by over 50 percent since the CD was lodged in 2012. For maintenance-related SSOs, this is largely attributable to the County’s MMS program including sewer cleaning, the FOG program, and extensive public education campaigns. Figure ES-1 shows the number of SSOs from 2023 to 2025. A higher number of SSOs were experienced in 2024 compared to 2023 and 2025 which can be attributed to a higher number of significant rain events resulting in an increase in I/I-related SSOs.

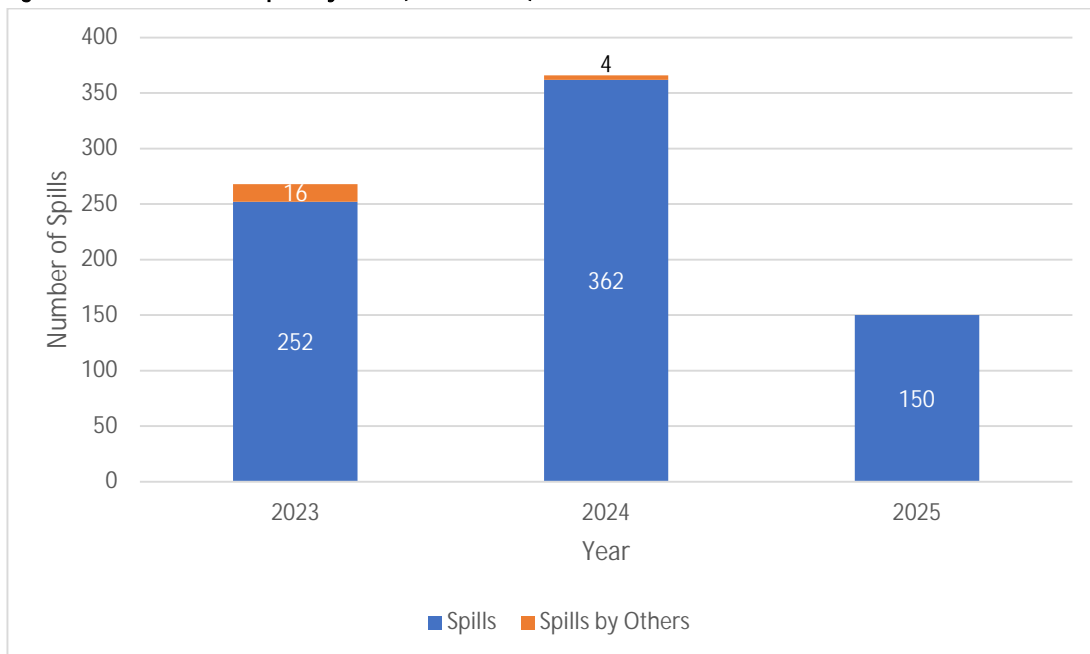
Figure ES-2 Total Spills by Year (2023–2025)

Figure ES-2 shows the number of spills, or discharges of wastewater, that reach waters of the United States or the State. The number of spills, excluding spills by others, increased from 252 in 2023 to a peak of 362 in 2024, again, attributed to the increase in significant wet weather events, before ending 2025 at 150 spills.

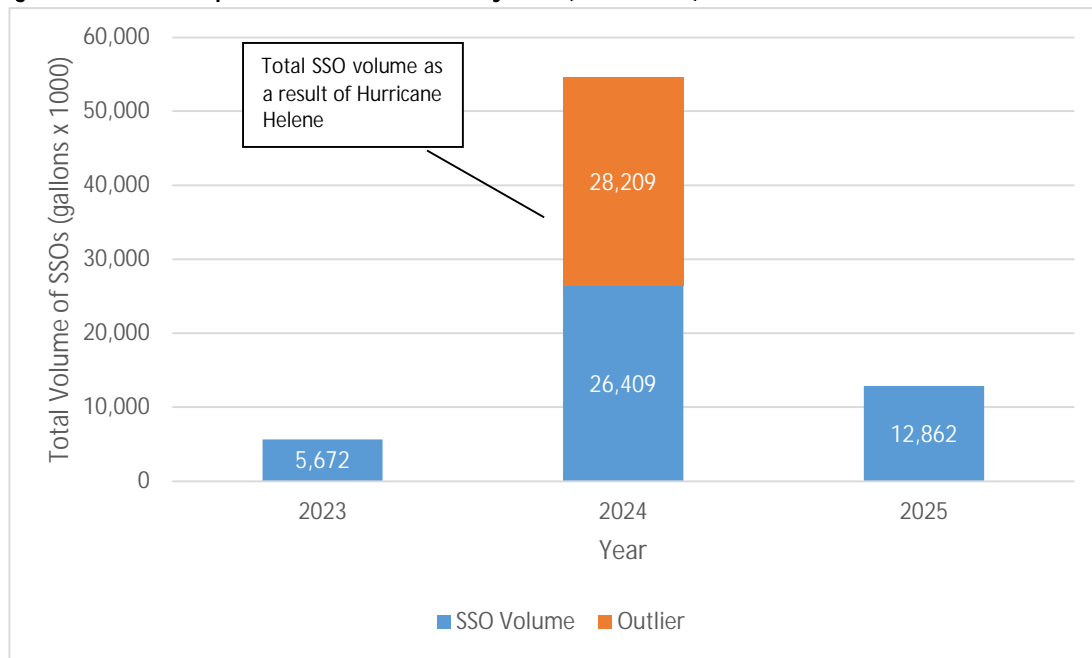
Figure ES-3 **Reported Volumes of SSOs by Year (2023–2025)**

Figure ES-3 shows the total annual reported SSO volumes for 2023 through 2025. The largest contributors to spill volume are structural SSOs involving breaks on large diameter sewer trunks and wet weather-caused SSOs. As stated previously, 2024 experienced a number of significant wet weather events, including Hurricane Helene.

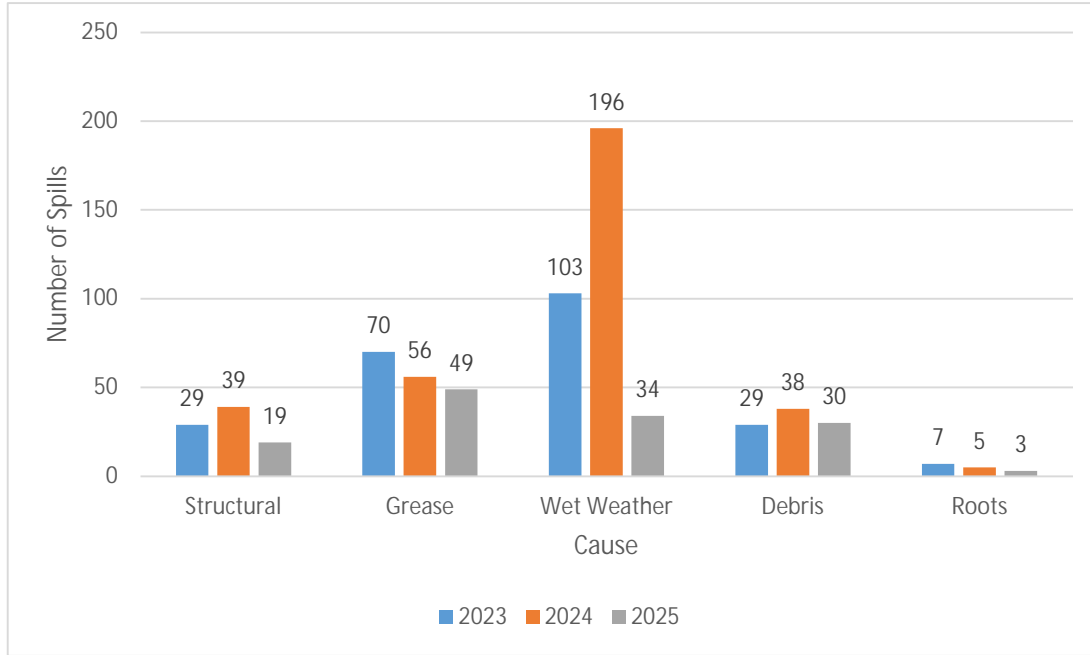
Figure ES-4 Total Spills by Year by Cause Category (2023–2025)

As shown on Figure ES-4, the number of spills attributable to the shown causes decreased from 2024 to 2025.

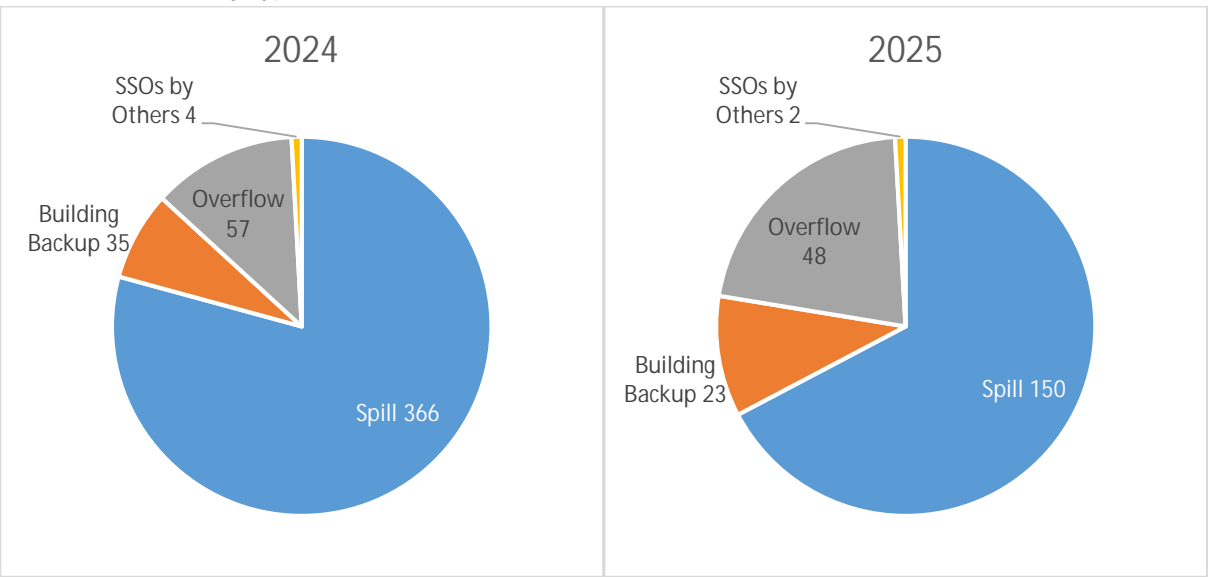
Figure 1-1 SSOs by Type (2024–2025)

Figure 1-1 shows the distribution of SSOs by type for 2025 as compared to 2024. Spills account for the majority of the SSOs followed by overflows then building backups. Beginning in the 3rd Quarter 2022 Report, the County reported SSOs by Others separately. SSOs by Others are SSOs that occur from County laterals, but the root cause is attributed to sewer mains owned and maintained by other utilities. As a result of ongoing coordination with City of Atlanta, SSOs within the County as a result of capacity issues on Atlanta owned sewer mains are now being reported by the City.

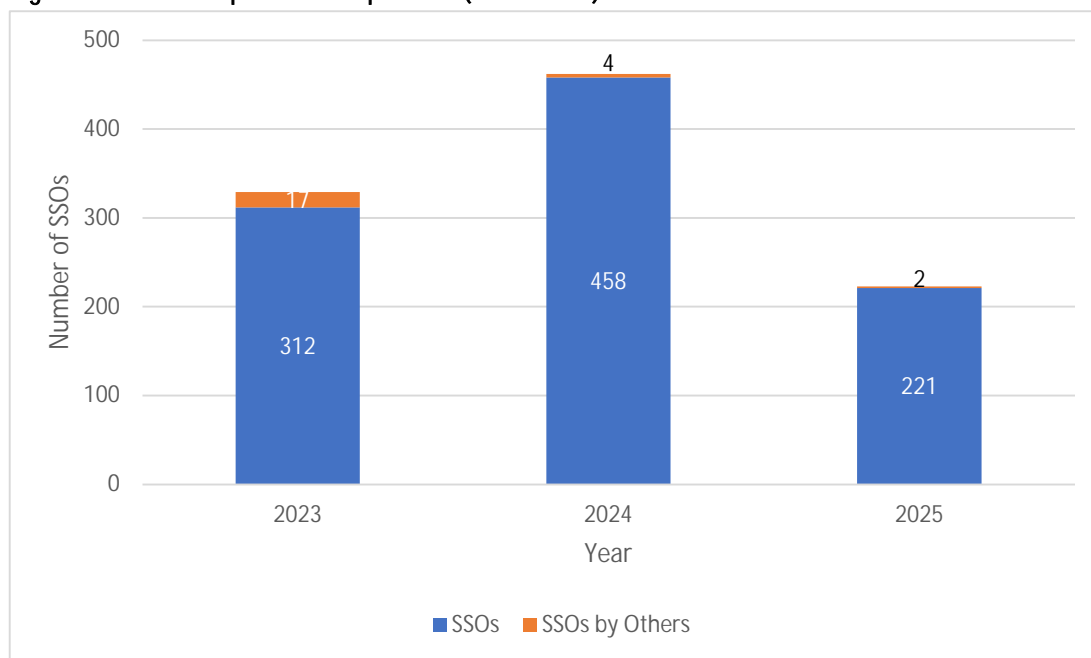
Figure 2-1 Reported SSOs per Year (2023–2025)

As shown on Figure 2-1, when excluding SSOs by Others, the number of SSOs per year decreased by 48 percent from 2024 to 2025. 2024 was a year of increased severe wet weather events that resulted in more I/I SSOs than average. Comparing 2025 to 2023 which was more similar in annual rainfall still showed a 28% decrease in SSOs. Overall, the number of SSOs has decreased by more than 50% since the CD was lodged in 2012. 2025 has the lowest number of SSOs reported since the beginning of the CD, including 2016, a drought year. There is an overall decreasing trend in the number of SSOs, particularly dry weather SSOs, since 2012, which can be attributed to the County's MMS programs including sewer cleaning, root control, the FOG program, and extensive public education campaigns. Several program improvements have allowed the County to identify and respond to SSOs more readily. These improvements include expansion of the County's flow monitoring network, further progress of sewer system investigation activities, new stream sampling protocols to detect spills, and implementation of the Cityworks work order management system to track identification and response to SSOs.

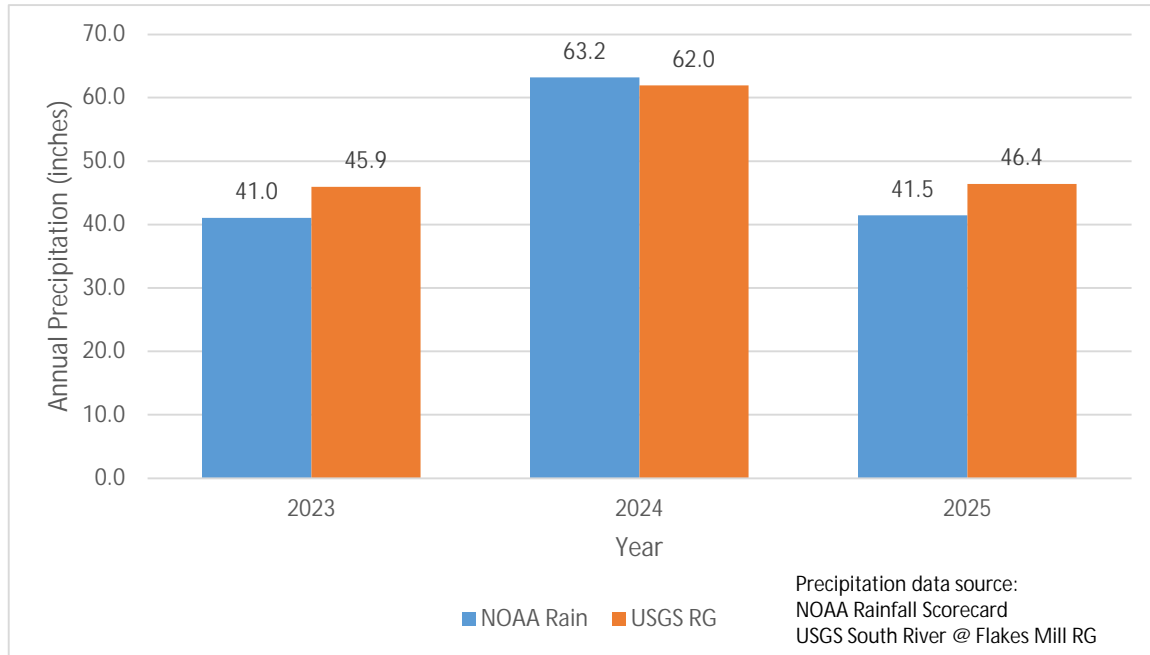
Figure 2-2 Annual Precipitation (inches) (2023–2025)

Figure 2-2 shows annual rainfall for the same period of record (2023–2025). In previous reports, the County would utilize the NOAA Rainfall Scorecard for Atlanta, which utilizes a rain gauge at Hartsfield Jackson International Airport. In conducting the SSO trends analysis, further evaluation was conducted to review USGS rain gauges that were located within the County to understand the effects of localized rain events. Utilizing USGS rain gauge 2203900, located at South River and Flakes Mill Road, located near the Snapfinger AWTF and in closer proximity to many of the wet weather SSOs was determined to be more applicable to the rainfall analysis. Total annual rainfall can vary by 5 – 6 inches between the NOAA and USGS rain gauges, with monthly variations as great as 2.5 inches.

Utilizing the rain gauges, total rainfall for 2025 decreased by 15 - 22 inches from 2024 levels. Annual rainfall levels of 41-46 inches are less than the average annual rainfall for the metro Atlanta area (~50 inches). There were 9 wet weather events greater than 1 inch total rainfall in 2025 compared to 16 in 2024. While there were no Severe Natural Condition events in 2025, there was one event that was equivalent to a 2-year storm on February 12-13, 2025.

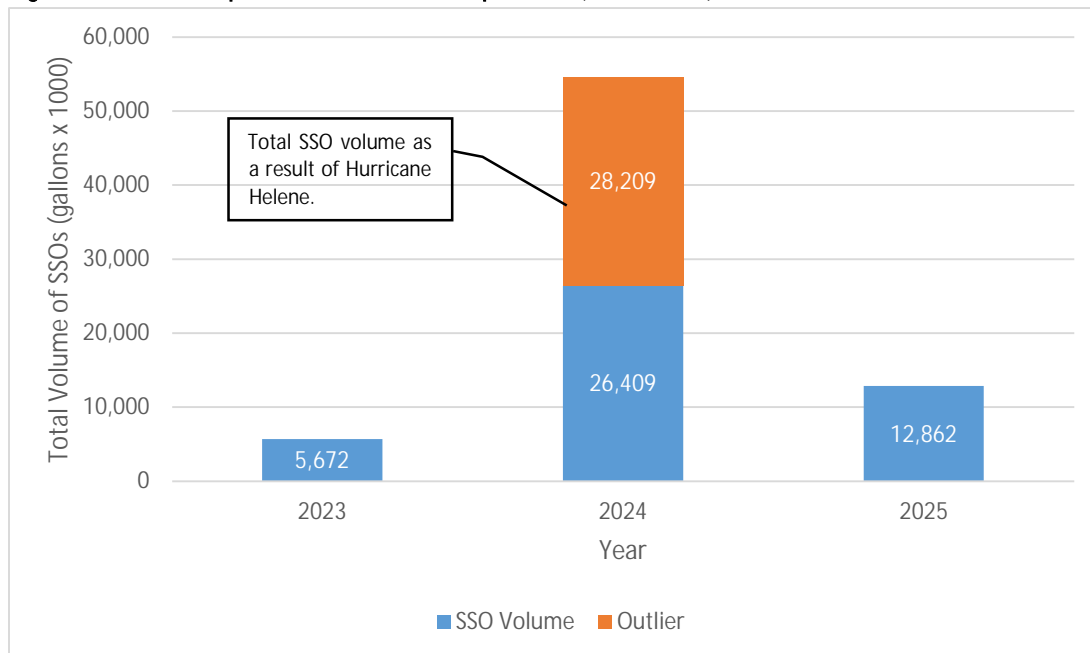
Figure 2-3 Reported Volume of SSOs per Year (2023–2025)

Figure 2-3 presents the total volume (gallons) of SSOs for 2023–2025. There was less rain observed in 2025 with one 2-year storm observed. Over 50% of the total SSO volume, 7.7 MG, occurred due to I/I from that event. While cleaning and FOG program enforcement have decreased maintenance-related SSOs overall, wet-weather-related SSOs are expected to decrease as the County begins construction on large-capacity projects.

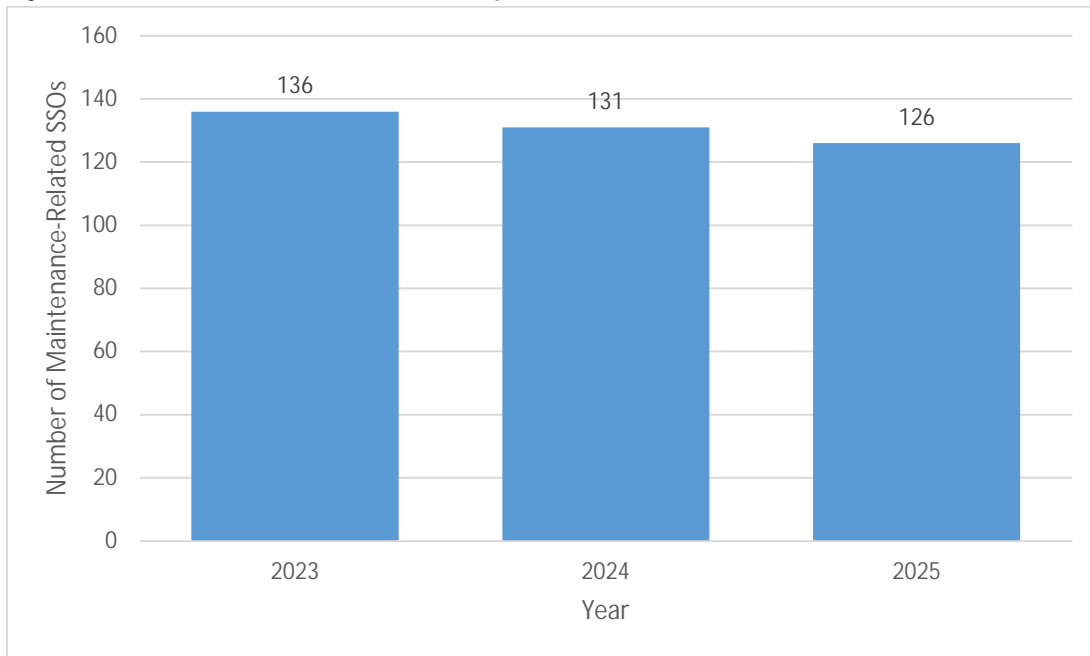
Figure 2-4 Maintenance-Related SSOs per Year (2023–2025)

Figures 2-4 and 2-5 show the number of maintenance-related SSOs and the associated annual volumes, respectively, from 2023 through 2025. From a peak of 238 SSOs in 2014 to 126 SSOs in 2025, DWM has reduced maintenance-related SSOs by 47 percent through a steady downward trend. In 2022, the County began to review the details of SSOs with a cause of unknown. If the work order comments indicate the

Note: Maintenance-related SSOs are caused by grease, roots, debris, or any combination thereof.

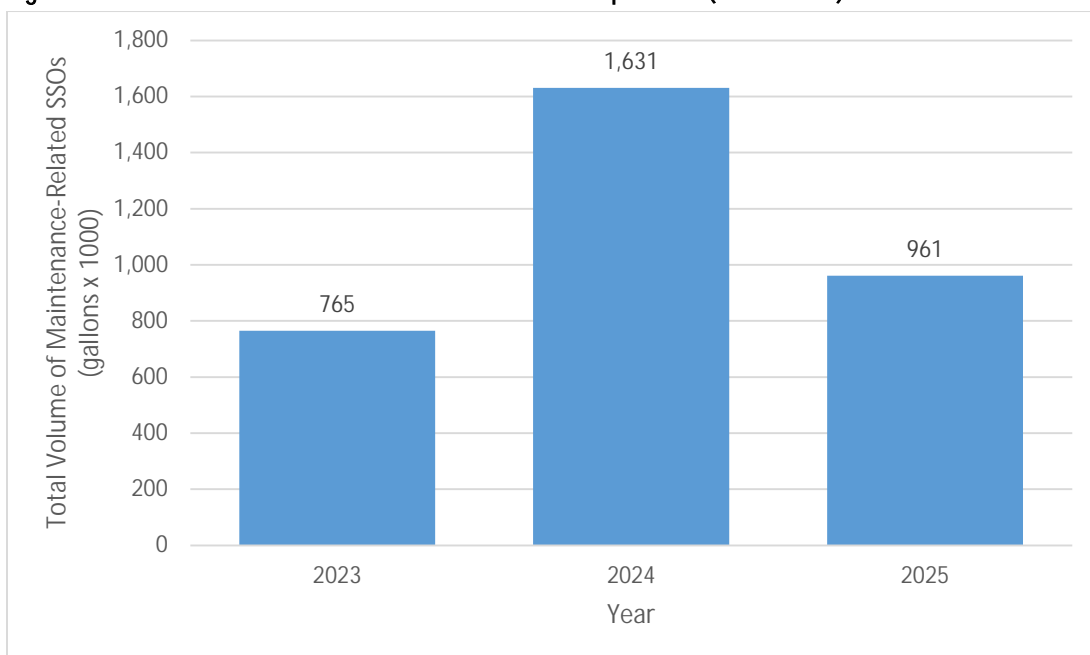
Figure 2-5 Volume of Maintenance-Related SSOs per Year (2023–2025)

The volume of maintenance-related SSOs for 2025 decreased from 2024. On average, maintenance related SSOs from 2025 are 7,000 gallons per SSO. Some maintenance related SSOs exceed that volume due to the size of the sewer main and quantity of flow or due to an extended duration in locating the source of the SSO. DWM believes decreases in the general trend of maintenance related SSO is attributable to the County’s implementation of MMS programs, such as sewer cleaning, root control, Cityworks, and the effectiveness of the FOG Management Program and public education campaigns.

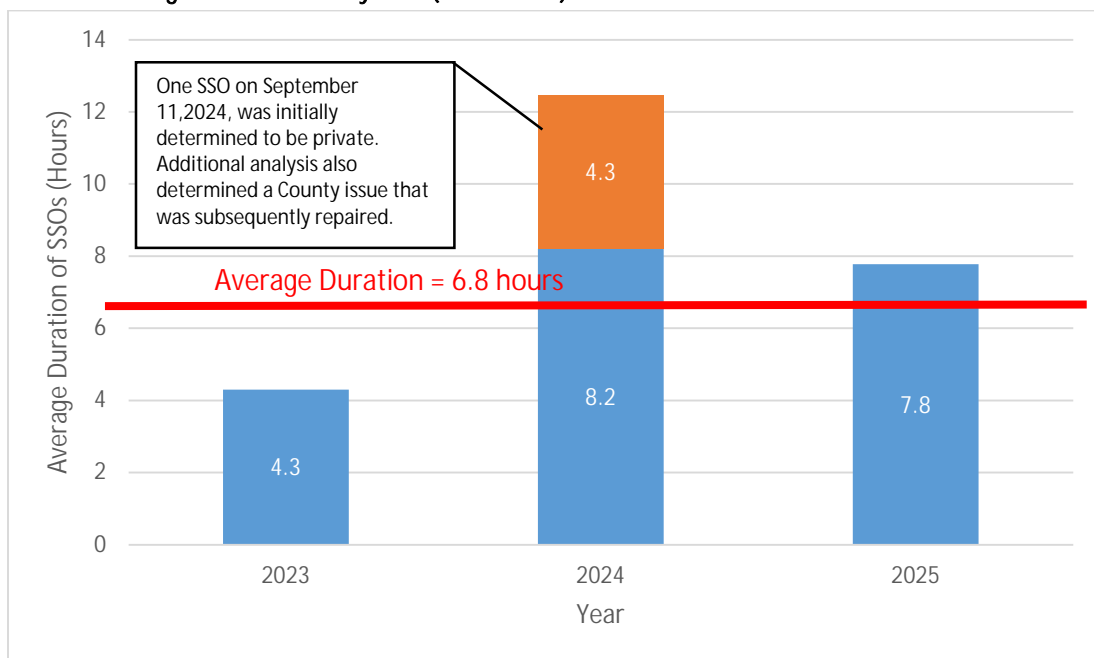
Figure 3-1 Average SSO Duration by Year (2022–2024)

Duration of SSOs are calculated from the time the SSO was reported until it is resolved. This parameter depends on how the SSO was identified, how quickly the source can be located and accessed, and the cause of the SSO. The average SSO duration from 2023 through 2025 was approximately 6.8 hours, when removing one outlying SSO from September 11, 2024 as shown on Figure 3-1.

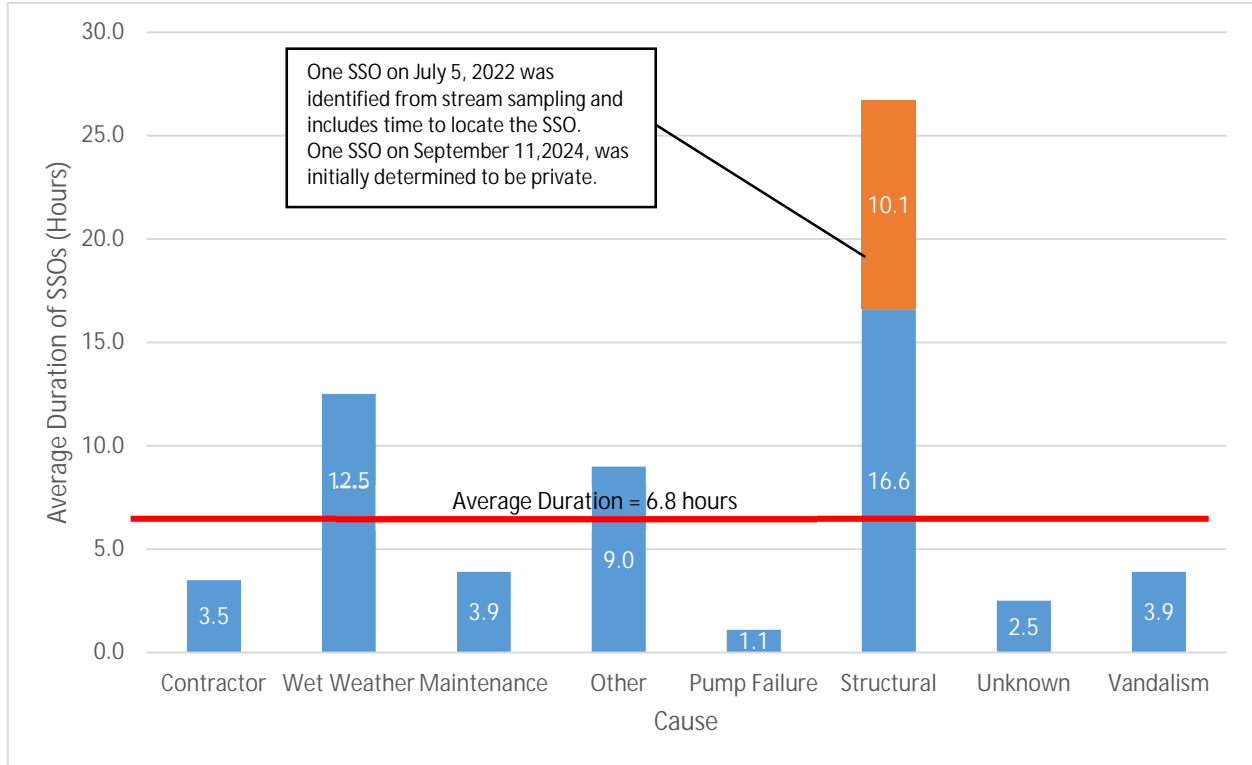
Figure 3-2 Average SSO Duration by Cause (2023–2025)

Figure 3-2 presents average durations for all SSOs from 2023 through 2025. Three causes had durations that were greater than average: wet weather structural, and other.

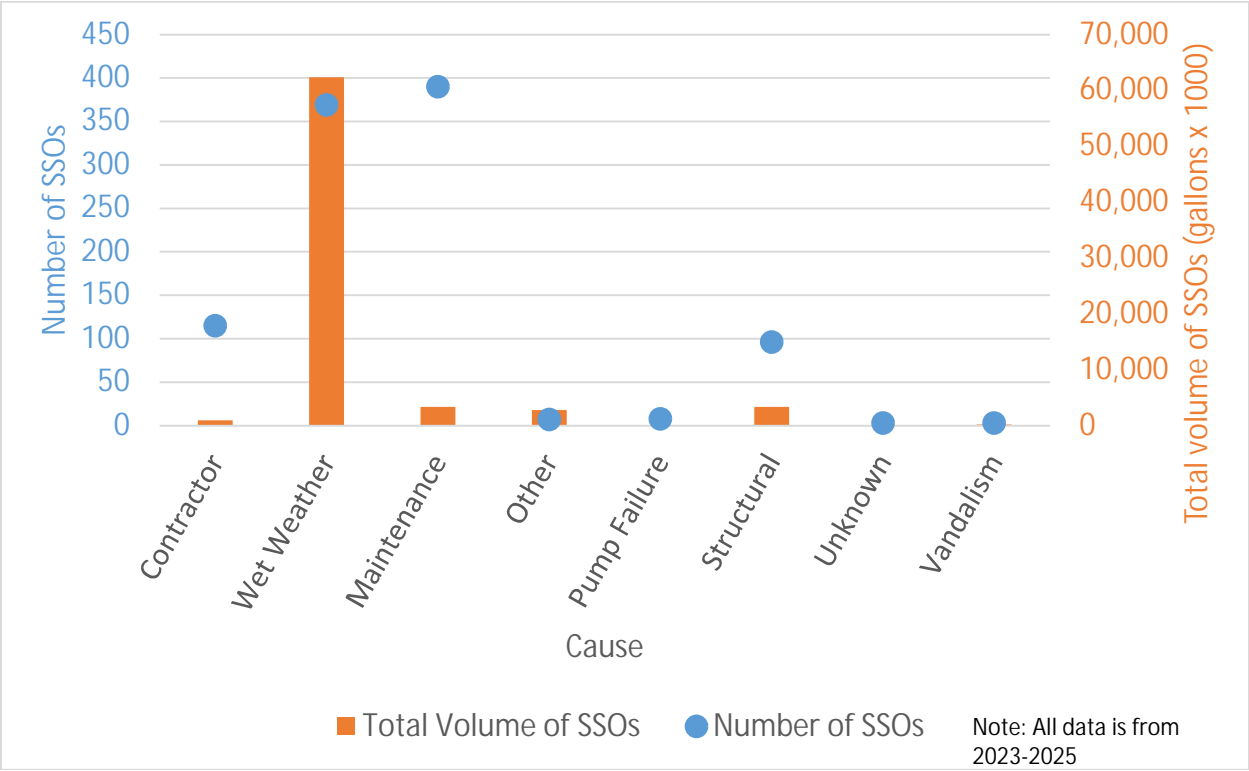
Figure 4-1 SSOs by Count, Volume, and Cause (2023–2025)

Maintenance-related SSOs, including grease, roots, and debris, decreased from 2012 to 2025 by 47 percent, a result, in part, of increased sewer cleaning and the County's commercial FOG Management Program and Public Education Programs. In reviewing data from the past 3 years, blockages continue to account for more SSOs than any other cause (39 percent) and only represent the third greatest volume (5 percent) of all SSO causes (refer to Figure 4-1). The cause with the greatest volume is wet weather, and the County is continuing to take steps to address impacts from storm-related events. Specifically, the County has undertaken follow-up and corrective action for private I/I and stormwater connections to the sanitary sewer in the Priority Areas. In 2025, 930 cleanout caps were replaced by DWM in the field. The continuation of these programs, along with the rehabilitation construction that is now underway, will begin to eliminate sources of I/I within the sewer system and provide additional capacity to help reduce the SSOs that occur because of wet weather.

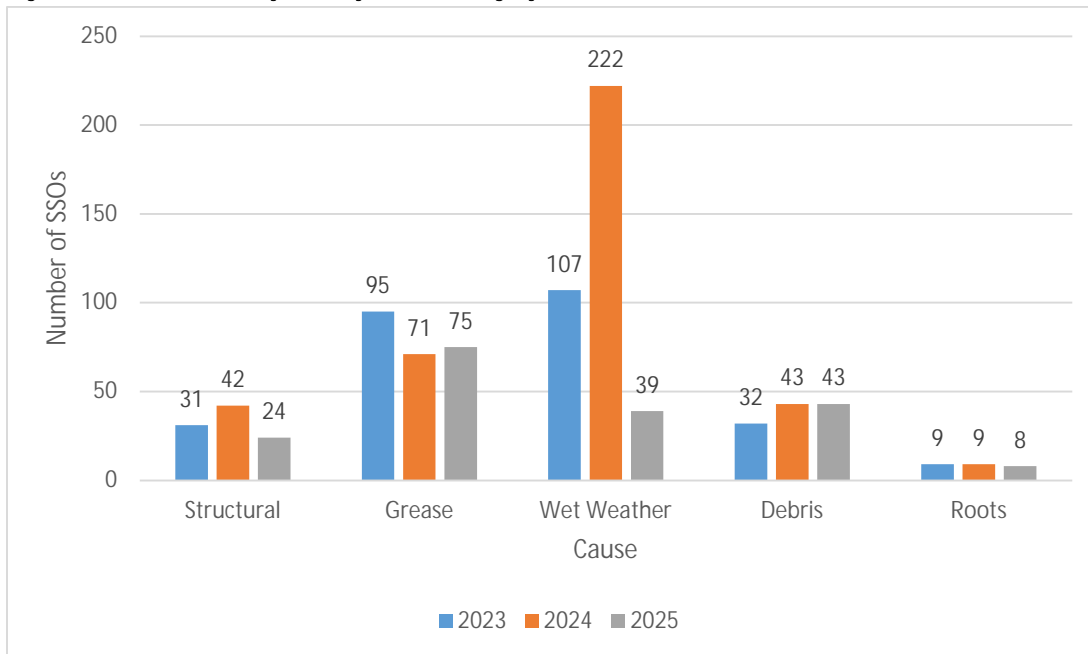
Figure 4-2 SSOs by Year by Cause Category (2023–2025)

Selected causes can be grouped into categories that help assess the effectiveness of DWM’s efforts to reduce SSOs. These broader categories are grease, structural, wet weather, and debris. Table 4-1 lists the causes assigned to each category. As shown on Figure 4-2, there has been a decrease in structural and wet weather SSOs, and grease, root and debris SSOs have remained steady compared to 2024 levels.

Notes:
Cause Categories may include more than one cause. Some SSOs appear in more than one Cause Category.
Other causes for spills not shown in this figure include pump failure, vandalism, contractor-related, etc.

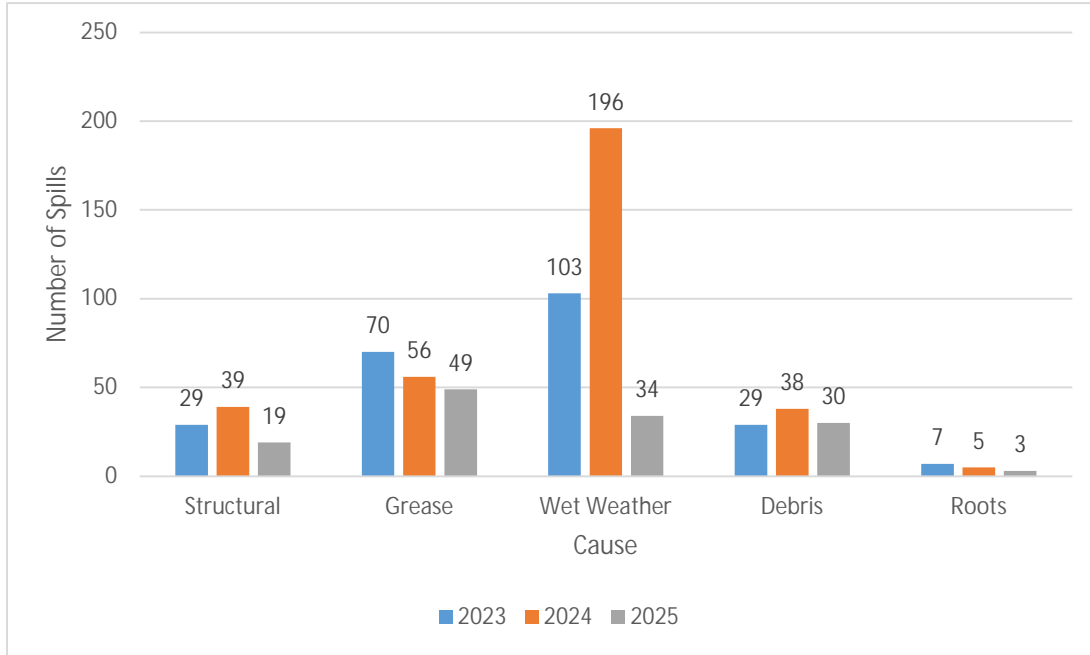
Figure 4-3 Spills by Year by Cause Category (2023–2025)

These same cause categories, when applied specifically to spills, show similar trends (refer to Figure 4-3).

Note: Cause Categories may include more than one cause. Some SSOs appear in more than one Cause Category. Other causes for spills not shown in this figure include pump failure, vandalism, contractor-related, etc.

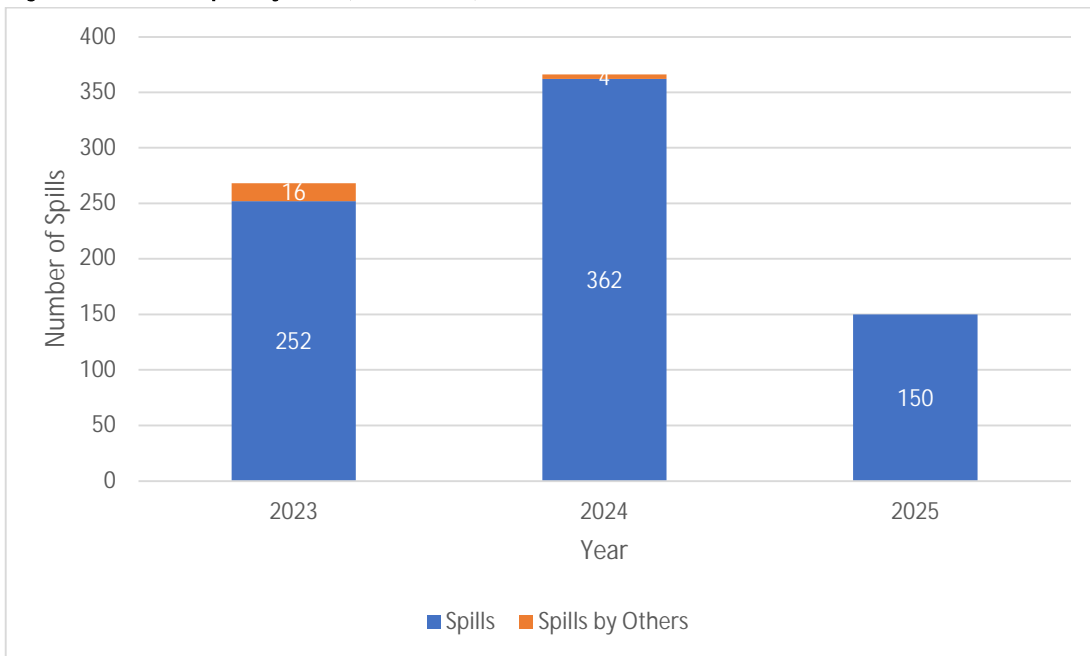
Figure 4-4 Spills by Year (2023–2025)

Figure 4-4 presents the number of spills by year. The number of total spills per year decreased from 2023 to 2025. This is heavily influenced by the number and type of rain events over the course of the year causing wet weather spills. Sewer rehabilitation and capacity relief projects have continued under a number of projects to reduce wet weather SSOs. In 2025, pipe upsizing projects completed at a number of repeat SSO sites including 1440 Sowell Estate, 2060 Keheley Drive, 2562 Tilly Mill Rd, 307 2nd Avenue/607 3rd Avenue, Brookfield Lane/Cobb Branch Drive, and 3911/3924 Roman Court have reduced the number and volume of wet weather SSOs.

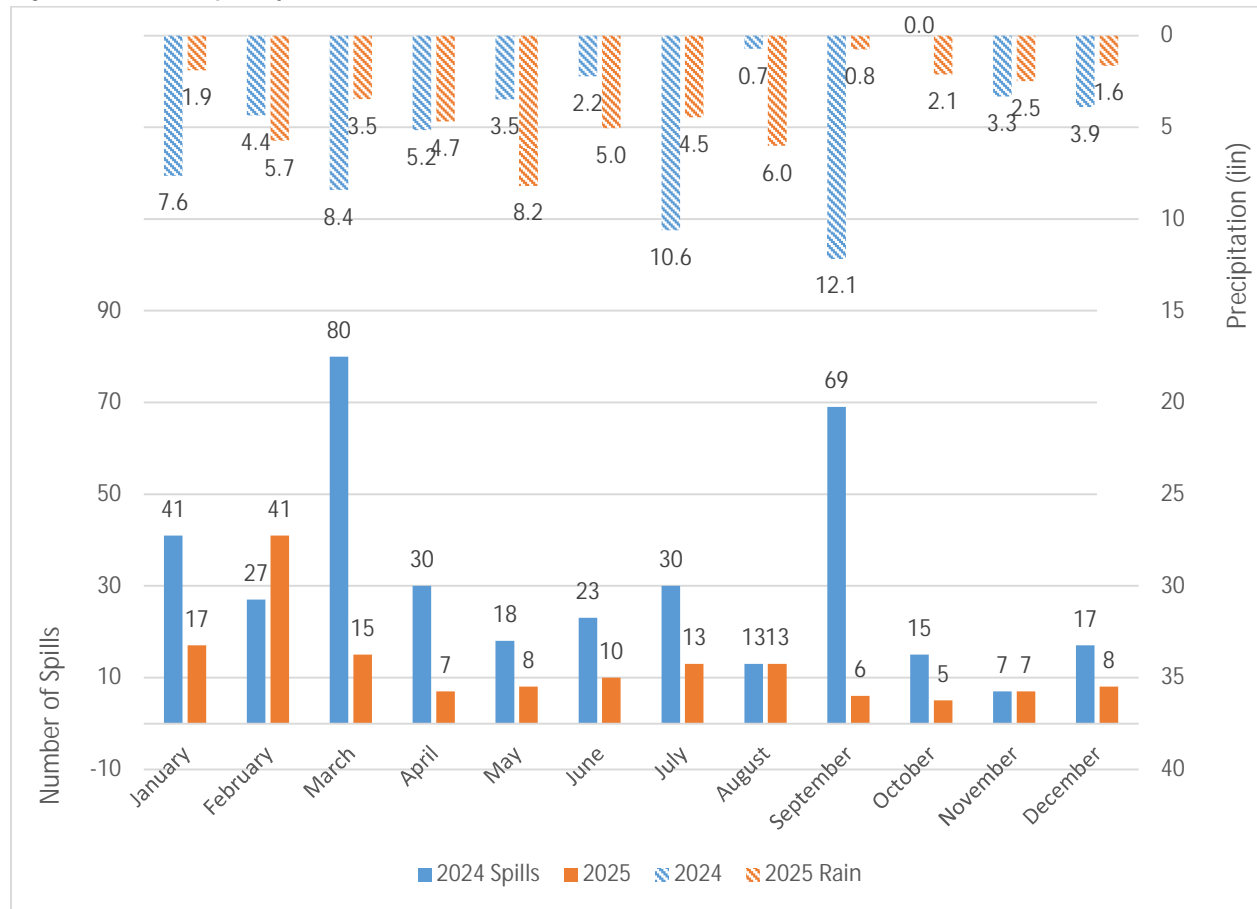
Figure 4-5 Spills by Month (2024–2025)

Overall, spills decreased between 2024 and 2025. Figure 4-5 shows a month-to-month comparison of spills from 2024 and 2025. In 2025, February saw the most spills due to the February 12-13, 2025 2 year storm event.

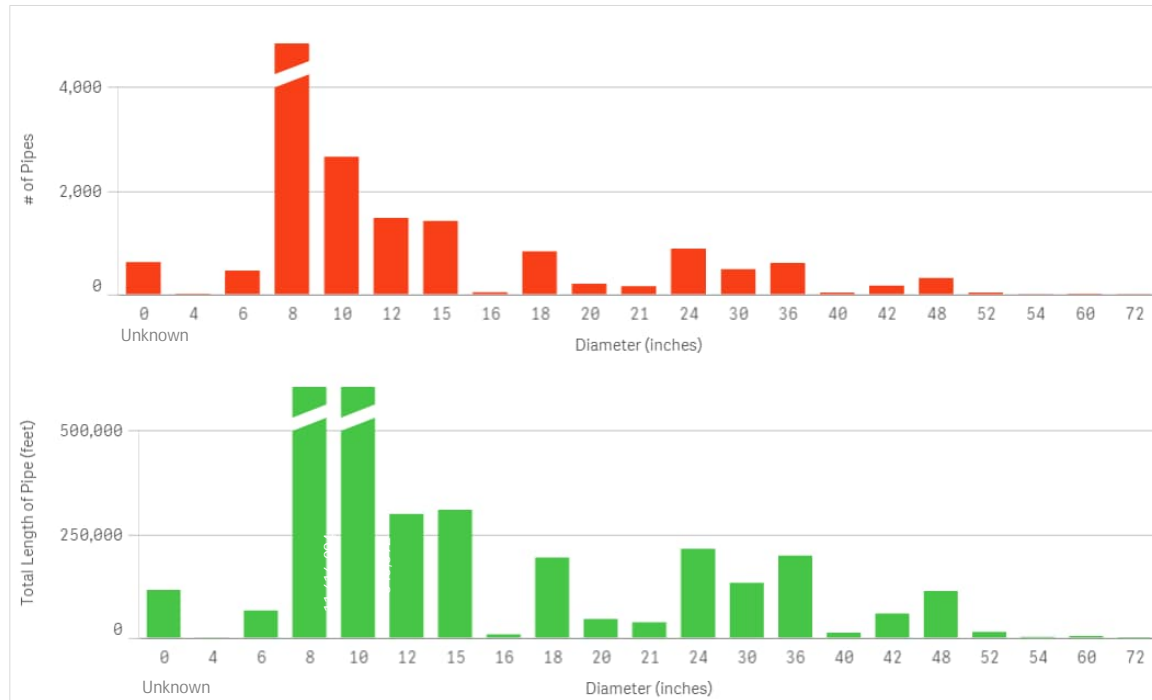
Figure 5-1 Sewer Gravity Main Pipe Count and Length by Diameter

The most common pipe diameter in the collection system is 8 inches, as shown on Figure 5-1. Pipes with a diameter of 8 inches account for 85 percent of the total number of pipes and 83 percent of the total length of pipe. Likewise, most spills are associated with pipes of 8 inches in diameter (Figure 5-2).

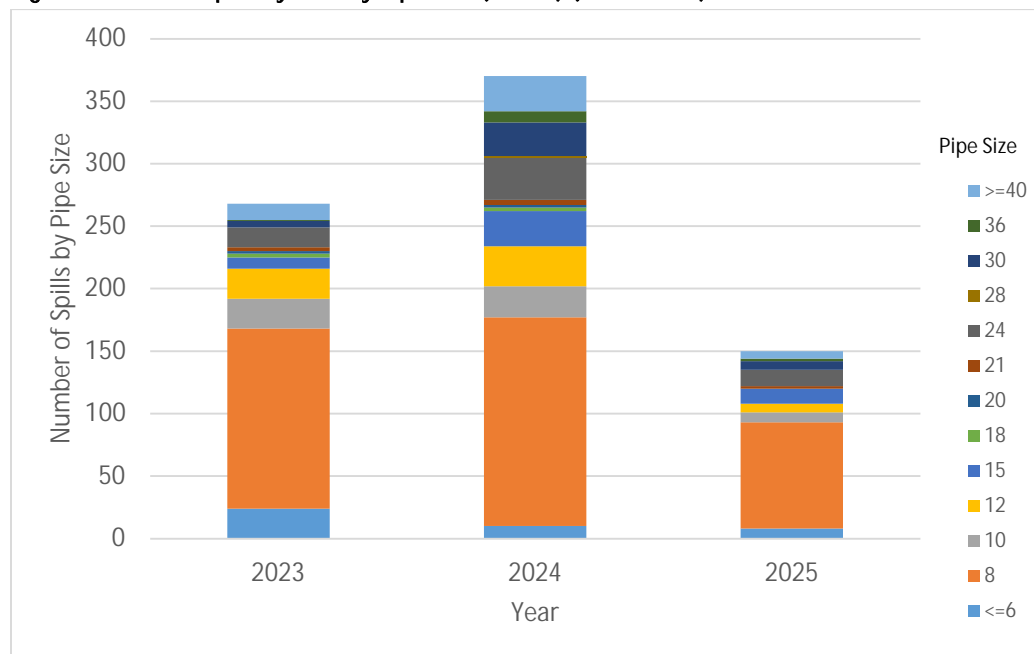
Figure 5-2 Spills by Year by Pipe Size (Inches) (2023–2025)

Notes: Only spills have an associated pipe size linked to an SSO, so only spills are included in this figure.

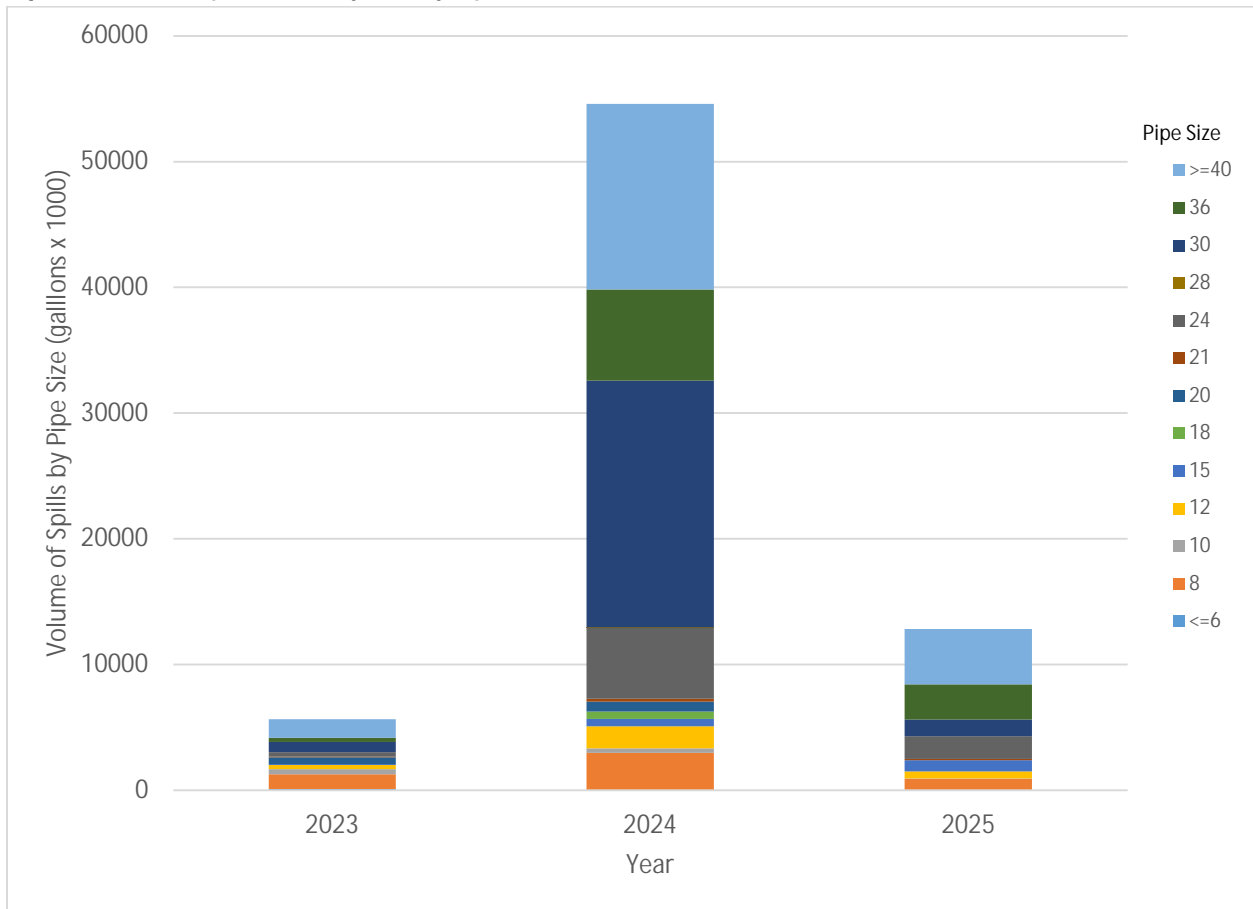
Figure 5-3 Spill Volume by Year by Pipe Size (2023–2025)

Figure 5-3 shows the volume of spills by pipe size. There is correlation between pipe size and volume of SSO, as larger pipes have greater capacity, generally convey more flow, and in cases of structural repairs, can take longer to restore.

Only spills have an associated pipe size linked to an SSO, so only spills are included in this figure. Pipe diameter was not always recorded; thus, some are blank or N/A.

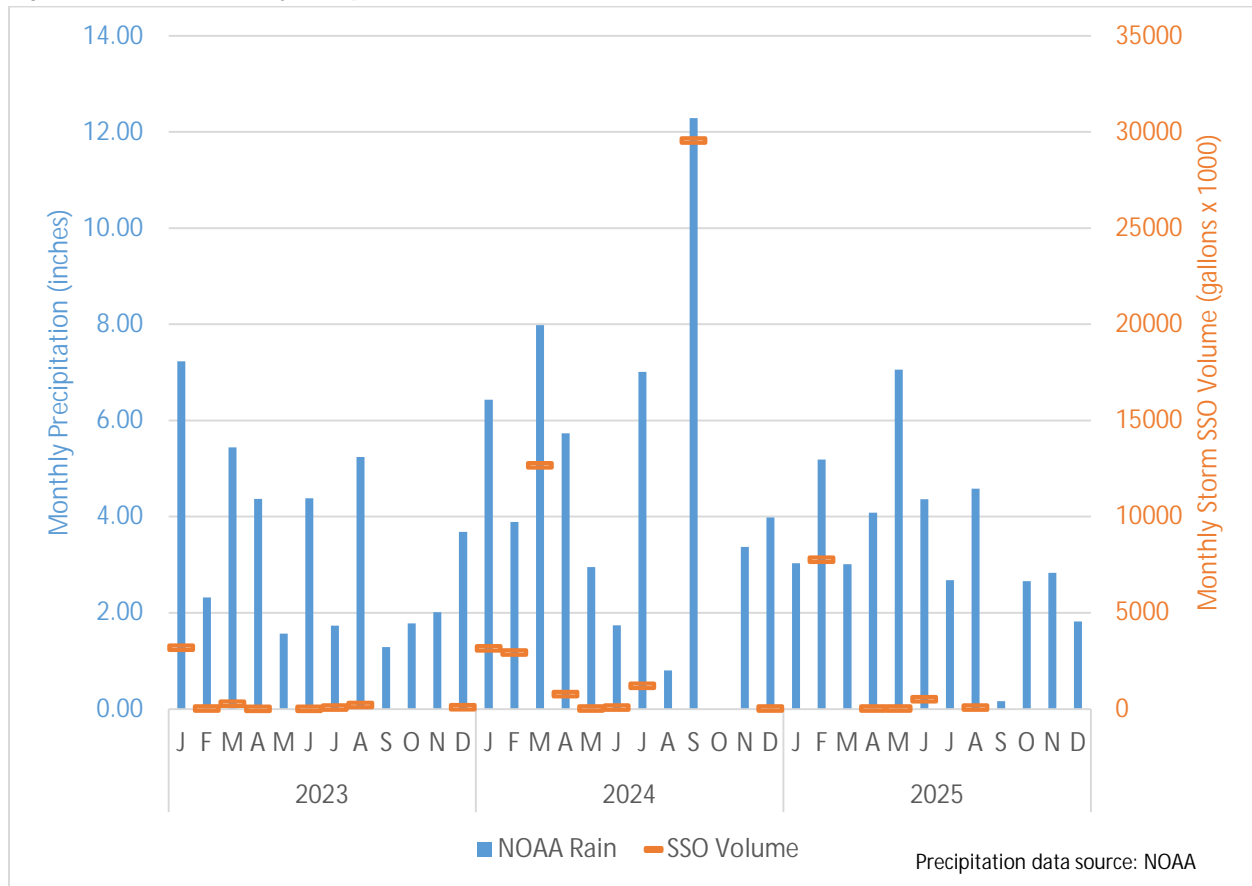
Figure 5-4 Monthly Precipitation and Wet-Weather-Induced SSO Volume (2023–2025)

The difference in rainfall intensity is reflected in the data for SSOs and spills caused by wet weather. In 2023, 103 spills were attributed to wet weather (39 occurred on 2 wet weather events that exceeded 2-year recurrence levels) and in 2024, 196 spills were attributed to wet weather (54 occurred during Hurricane Helene and an additional 77 during the two other Severe Natural Condition events). In 2025 34 spills were attributed to wet weather (25 occurred on 1 wet weather event equal to a 2-year recurrence level). The volume for spills caused by wet weather was approximately 3.7 million gallons in 2023, 50.3 million gallons in 2024 (28.2 MG during Hurricane Helene and another 14.6 MG from the other two Severe Natural Condition events) and 8.3 million gallons in 2025. Figure 5-4 shows rainfall and SSO volume by month from 2023 through 2025.

Note: Only spills with a cause of STORM or I/I are represented on this figure.

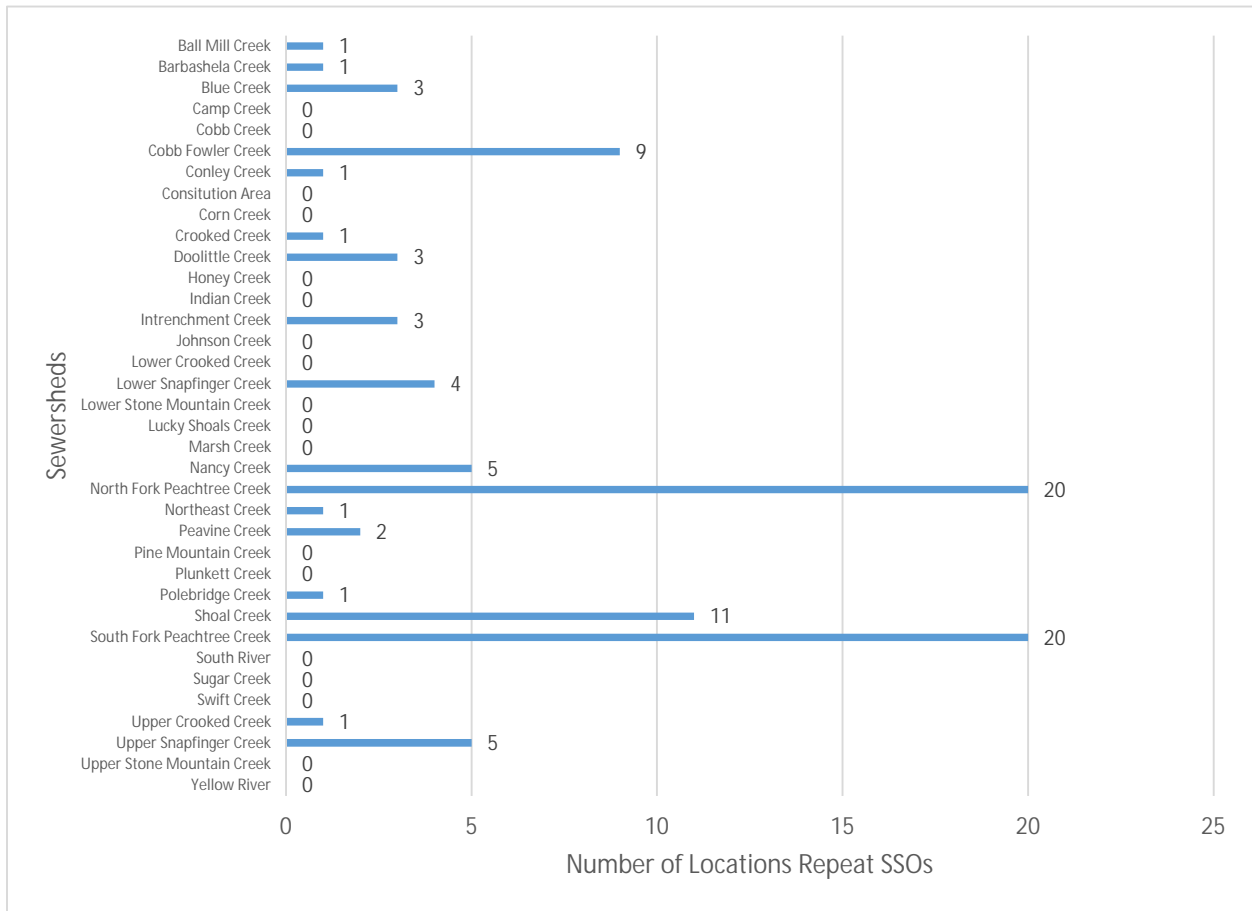
Figure 5-5 Number of Locations with Repeat SSOs by Sewershed (2025)

DWM defined 500-foot-radius areas with repeat SSOs and tallied the repeat SSO locations by sewershed (refer to Figure 5-5). For 2025, the total number of repeat SSOs was 92. North Fork Peachtree Creek and South Fork Peachtree Creek had the greatest number of repeat SSO locations. The majority of these SSOs are maintenance related in North Fork Peachtree Creek and maintenance and structural related in South Fork Peachtree Creek. Focused cleaning and implementation of the Find and Fix Program is aimed at reducing these repeat SSOs.

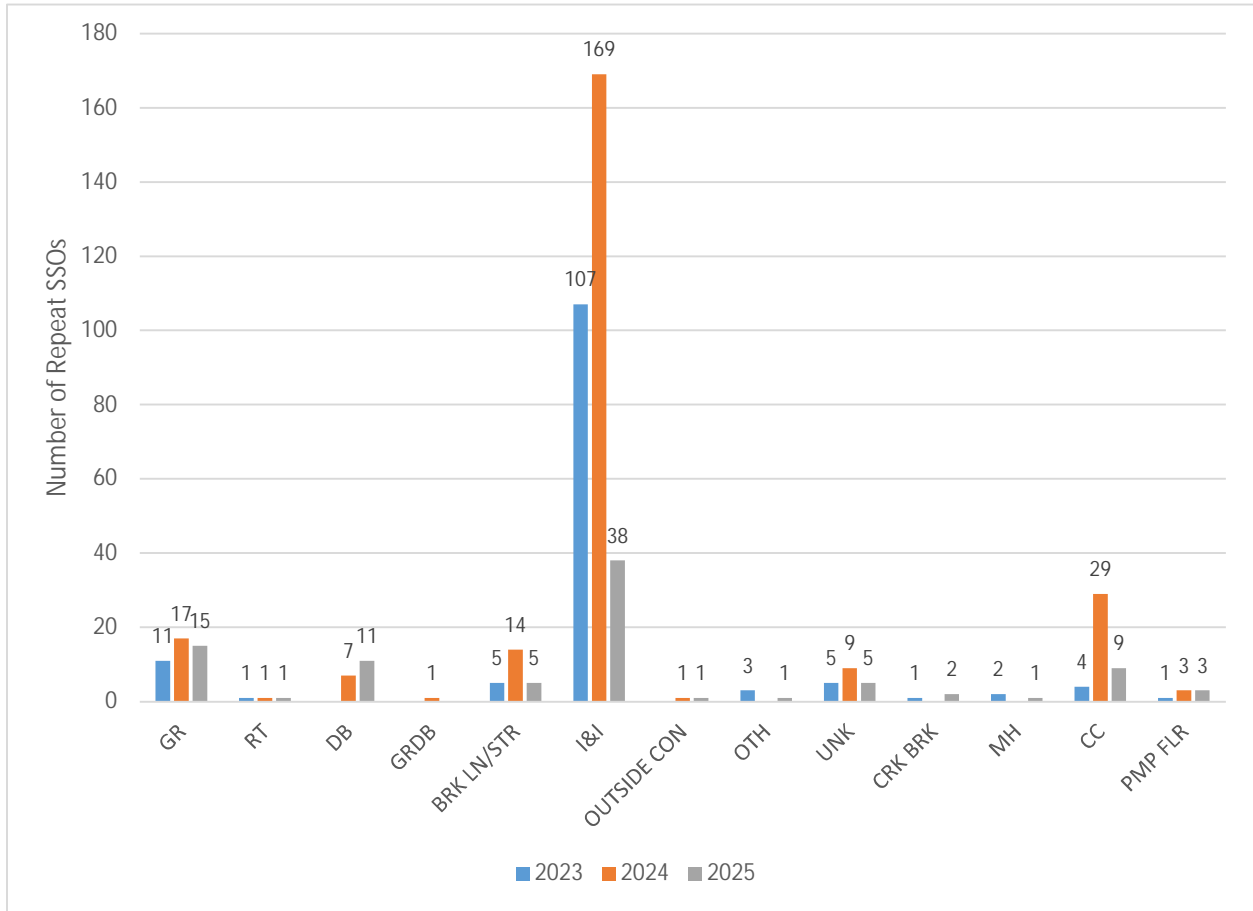
Figure 5-6 Number of Repeat SSOs by Cause (2023–2025)

The most common cause of repeat SSOs in 2025 was wet weather (refer to Figure 5-6). Wet-weather-related, repeat SSOs have decreased 2023 to 2025 due to decrease in severe weather events and completion of a number of capacity relief projects. As planned rehabilitation measures are constructed to reduce I/I sources and provide capacity in the system, wet-weather SSOs are expected to continue to decrease. DWM has identified historical repeat SSOs and has developed remediation plans to address these issues.

Note: All I/I SSOs recorded to date were wet-weather-related.
