RE: Clean Water Act Consent Decree 1:10cv 4039-SDG
Annual Report #14 Submittal due March 2, 2026

Annual Report No. 14

January 1, 2025, to December 31, 2025
Civil Action No. 1:10cv4039 - SDG

DeKalb County
Department of Watershed Management

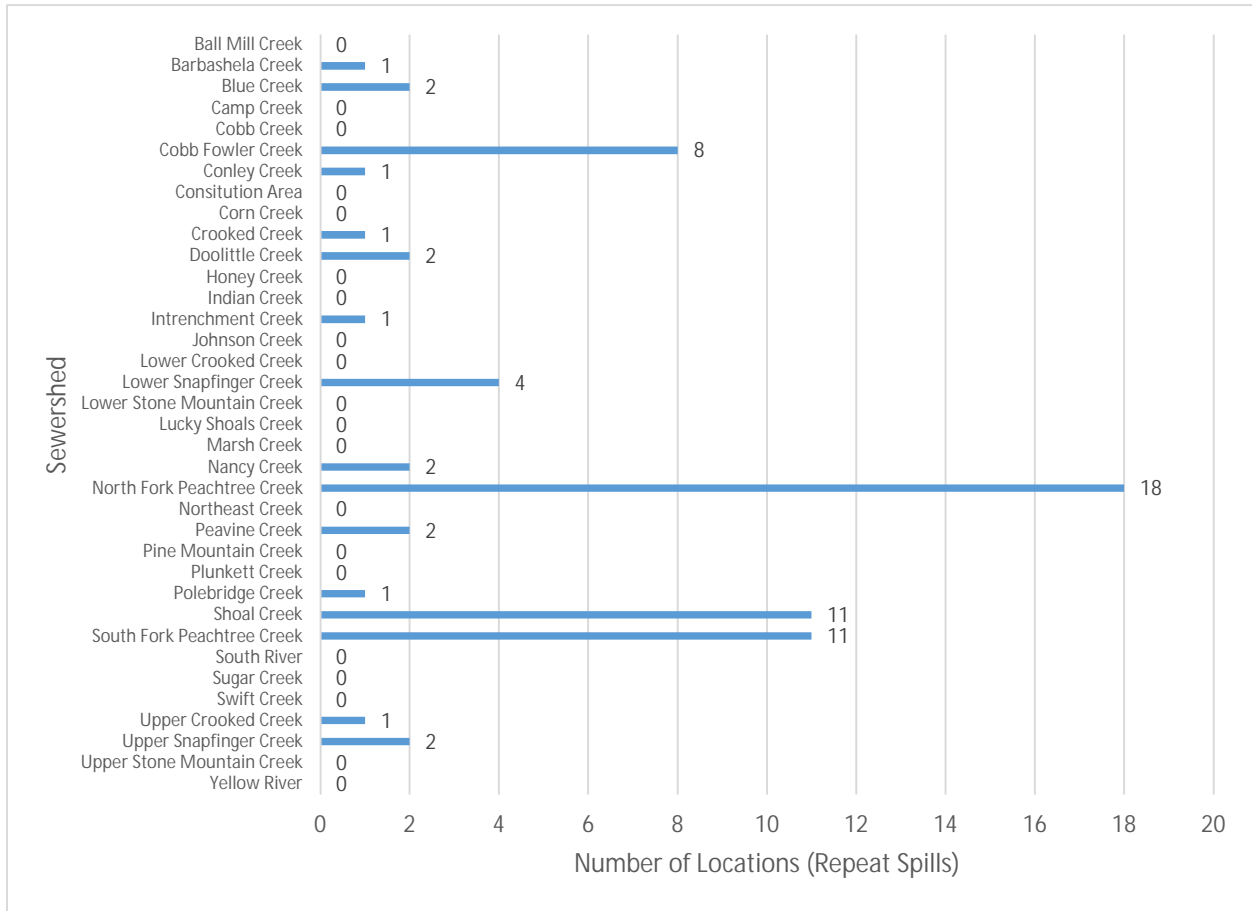
Figure 5-7 Number of Locations with Repeat Spills by Sewershed (2025)

Similarly, DWM analyzed only those SSOs that are categorized as spills. From 2024 to 2025, repeat spills decreased. North Fork Peachtree Creek, South Fork Peachtree Creek, and Shoal Creek had the greatest number of repeat spill locations in 2025 (refer to Figure 5-7).

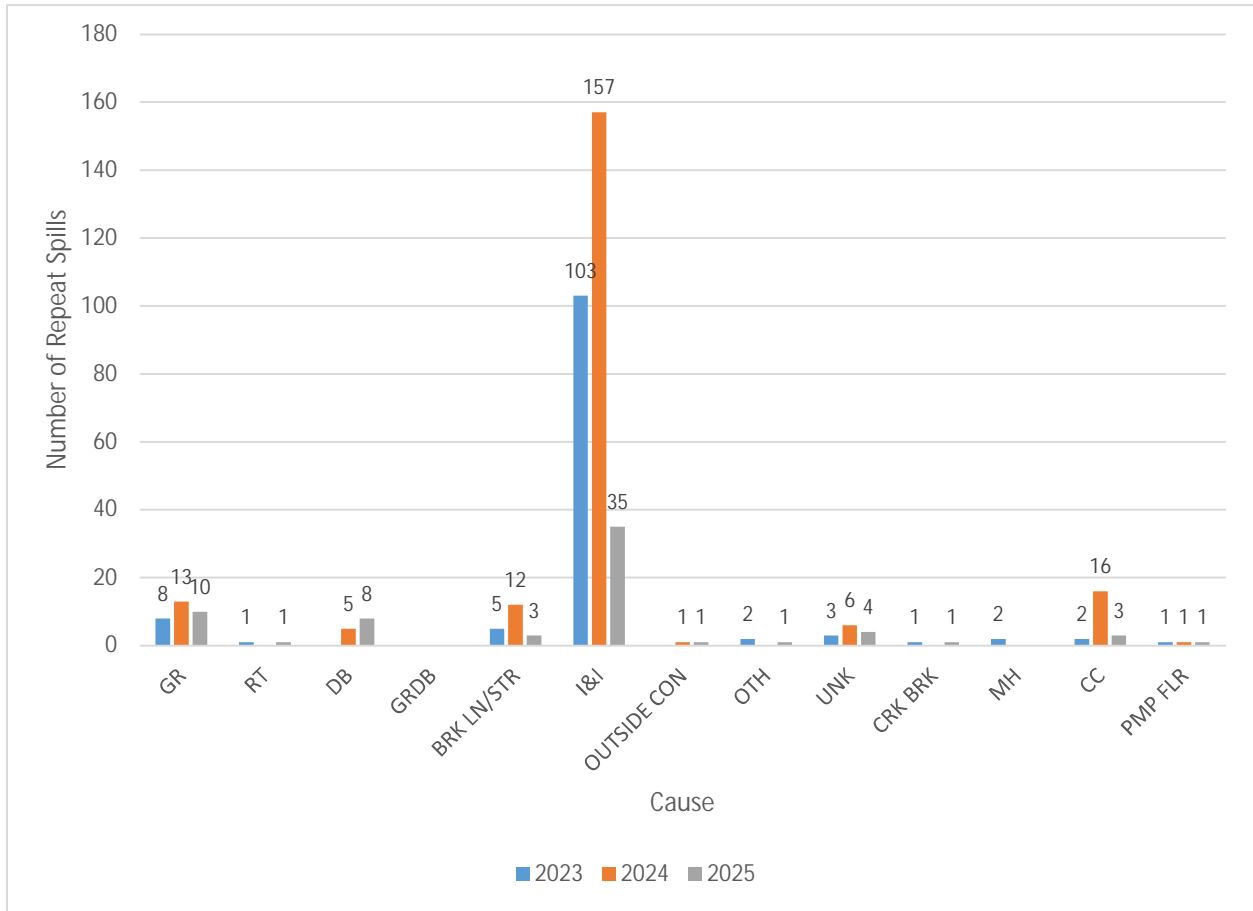
Figure 5-8 Number of Repeat Spills by Cause (2023 – 2025)

The most common cause of repeat spills is wet weather (refer to Figure 5-8). Wet-weather-related repeat spills increased from 2022 to 2024. As rehabilitation measures are constructed to reduce I/I sources and provide capacity in the system, wet weather SSOs are expected to decrease.

Note: All I/I SSOs recorded to date were wet-weather-related.

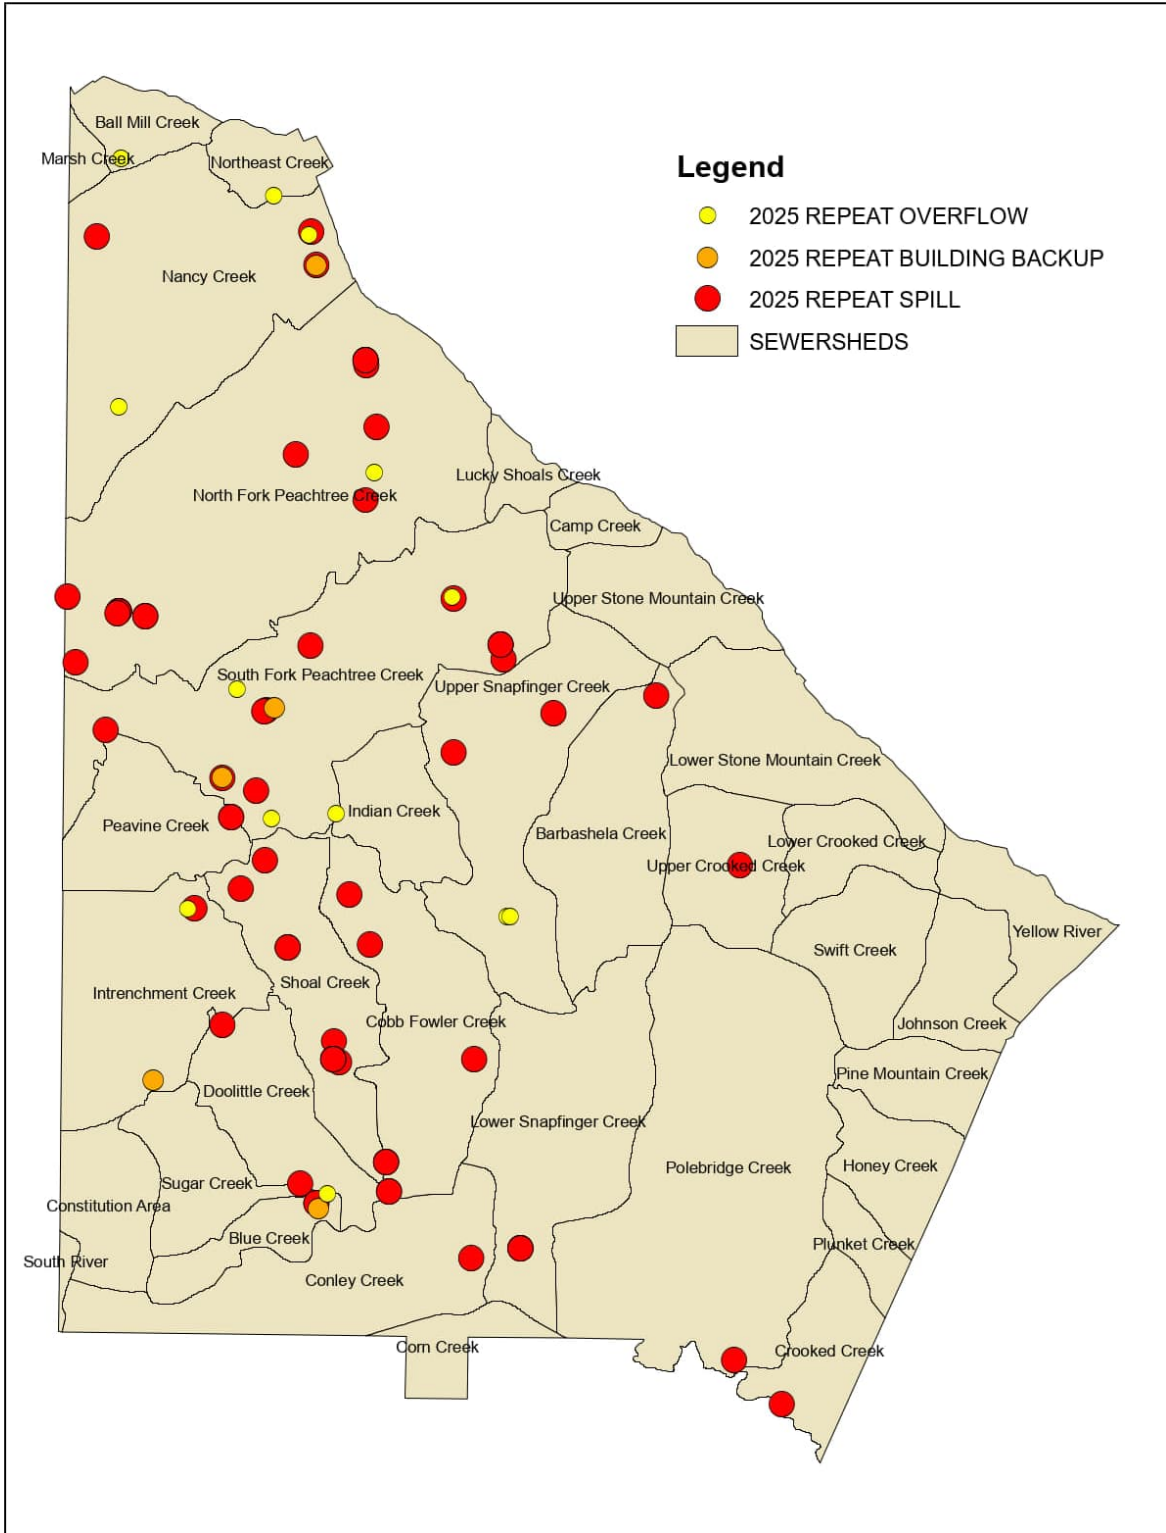
Figure 5-9 Repeat SSOs

The spatial distribution of repeat SSOs and repeat spills are shown on Figures 5-9 and 5-10, respectively.
