DeKalb County Historic Preservation Commission

K. 1080 Clifton Road, Brian E. Daughdrill. Demolish a historic house, remove a nonhistoric garage, and construct a nonhistoric house. **1248160.**

Subject: **Structural Assessment**
1080 Clifton Rd
Atlanta, GA
CERM Project No. 2025-0862F-017F

STRUCTURAL ASSESSMENT

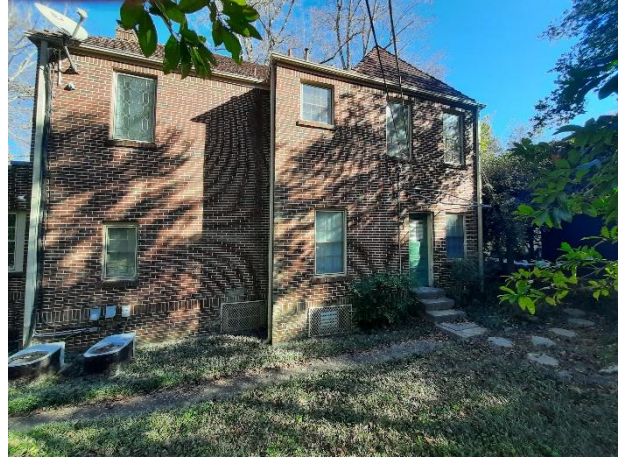
Photo 2
Rear of House (West Façade)

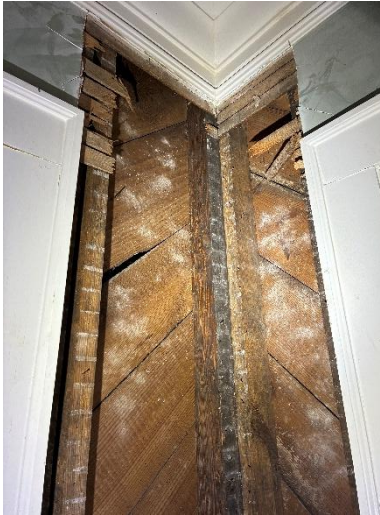
Photo 19

Dining Room Wall Framing

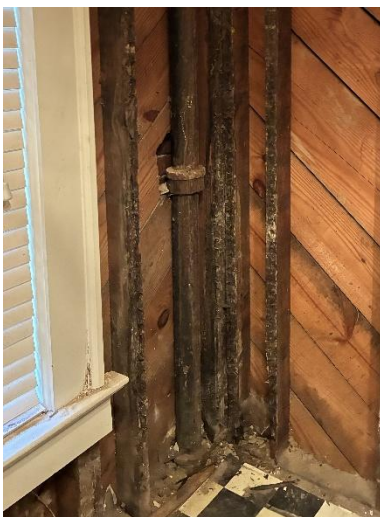
Photo 22

Breakfast Nook Wall Framing

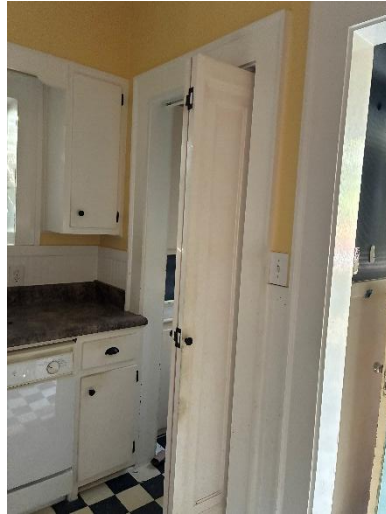
Kitchen

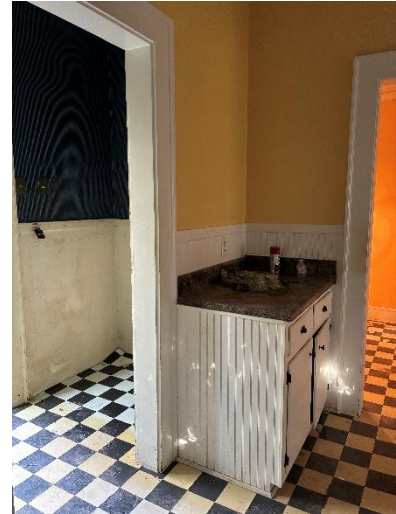
Kitchen

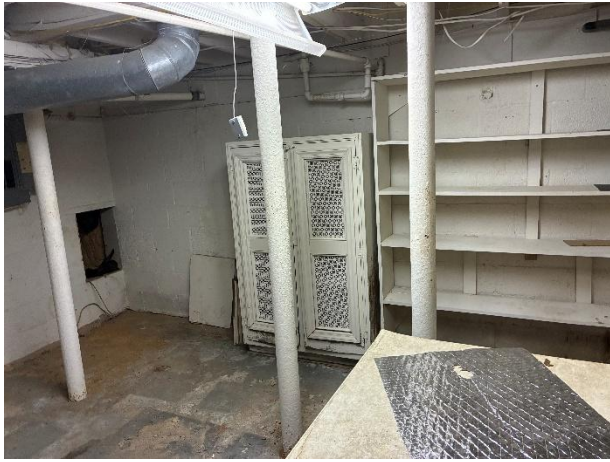
Basement

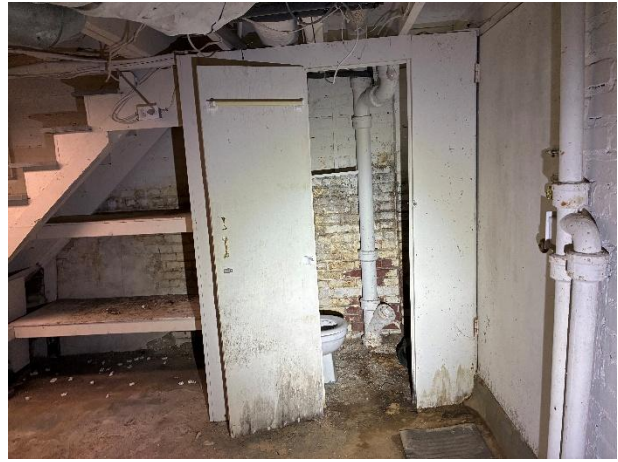
Basement
